Arlington National Cemetery Southern Expansion – Boundary Wall Evaluation

October 28, 2016

Prepared by:

BELL Architects, PC
1228 9TH Street NW
Washington DC 20001

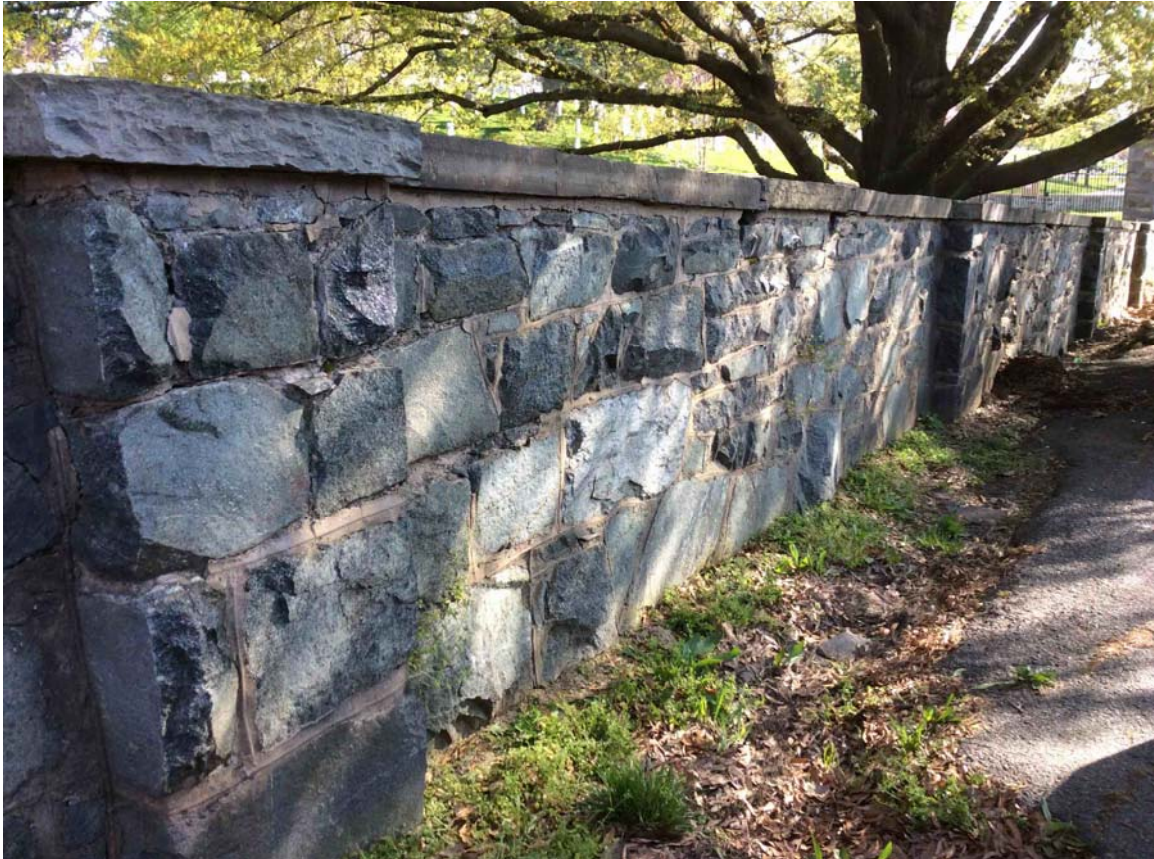
Figure 7- Westernmost section of boundary wall in study area

The westernmost section extending from the corner eastward to the South/Clayton Gate is built with rough ashlar coursing with a bluestone cap that slightly overhangs the wall below. This section of wall does not have a fence on top of the cap stones (**Figure 7 and Figure 8**).

The portion of the stone masonry wall west of the South/Clayton Gate at Patton Drive retains a high degree of integrity for all seven aspects (See Figure 7, and Appendix A1.02 to A1.12). This portion of the southern boundary wall has not been significantly altered and is in good repair. Minor deterioration of mortar, slight shifting of masonry units and an overall change of grade over time, which is expected for landscaped areas, do not diminish its integrity to convey the significance of this boundary wall.

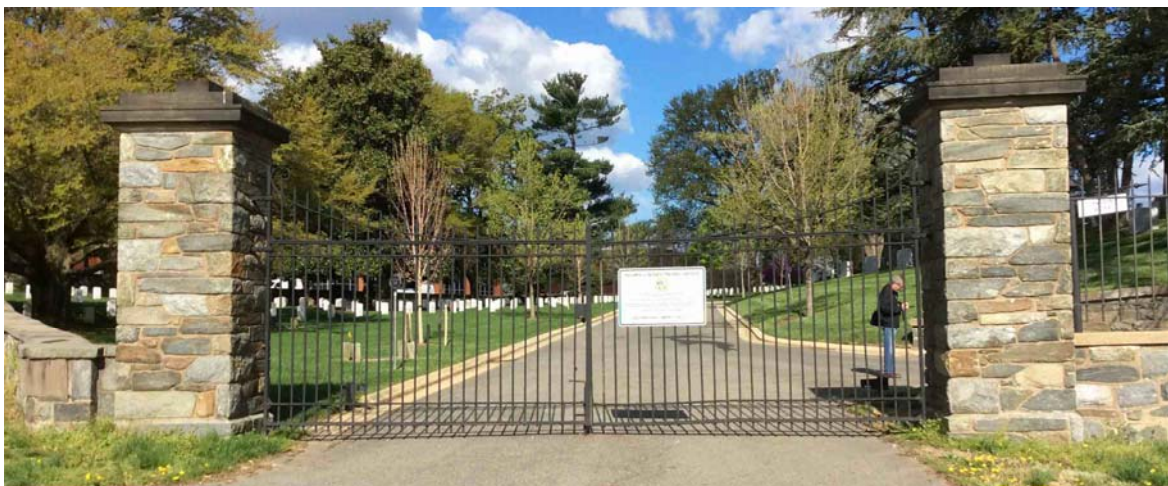
Figure 13- South/Clayton Gate

The portion of the stone masonry wall with concrete cap stone east of the South/Clayton Gate, extending to the former location of Georgetown and Alexandria Road retains its integrity (See Figure 13, and Appendix A1.13 to A6.12). This section has seen modifications including the replacement of the capstone and addition of a metal fence, along with changes to the grades. The grades were likely changed with the addition of Patton Drive. Even with these changes the fabric of the stone wall remains intact, and the grade changes and additional road contribute to the cemetery fabric. This section of wall retains its original location, materials, and association with the cemetery, while its integrity was reduced with the modifications performed with the addition of the metal fence.

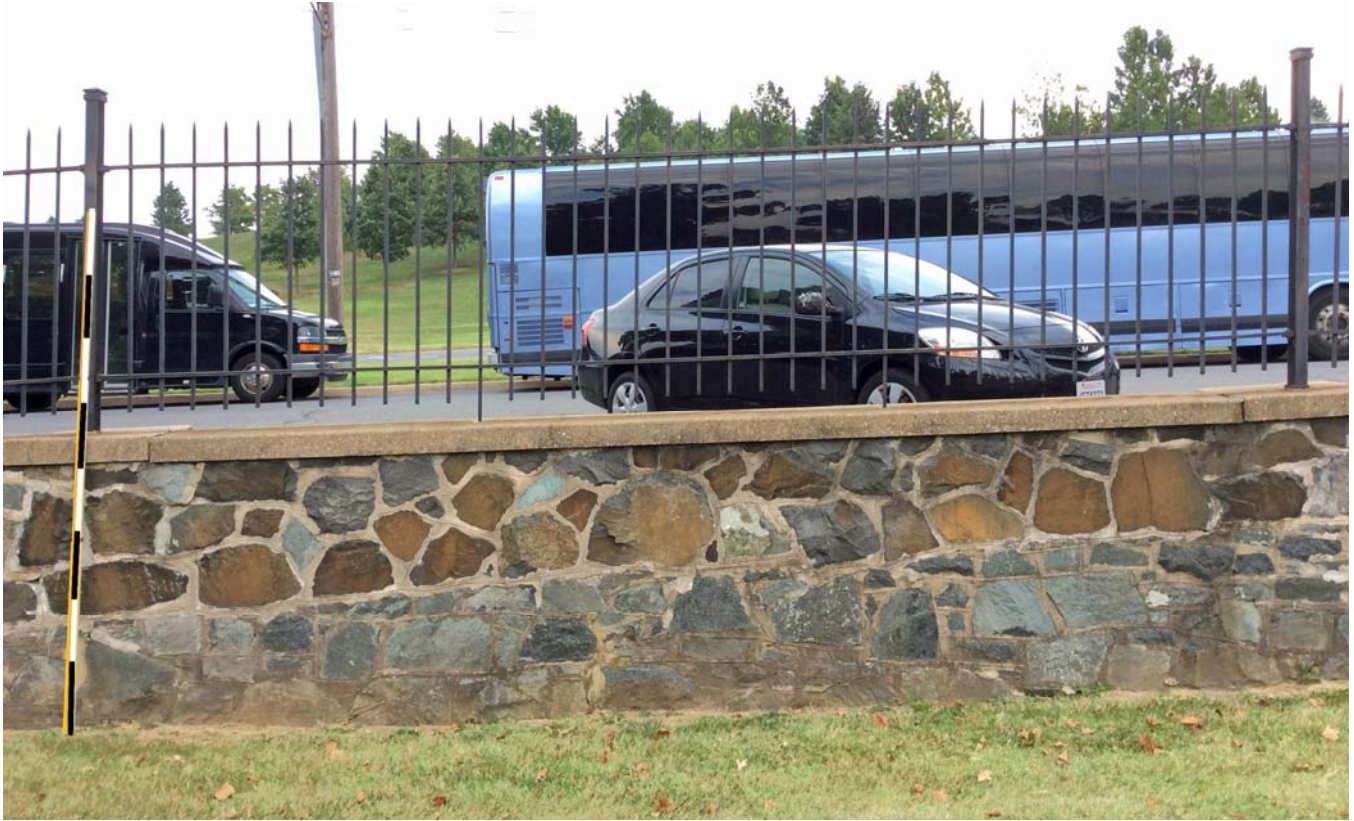
Figure 19- Boundary wall acting as a retaining wall

In some locations the wall is acting as a retaining wall as the cemetery side is typically lower than the sidewalk/street outside of the wall (**Figure 19**). There is a grade difference up to four feet between each side of the wall. **Figure 20** shows spot elevations on each side of the wall along the portion of the wall that currently serves as a retaining wall.

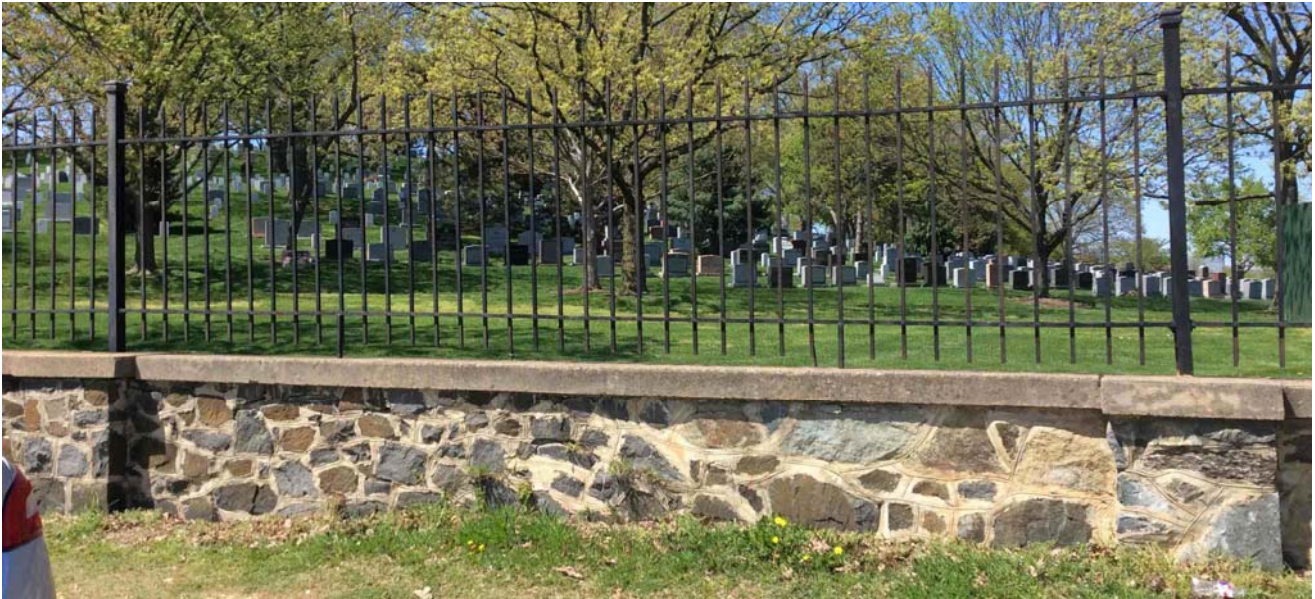
Figure 23- Area of large rubble stones

East of the Columbia Pike/Joyce Street intersection where the wall starts to undulate, the stone of the wall changes in color, shape, and size. Smaller rubble stones with a more brown color were used to construct this section of the wall. A approximately a third of the way through Section 3 near the edge of the Temporary Service Area the stones change in size to larger rubble stones, and the fence has welds from modifications (Figure 23 and Figure 24).

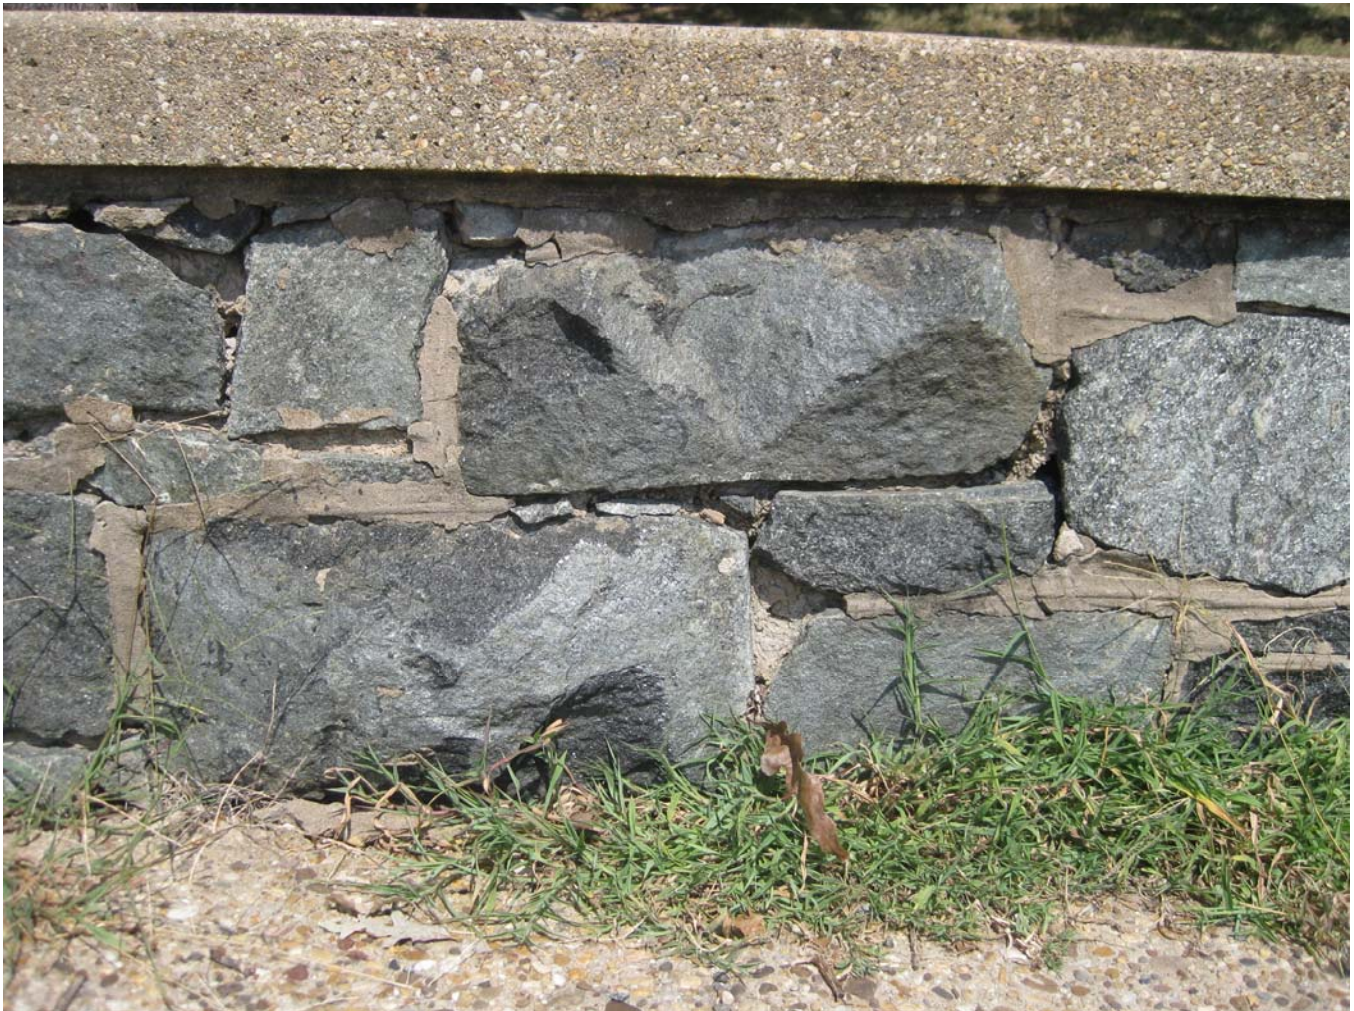
Figure 33- Deteriorated Mortar (typical view from outside cemetery)

Overall the boundary wall is in good condition with limited areas of mortar deterioration (**Figure 33**). In the worst cases plant material is growing from the mortar joint. Many of the sealant joints between the cap stones are no longer fully adhered. For the metal fence there is some surface rusting (**Figure 34**).

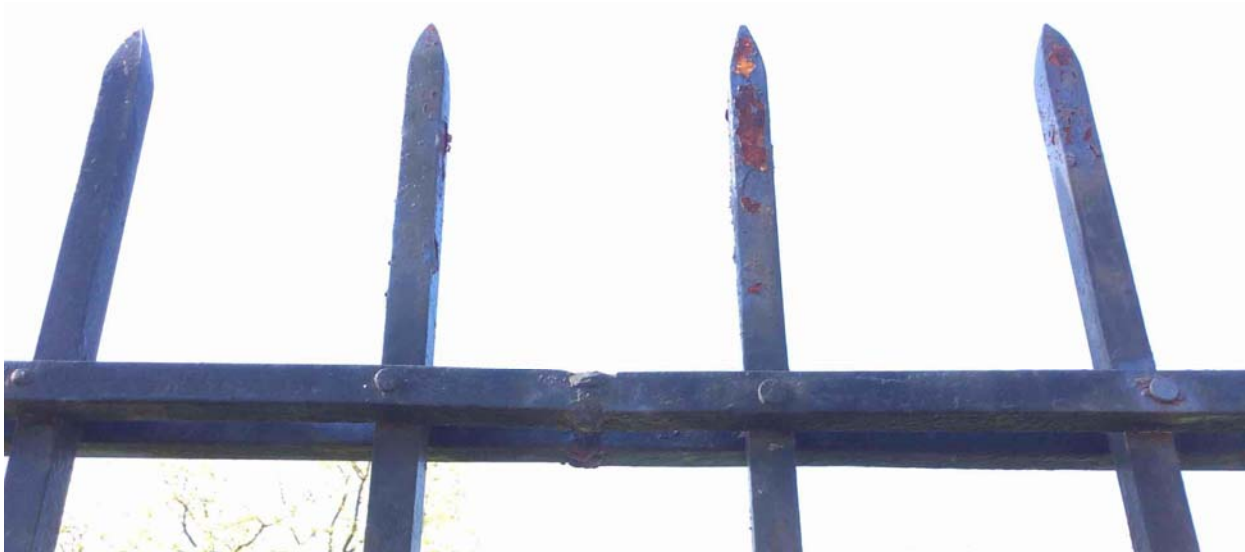
Figure 34- Fence Weld

One section of the fence and wall has evidence of modification. This includes welding segments of fencing and a variety of pipes and rebar that is embedded into to the cap and welded to the fence panel to provide intermediate support (**Figure 34** and **Figure 35**). This location of the wall was likely damaged by a vehicle or intentionally removed to provide a temporary access point.
