ANNUAL REPORT UPDATE

Arlington National Cemetery

VPDES Permit Number: VAR40139

FINAL – MS4 ANNUAL REPORT

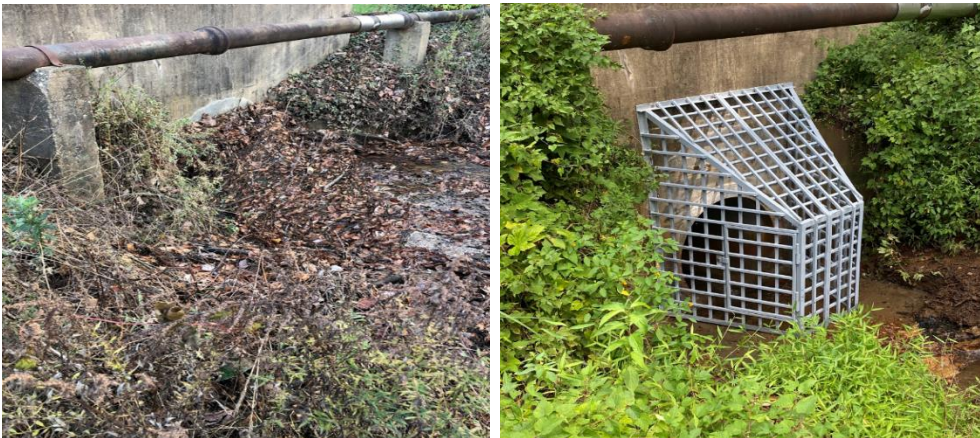
(Left) Excessive debris covers the trash screen and impedes water flow causing flooding during heavy rain events. (Right) The same location after removal of excessive debris and sediment and replacement of trash screen with a larger model.

specifications. This effort required removal of accumulated sediment and debris from the step pools and stabilization of the streambank with seed mix and erosion control matting. The culvert trash screen was replaced with a larger screen with more surface area for capturing debris, increasing the amount of time between future maintenance activities. Ultimately, these actions enhanced water flow in the stream, mitigated flooding, and reduced future maintenance costs. For more information about this project, please contact Stacey Rosenquist at stacey.m.rosenquist.civ@army.mil.

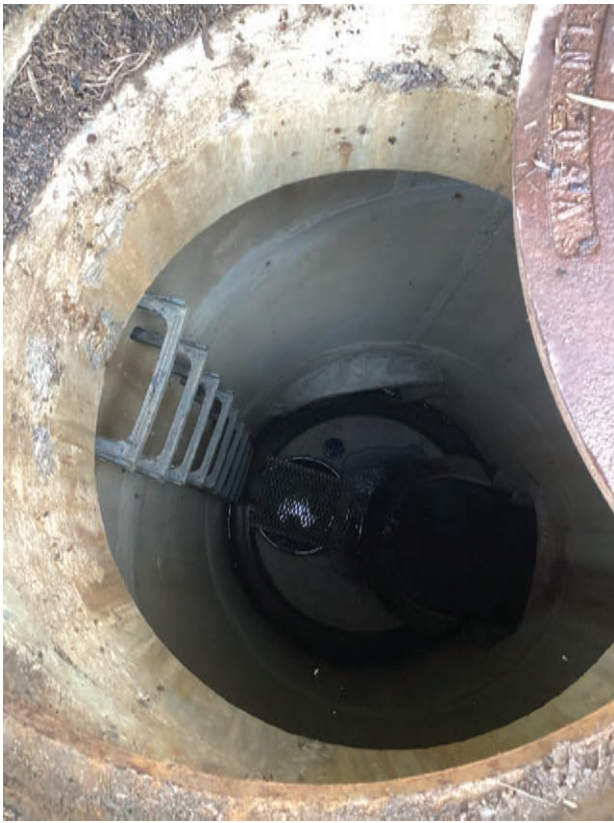
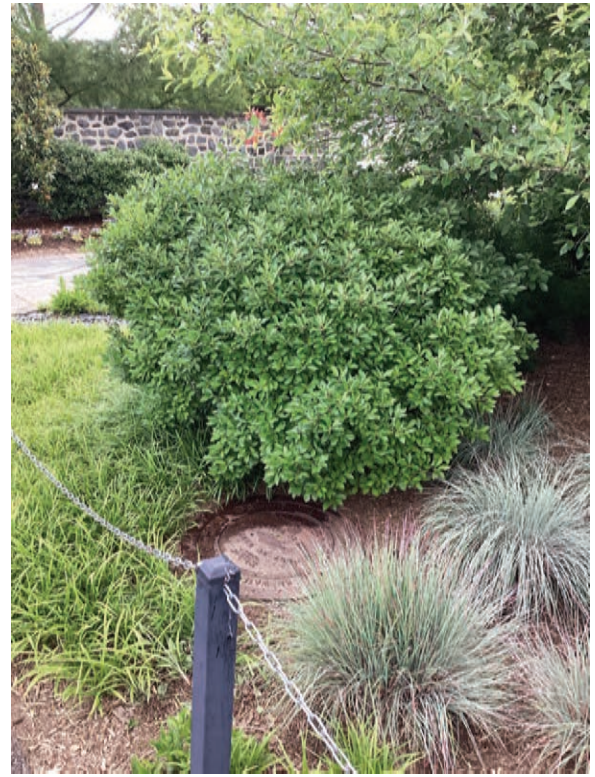
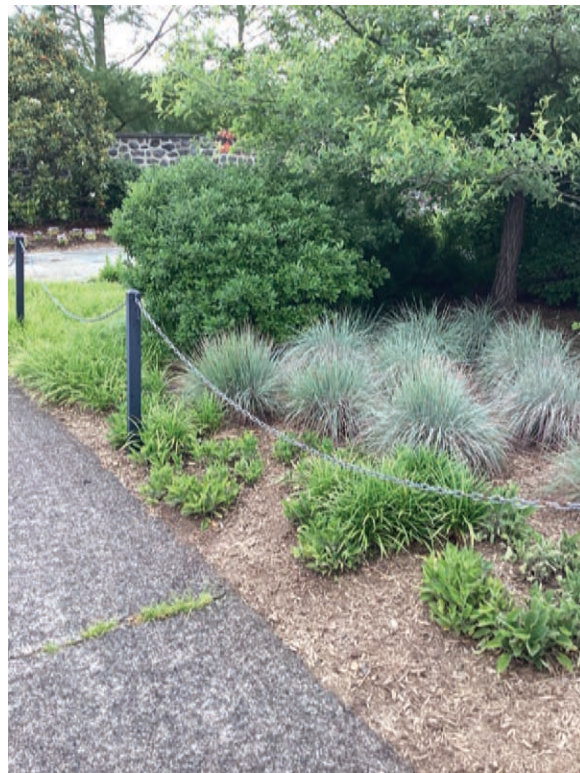
Arlington National Cemetery Post-Construction Inspection Checklist			HYDRODYNAMIC SEPARATOR															
Inspector Name, Title, Affiliation: Renee Lavinsky, Liz Shepherd (Bluestone)		Date: 6/12/2023	Date of last inspection: 6/28/2022															
Weather/site conditions: Cloudy, 80 degrees		Time since last rainfall: 72+																
BMP INFORMATION																		
BMP Installation Date: 2006		Model: <input type="checkbox"/> 900 <input type="checkbox"/> 1200 <input checked="" type="checkbox"/> 1800 <input type="checkbox"/> 2400																
BMP #: STC-6	Location: Section 73	As-Built Plans available: <input checked="" type="checkbox"/> Yes <input type="checkbox"/> No																
ROUTINE MAINTENANCE ACTIVITIES																		
Activity		Frequency		Completed														
None		NA		NA														
FIELD INSPECTION CHECKLIST																		
Criteria	Maintenance Required?	ANC or Professional fix	Comments	Date Repaired														
Inlet/Outlet/Access																		
Pipe blockages	<input type="checkbox"/> Yes <input checked="" type="checkbox"/> No																	
Pipe or joint breaks or cracks	<input type="checkbox"/> Yes <input checked="" type="checkbox"/> No																	
Access portals cracked, damaged, or unable to open	<input type="checkbox"/> Yes <input checked="" type="checkbox"/> No																	
Sediment Levels																		
Sediment depth of the following values (sampling procedures provided below):			Approximately twelve inches of sediment, will need clean out
