## **RECONSTRUCTION AND REHABILITATION PROJECT: CROOK WALK BRIDGE AND SECTION 37 STORMWATER CHANNEL**

### **SECTION 106 PROCESS SUBMISSION:**

PROJECT DESCRIPTION, IDENTIFICATION OF CONSULTING  
PARTIES, IDENTIFICATION OF HISTORIC PROPERTIES, AREA  
OF POTENTIAL EFFECTS, & ASSESSMENT OF EFFECTS

Submission: 9 September 2025

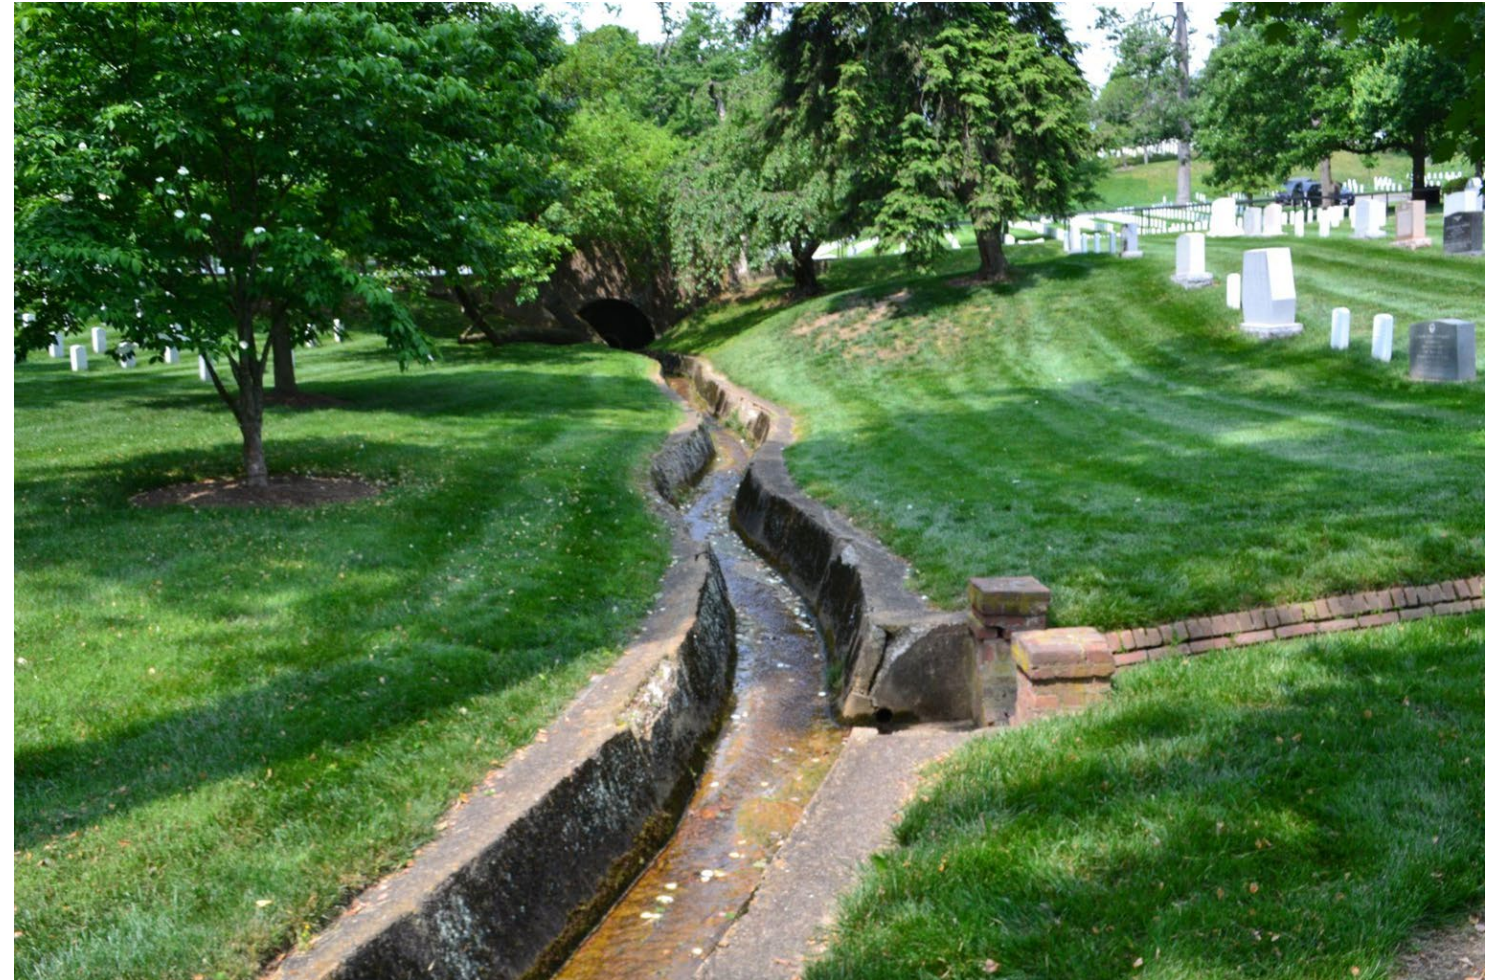
Section 37 drainage system, looking west toward the Crook Walk bridge, where the brick-lined channel connects with the concrete channel

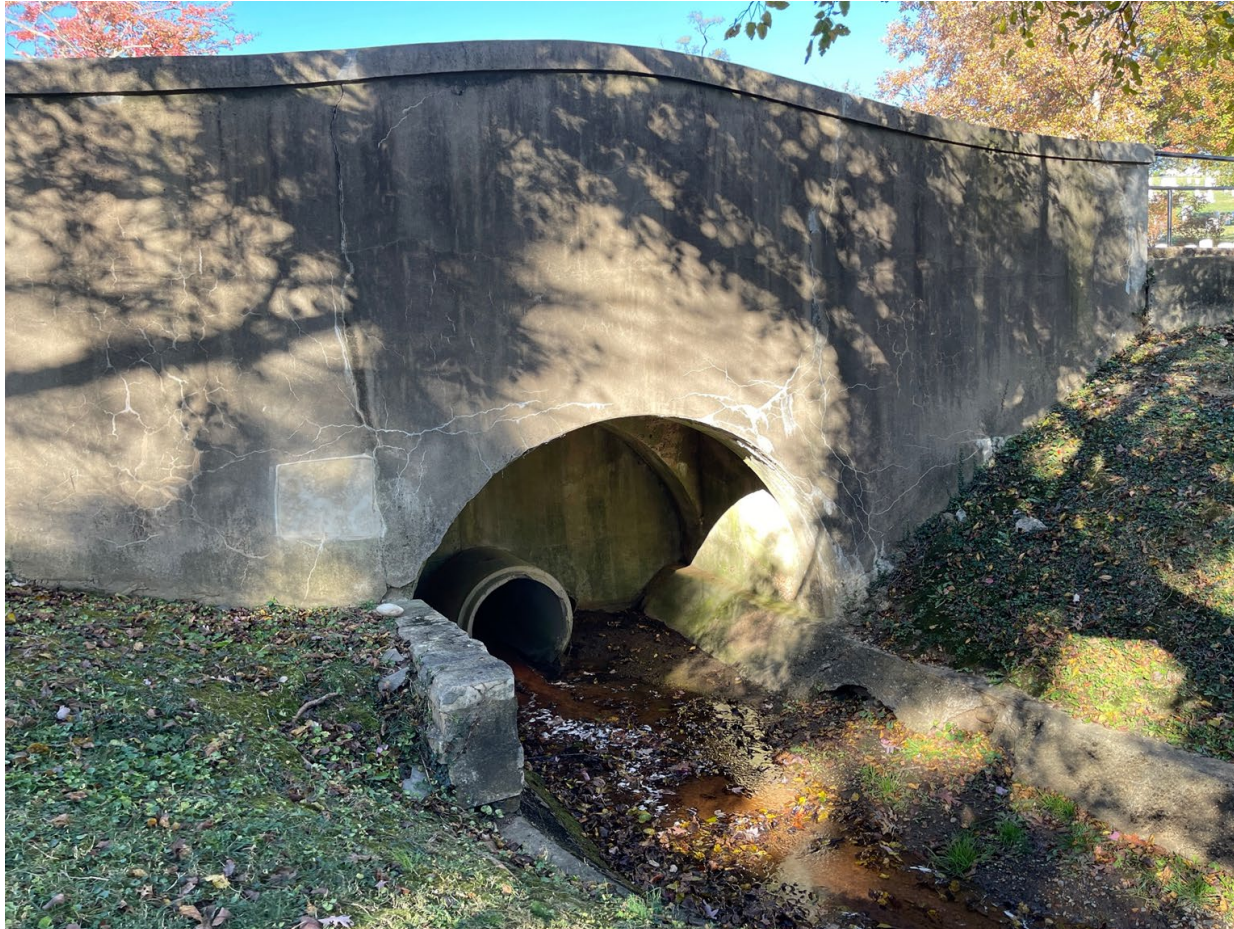
The conditions assessment identified fracture cracks through the parapet walls ranging between 1/8-inch and 1/4-inch, raising concerns about the structural integrity of the parapet walls and their foundations.

Eastern parapet wall, wingwalls, and culvert at Crook Walk bridge

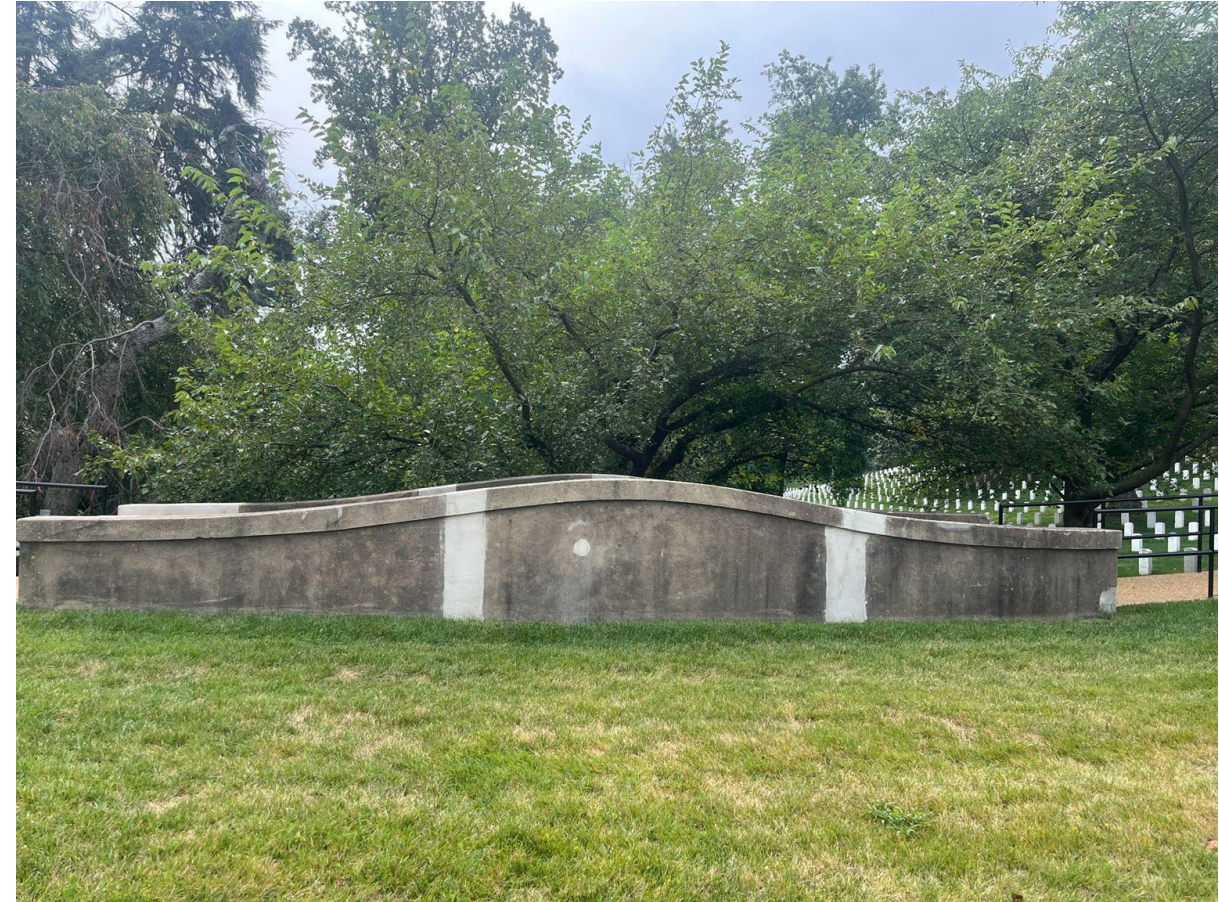
Western parapet wall of Crook Walk bridge, after structural investigation and temporary patching of cementitious parging and structural cracks

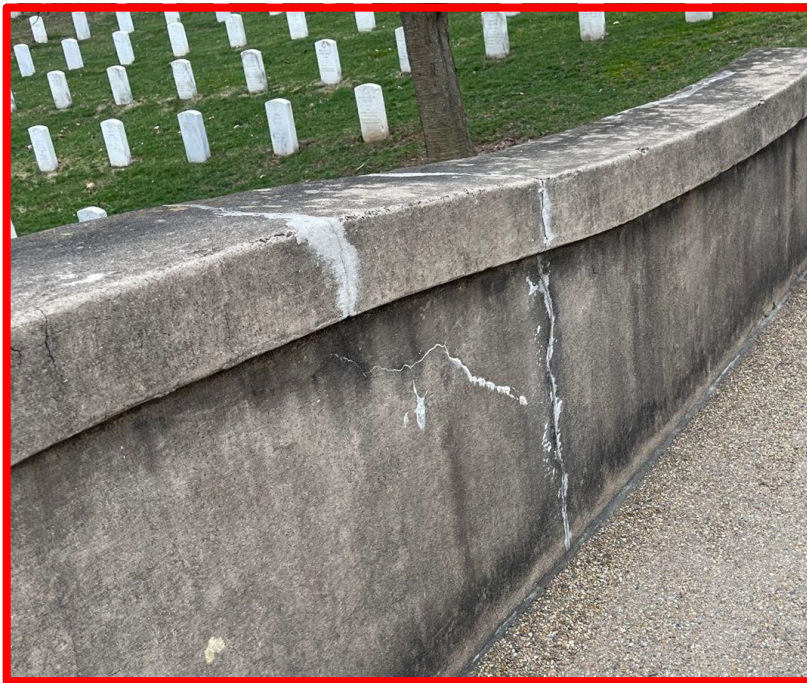
1. If the wingwalls have a footing foundation, the cracks between the slab bridge and the wing walls could be a result of the structure not being able to expand and contract at this location.
2. If the wing walls are functioning as a retaining wall, the walls could be experiencing vertical settlement due to insufficient soil strength or undermining beneath the foundation causing the walls to rotate and fracture. If the wing walls are cantilevers, vertical settlement or undermining may allow rotation if the horizontal rebars carrying the tension load at the top of the parapet have corroded and no longer carry the tension force.

**Detail of crack on the inside of the East parapet wall on Crook Walk bridge, before structural investigation**

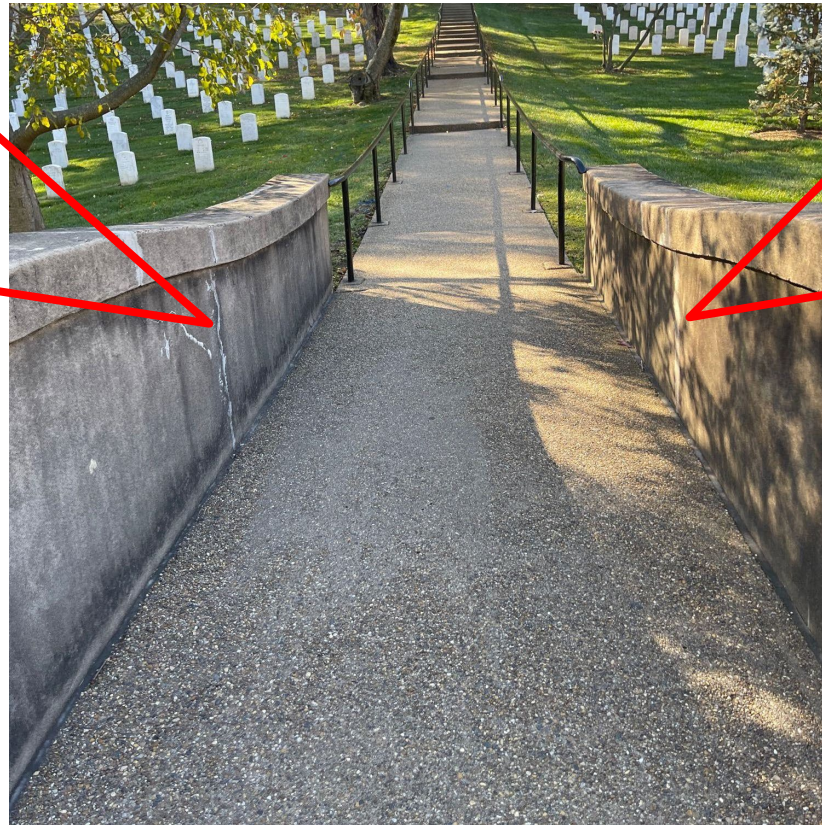
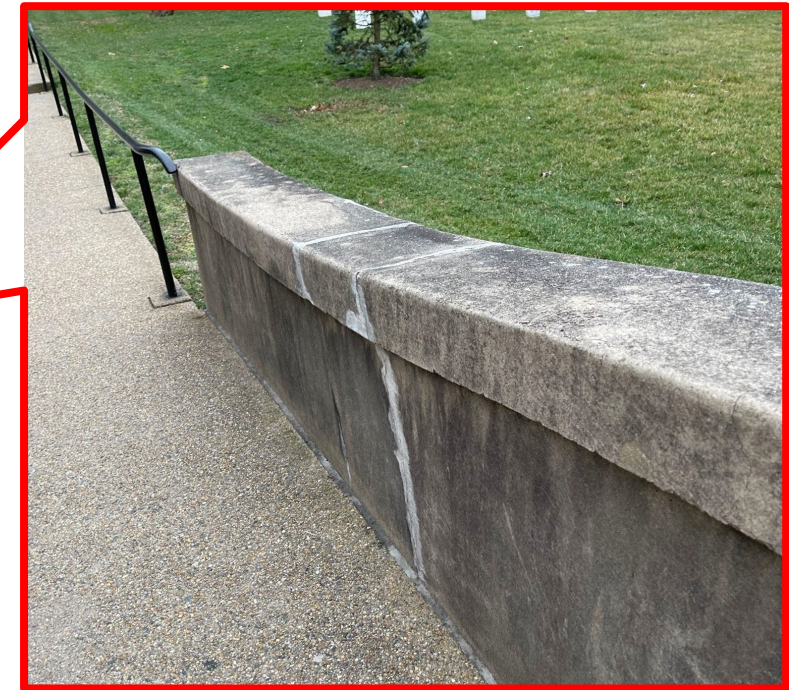
**Detail of crack on the inside of the West parapet wall on Crook Walk bridge, before structural investigation**

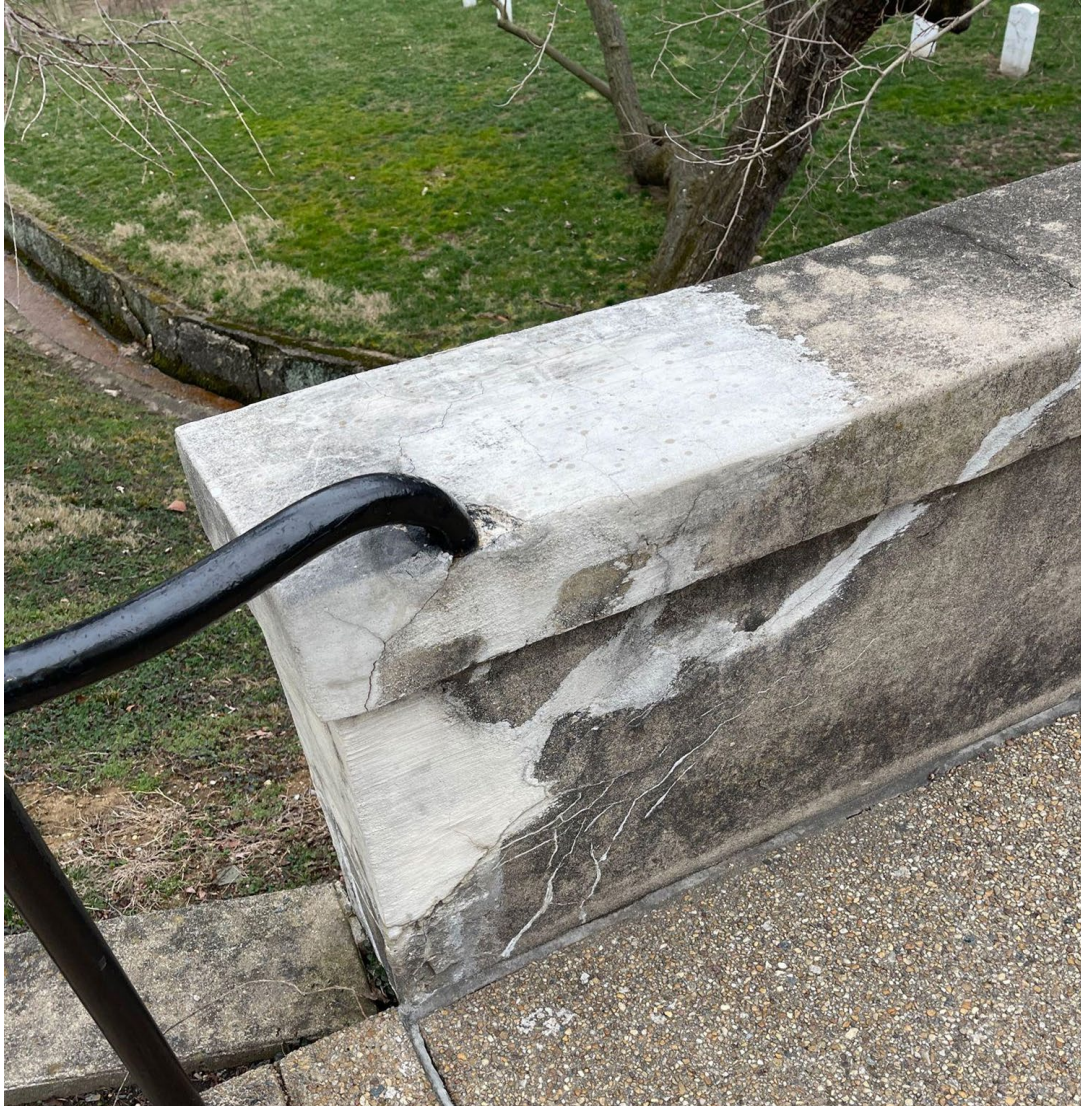
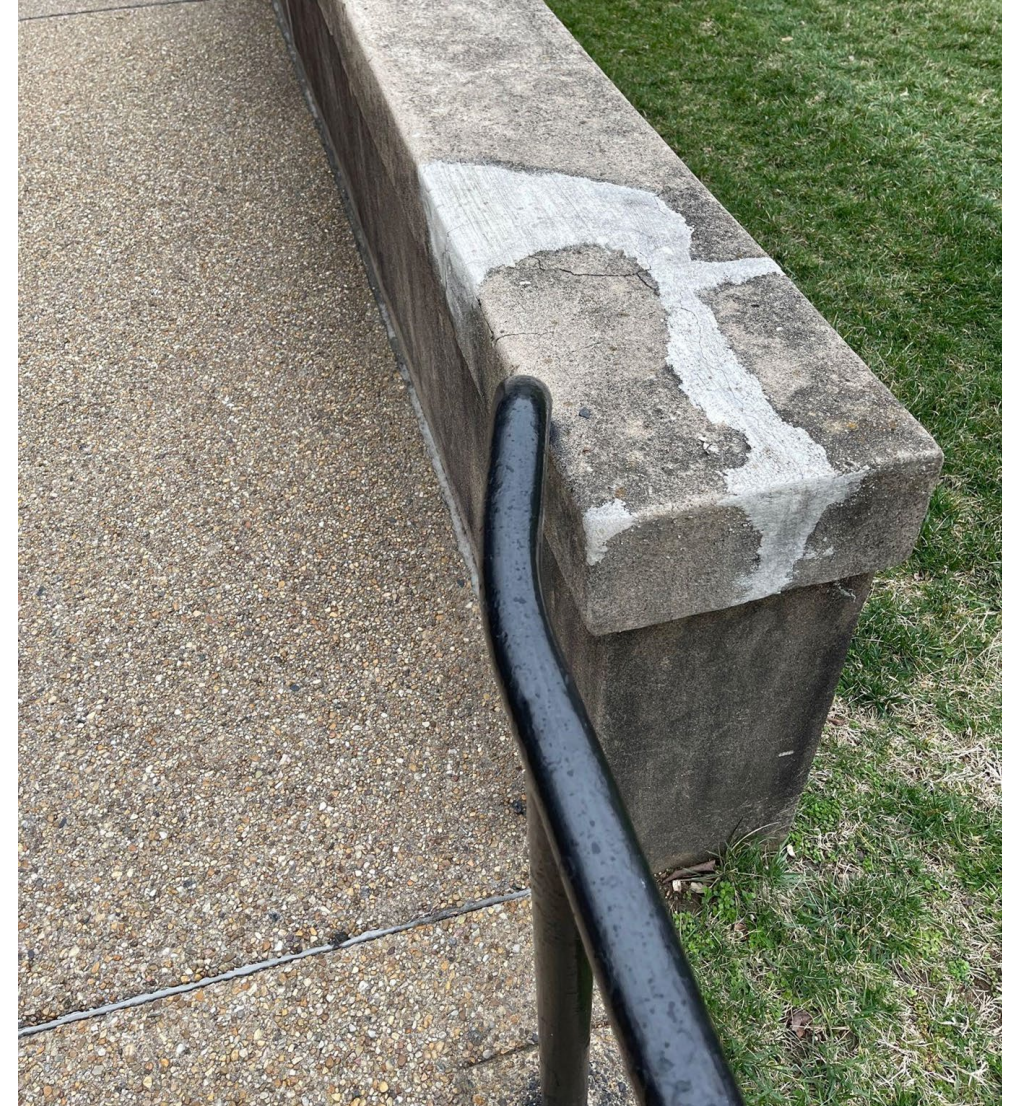
Detail images of  
North end of East &  
West parapet walls

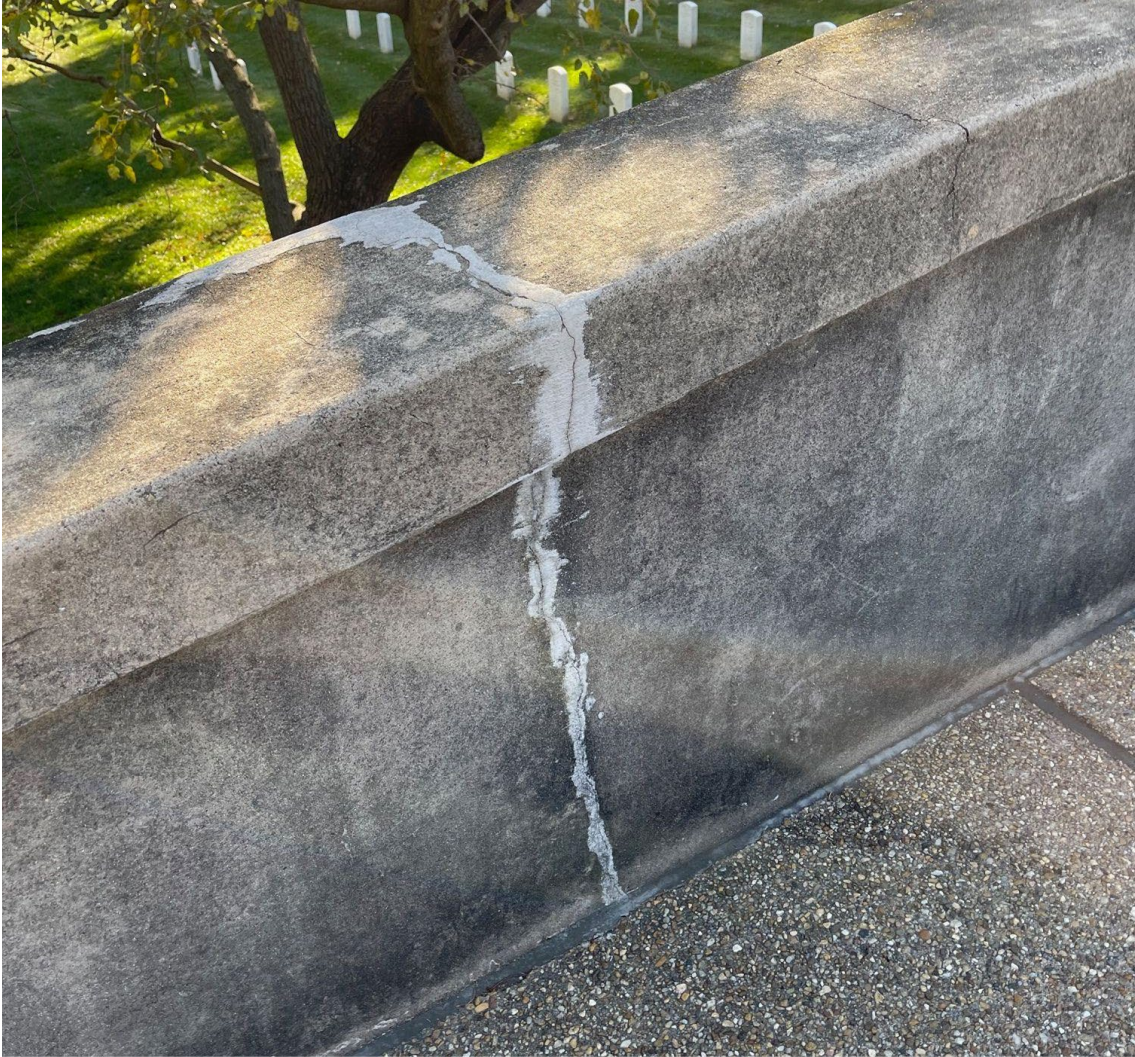
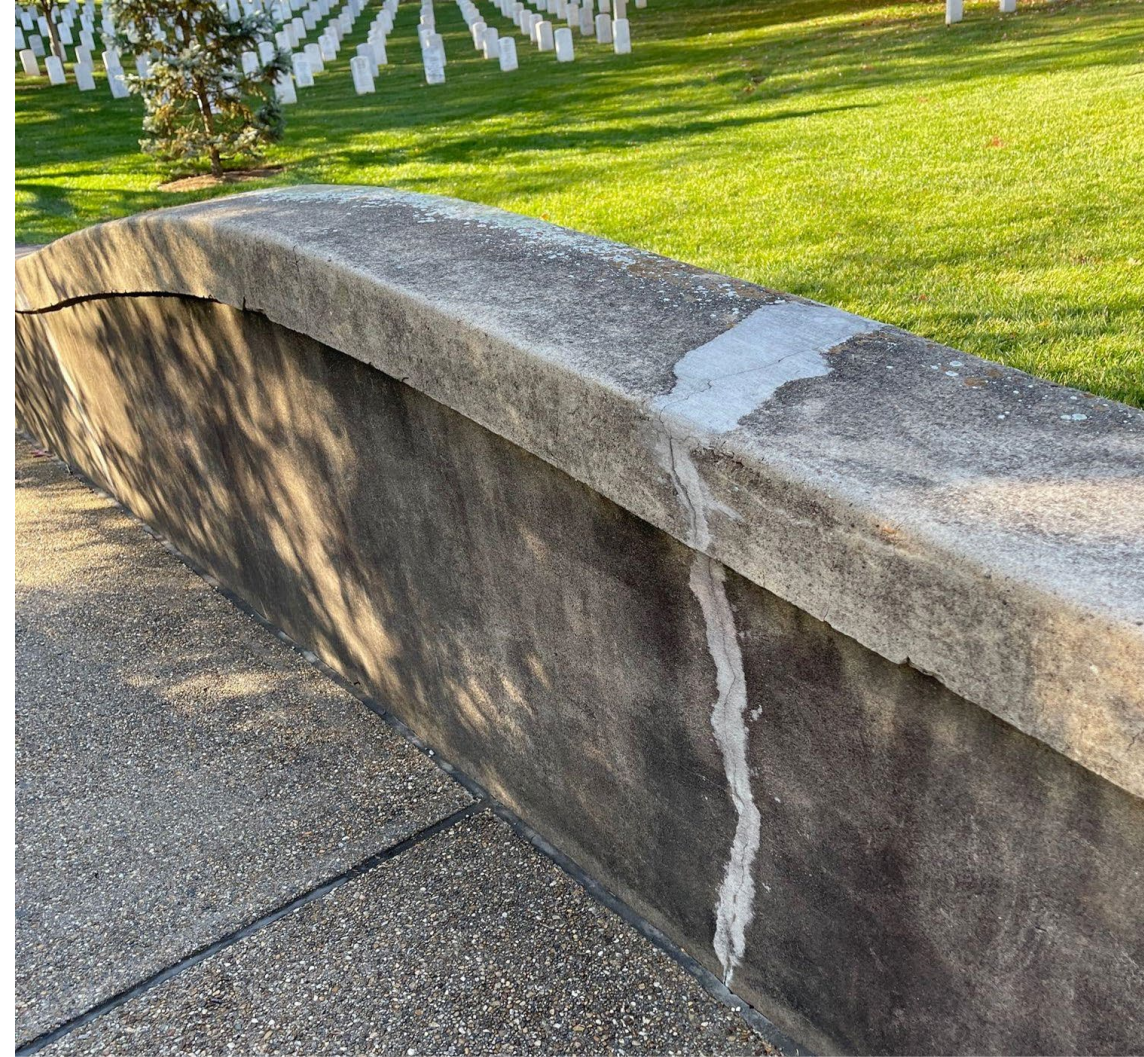
Details of  
cracking near  
the center of  
the East and  
West parapet  
walls

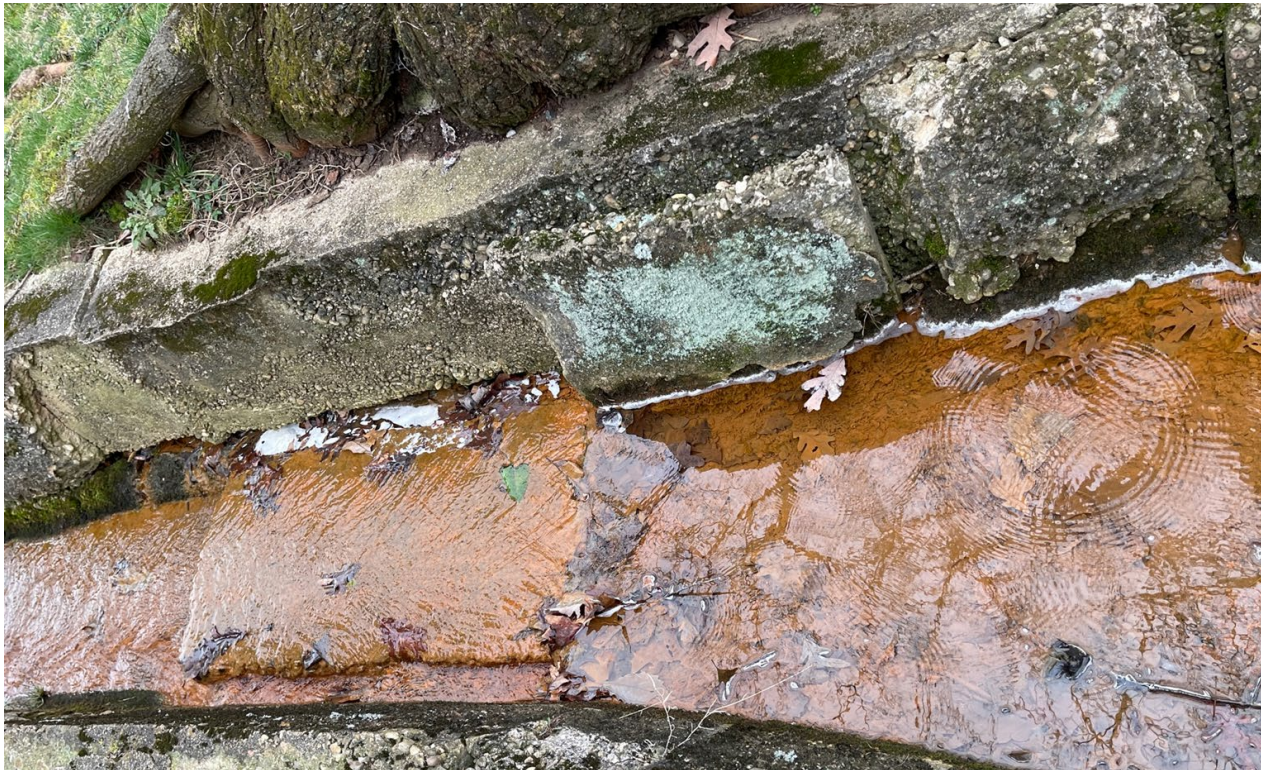
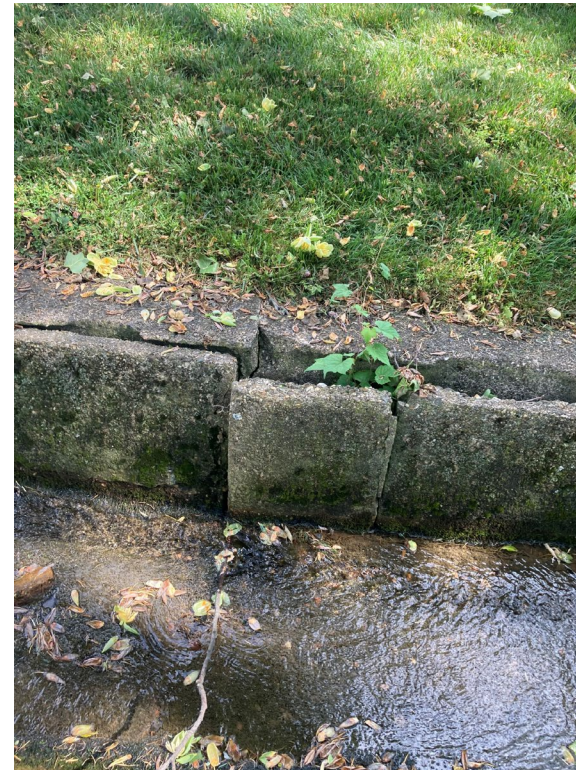
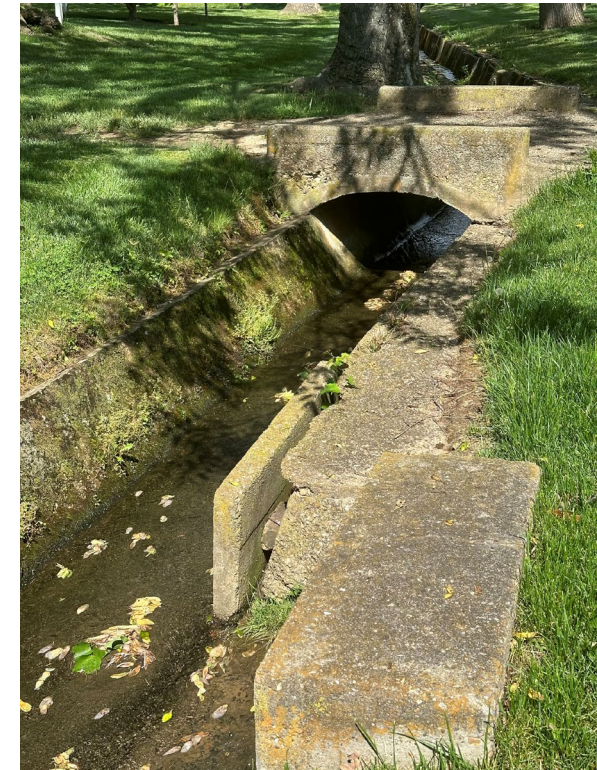
- Signs of deterioration due to age, erosion, and sediment accumulation.
- Between masonry units (concrete, brick, and stone), there is significant mortar loss, in addition to overall cracking, spalling, joint failure, displacement, and bio-vegetation growth on surfaces and between units.
- A majority of the concrete channel panels exhibit material/dimensional losses, displacement, detachment, and a loss of cementitious parge coatings. In several locations encroachment by trees and their root systems are contributing to movement of the concrete panels.

Detail photos of loose, deteriorated concrete panels in the Section 37 channel

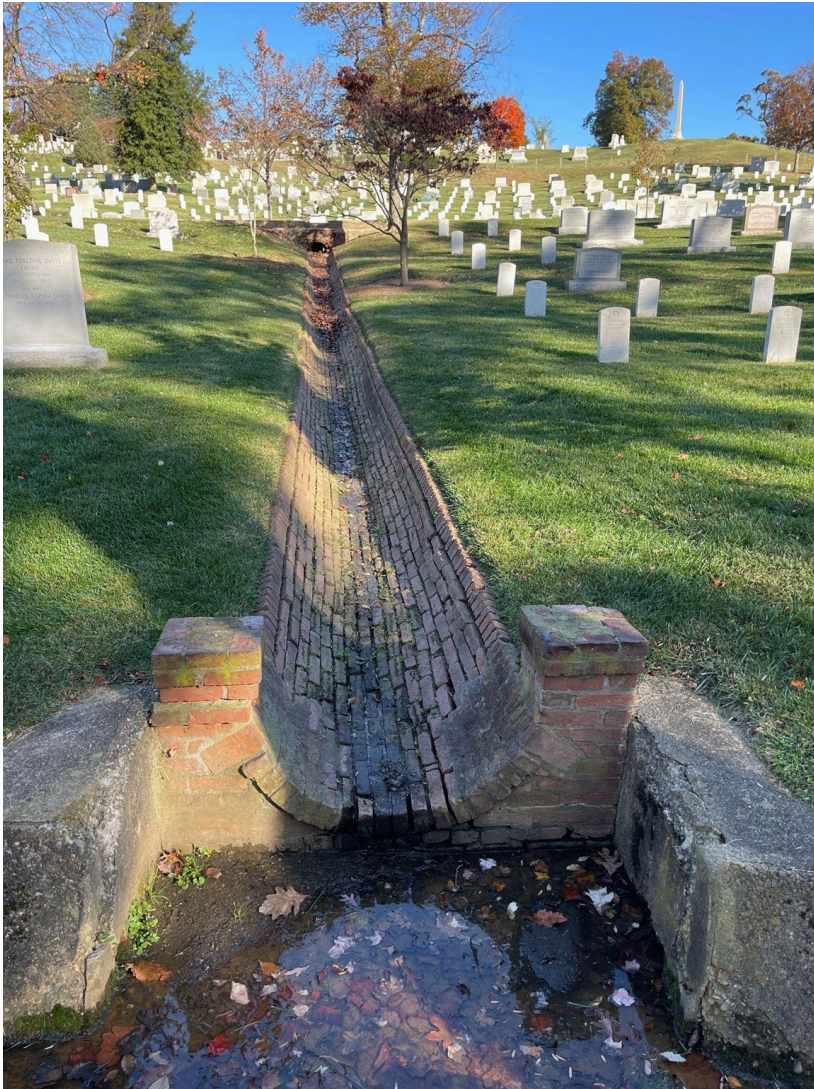
Section 37 brick-lined channel

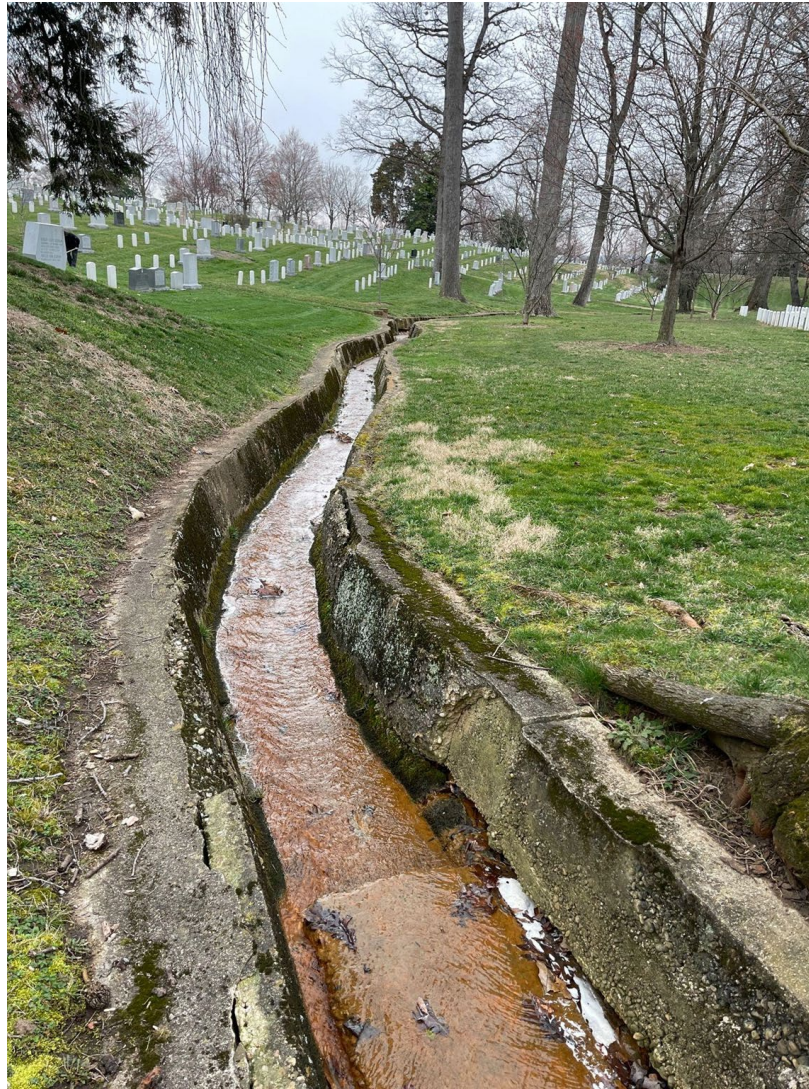
Section 37 Concrete Channel

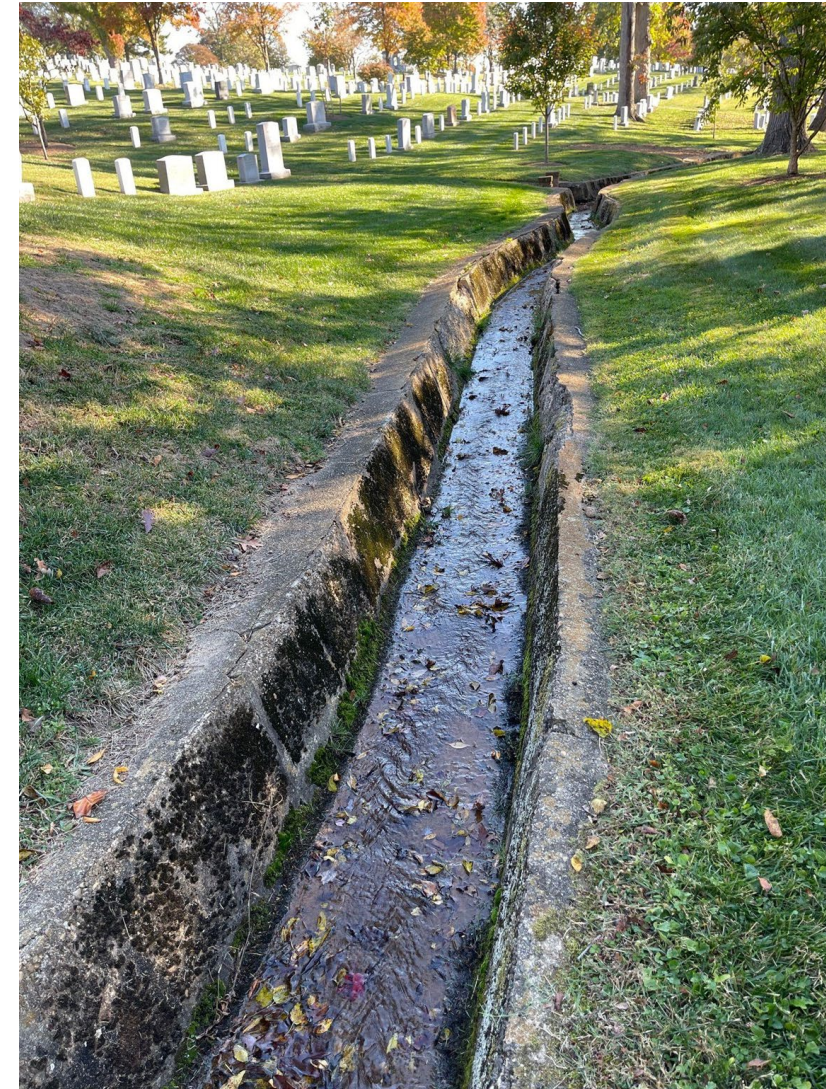
Detail image of cracking and concrete surface loss in the channel

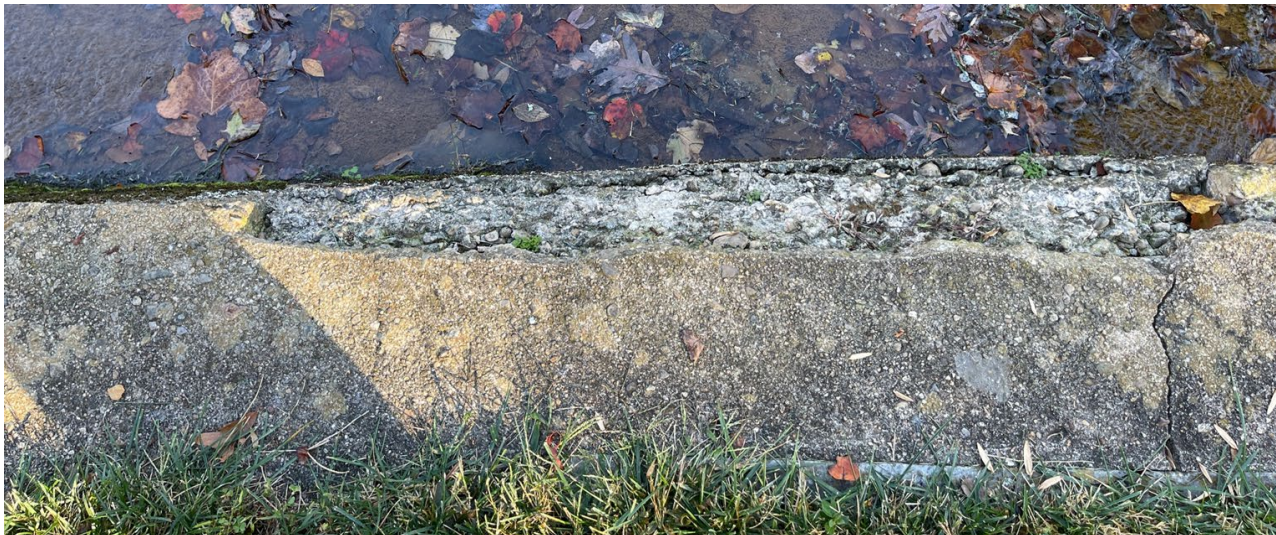
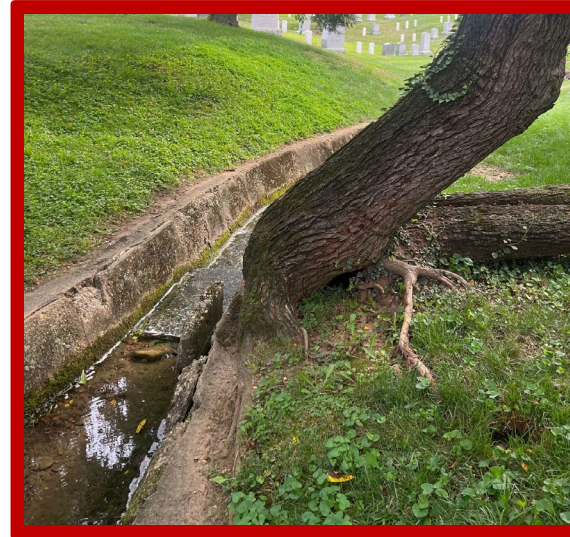
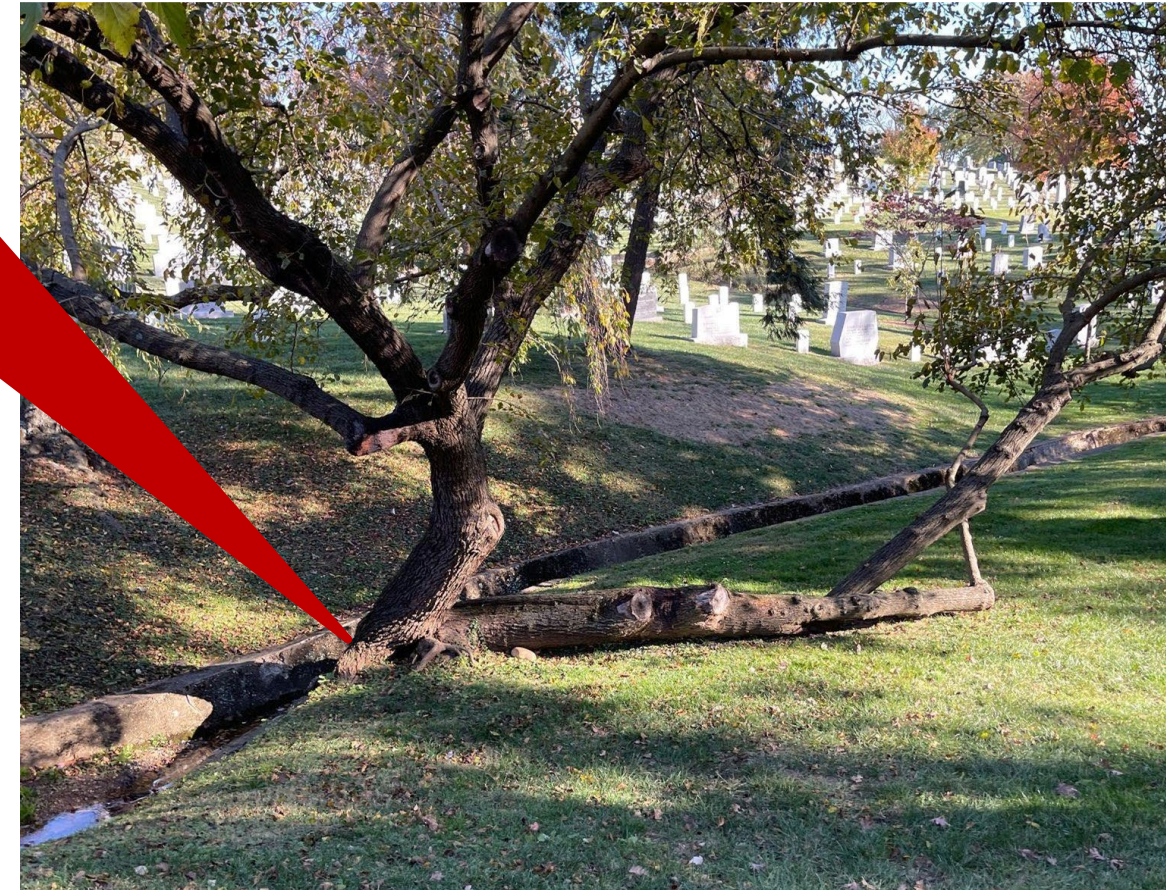
Detail of tree and its root system encroaching on the concrete channel

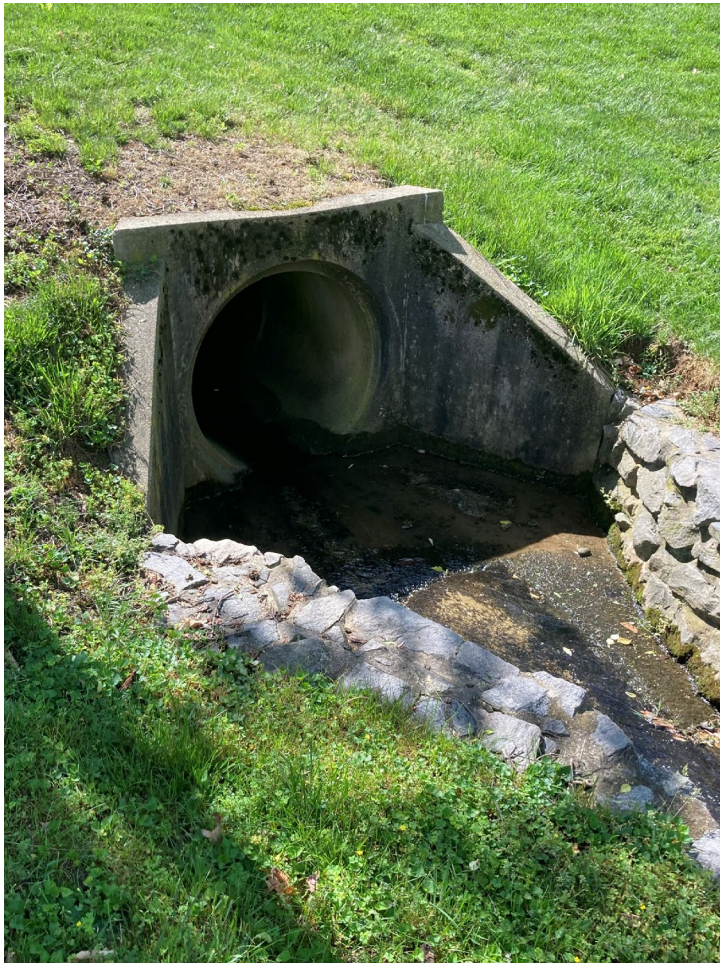
Culvert with granite sidewalls near  
Roosevelt Drive

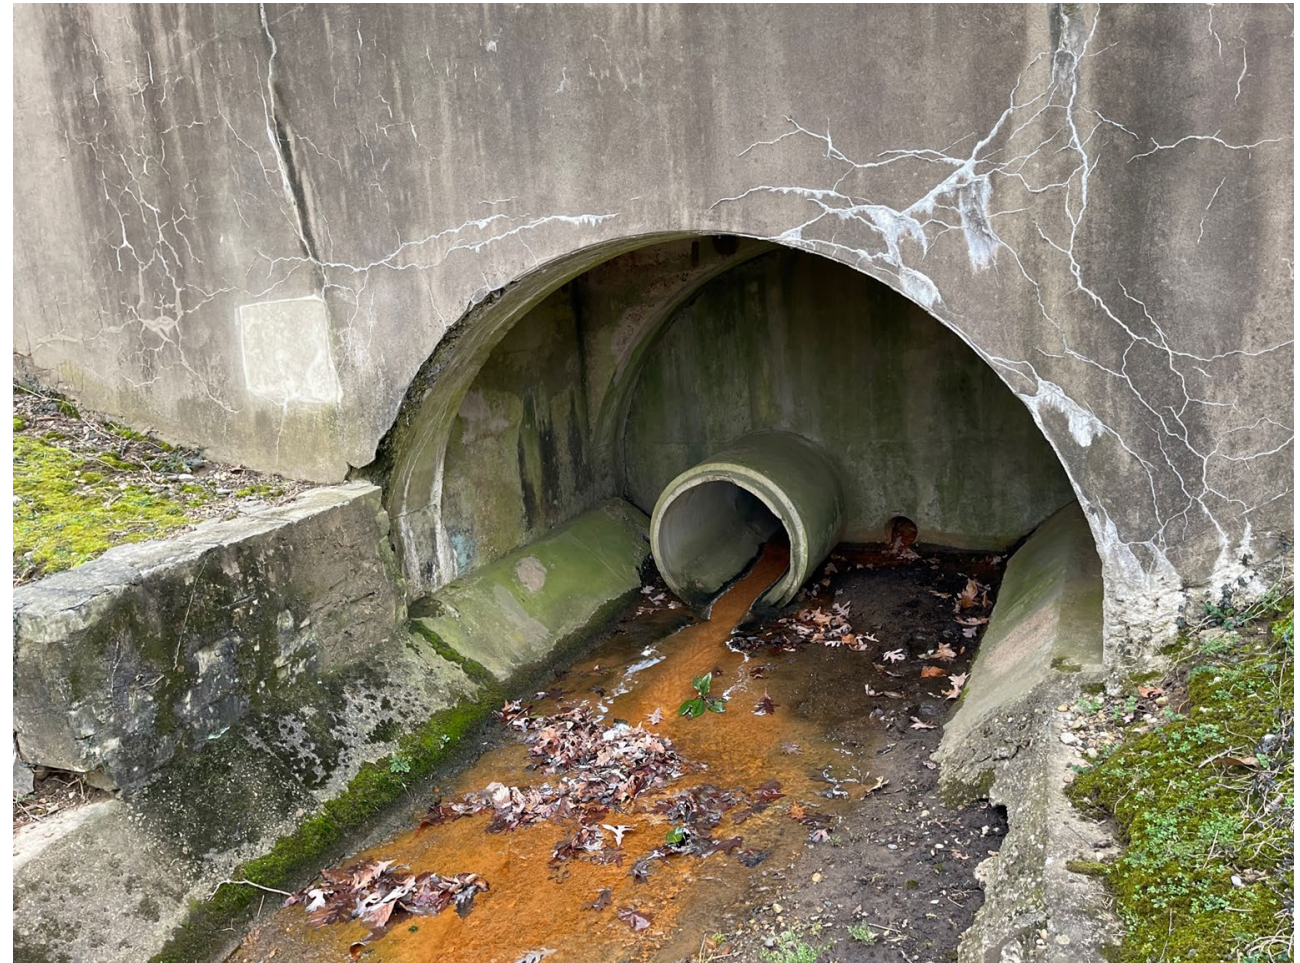
Culvert at Crook Walk bridge

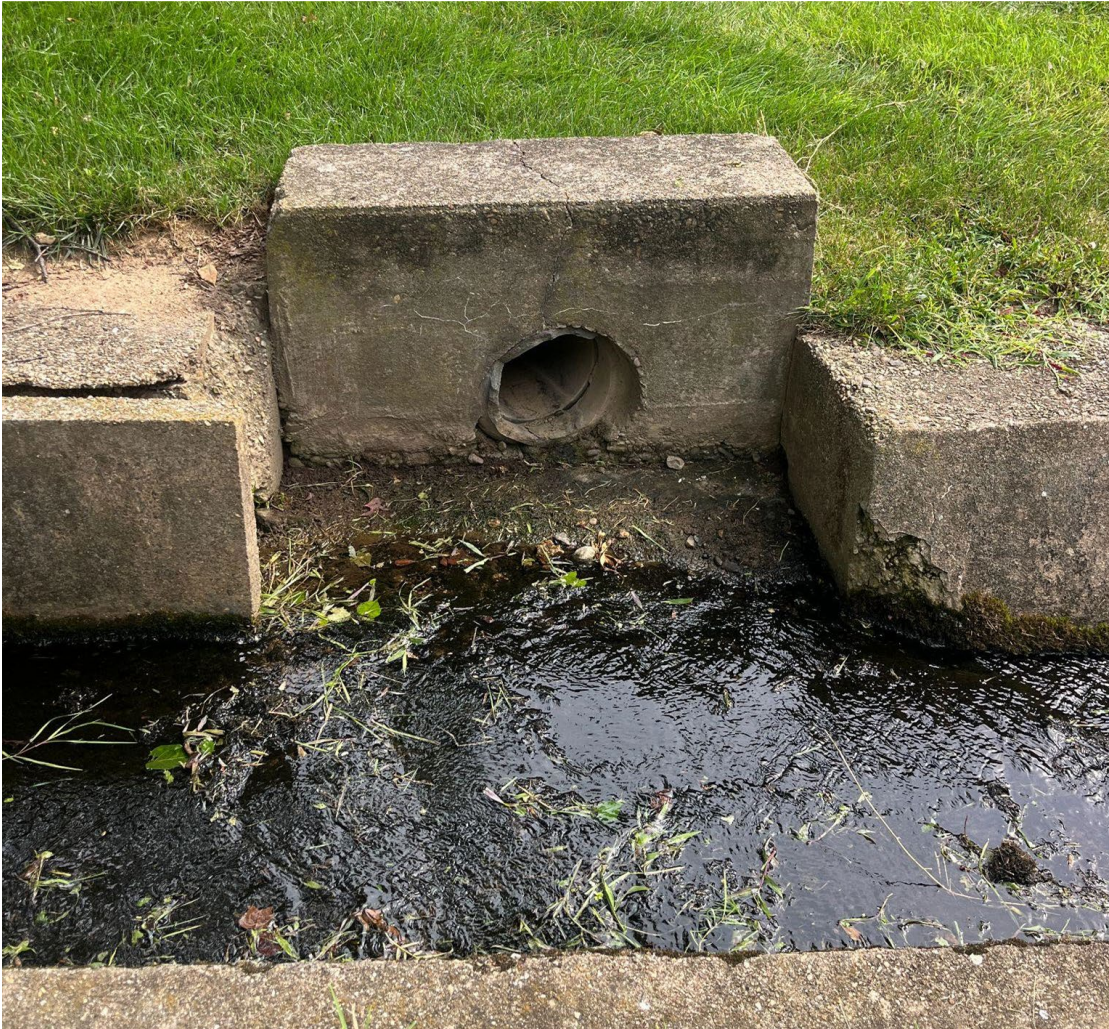
Abandoned culvert, northeast side of the channel

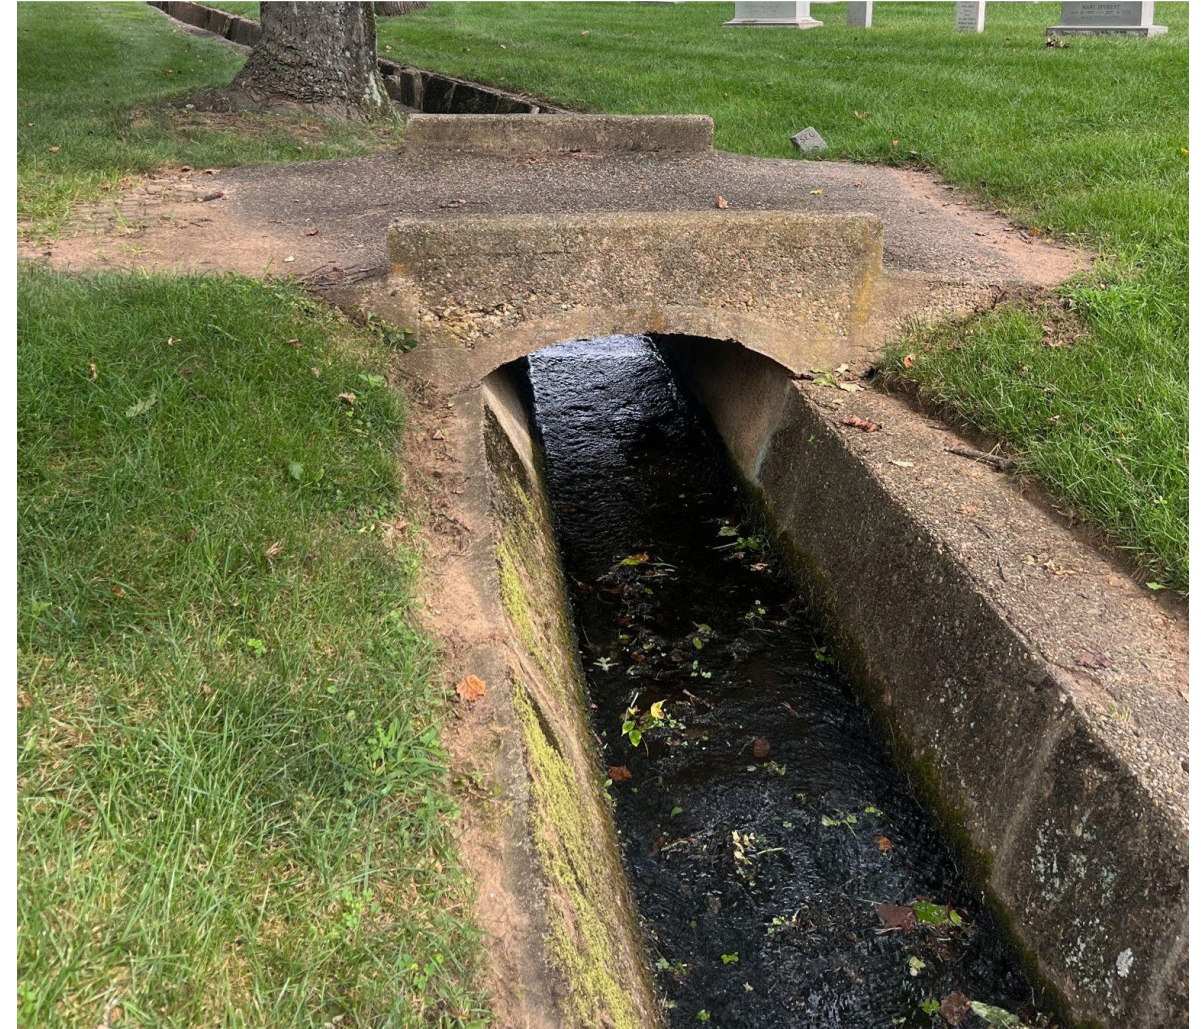
Secondary footbridge within Section 37 concrete channel

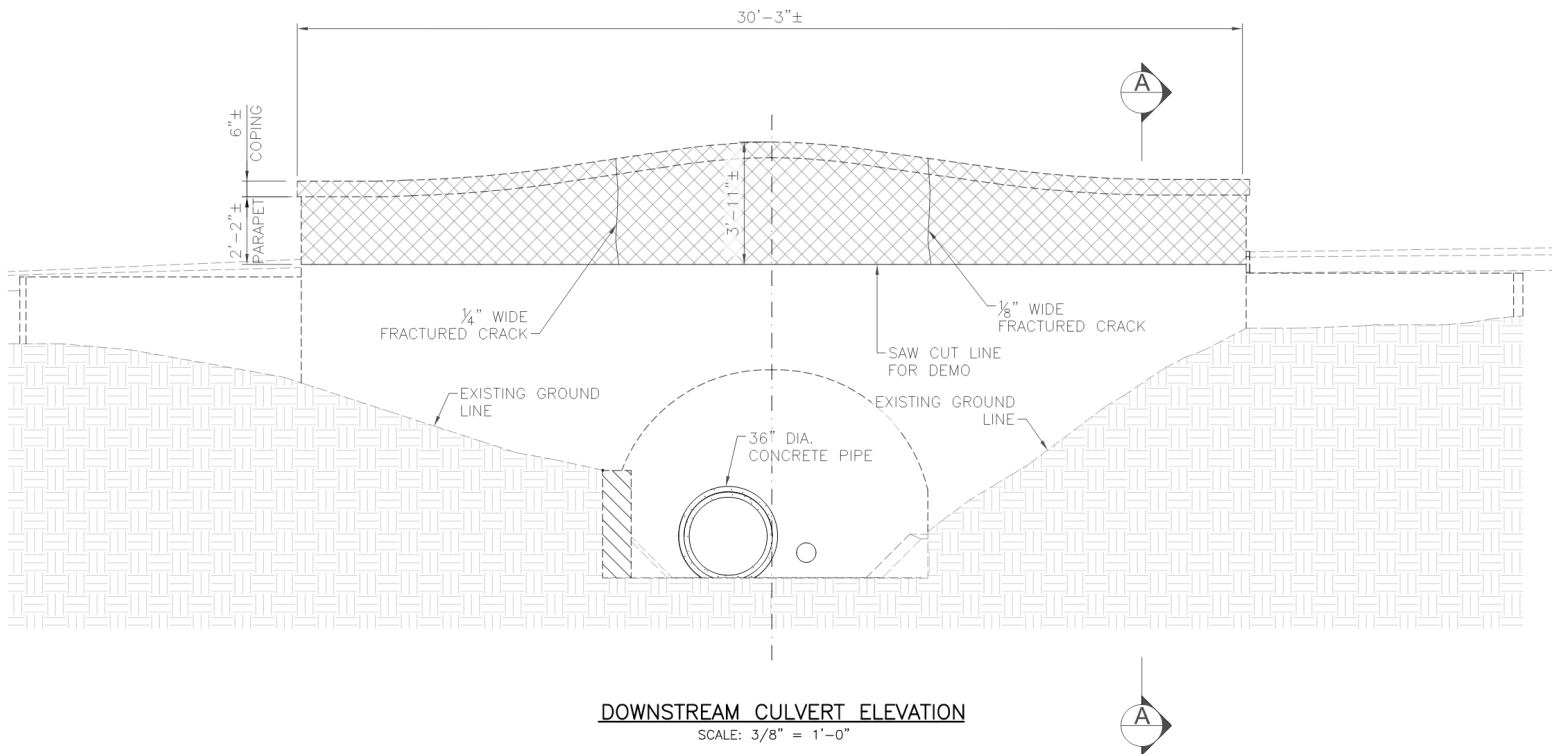
Downstream view of proposed East parapet wall removal

Removal and replacement of the concrete parapet with an in-kind parapet is recommended as the most robust and long-term solution. Restores the structural integrity and durability of the parapet by improving the quality and strength of the concrete, while restoring the historic appearance, preserving a portion of the existing structure while reducing future maintenance costs by addressing the underlying structural issues.

- Concrete Parapet Removal: Remove a 30'-3" long x full height x full-depth section of the concrete parapet.
- Remove 1/2" Existing Parging: Remove existing parging on the entire remaining exposed exterior surface area of the Downstream Headwall.
