## **RECONSTRUCTION AND REHABILITATION PROJECT: CROOK WALK BRIDGE AND SECTION 37 STORMWATER CHANNEL**

### **SECTION 106 PROCESS SUBMISSION:**

PROJECT DESCRIPTION, IDENTIFICATION OF CONSULTING  
PARTIES, IDENTIFICATION OF HISTORIC PROPERTIES, AREA  
OF POTENTIAL EFFECTS, & ASSESSMENT OF EFFECTS

Submission: 9 September 2025

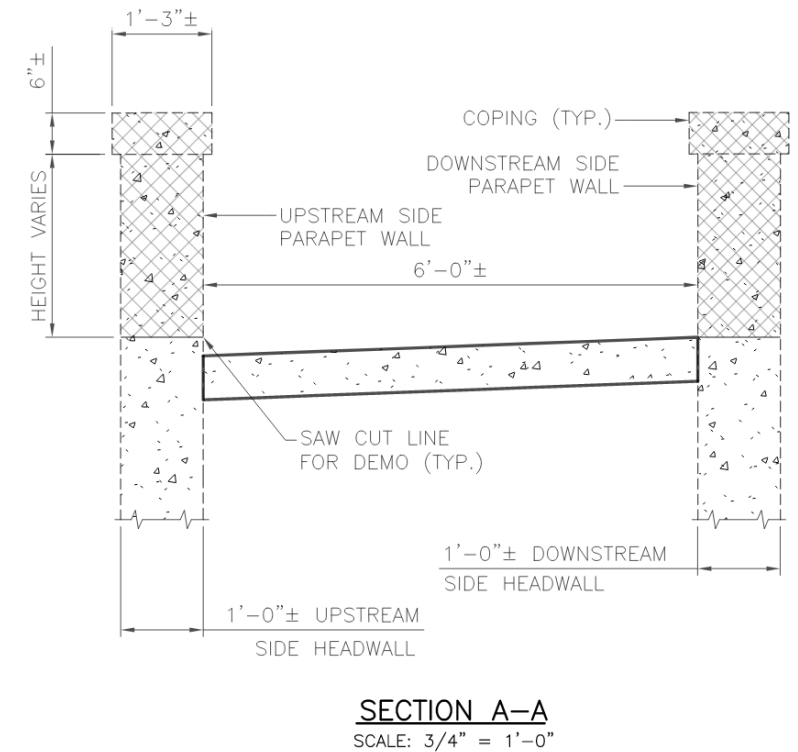
Section view of proposed parapet wall removals

- Concrete Parapet Removal: Remove a 30'-3" long x full height x full-depth section of the concrete parapet.
- Remove 1/2" Existing Parging: Remove existing parging on the entire remaining exposed exterior surface area of the Downstream Headwall.

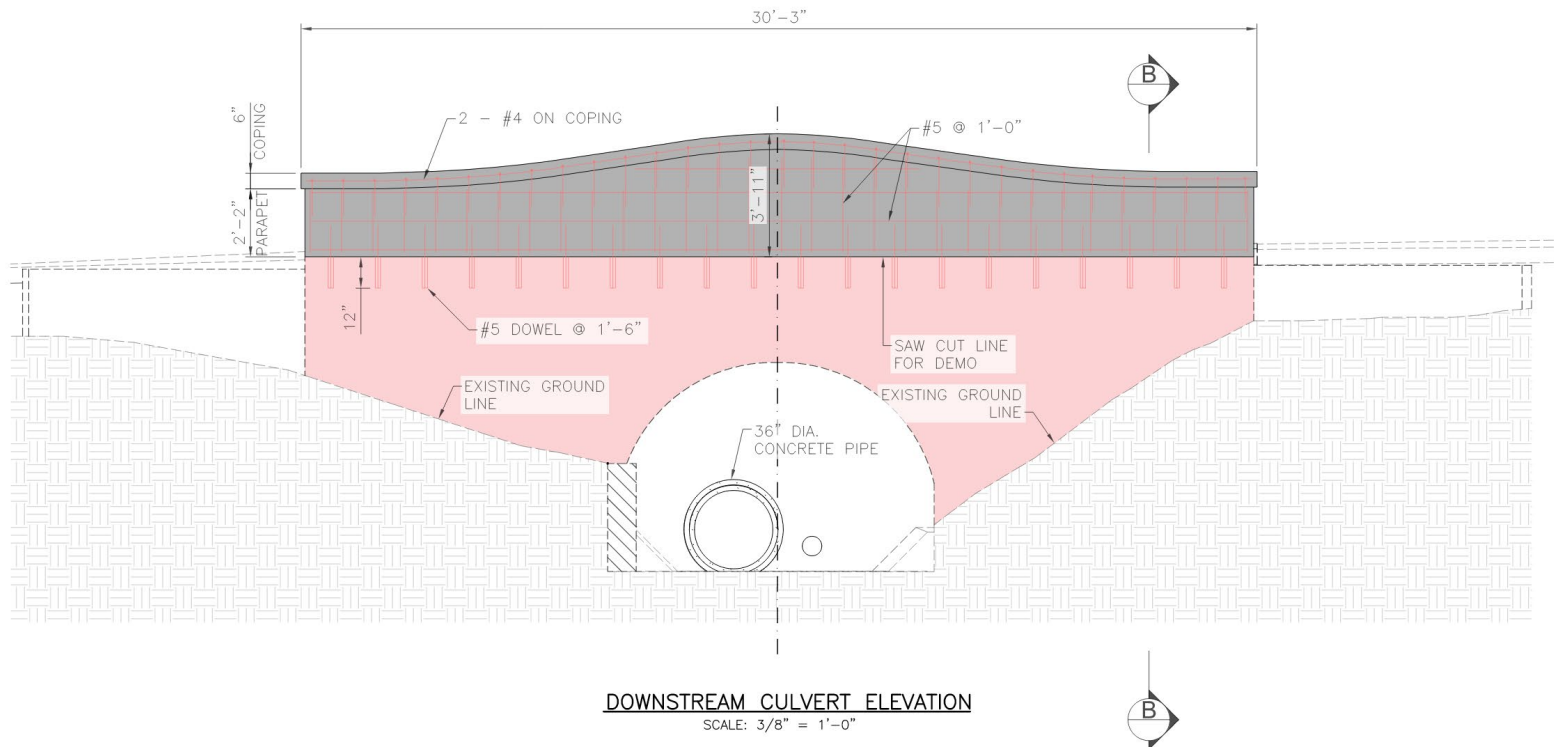
Downstream view of proposed East parapet wall reconstruction

- **Dowel Installation:** Install dowels at 1'-6" spacing into the existing headwall to tie the remaining portion of the head wall to the new concrete parapet.
- **Reinforcement Installation:** Place reinforcement for the new parapet wall section in accordance with the plan details.
- **Concrete Pour:** Cast the new reinforced concrete parapet to replicate the original parapet design, ensuring it matches the existing structure in dimensions and aesthetics.
- **Parging Application:** Apply a 1/2" thick layer of new parging on the surface of the newly parapet and the remaining existing headwall.

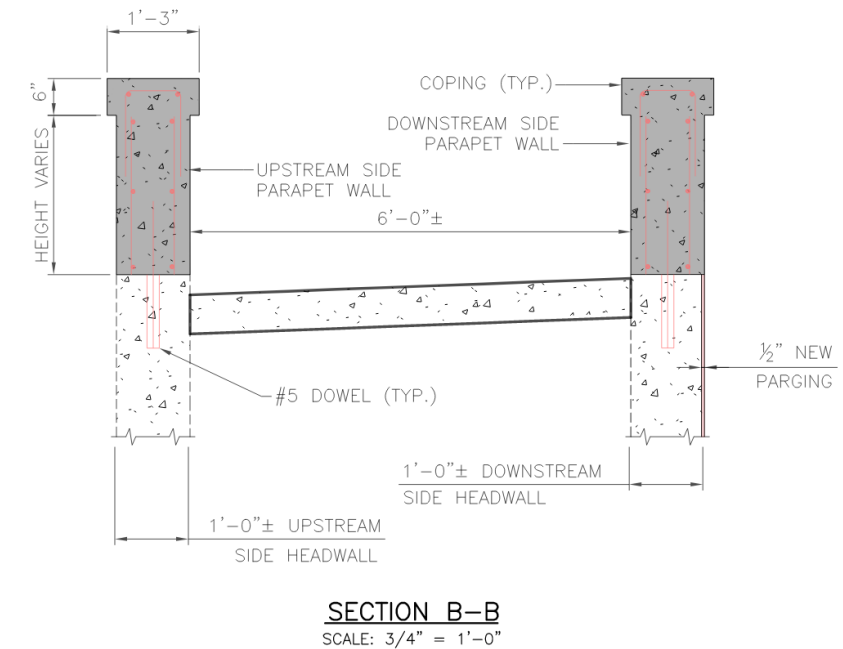
Section view of proposed parapet wall reconstructions

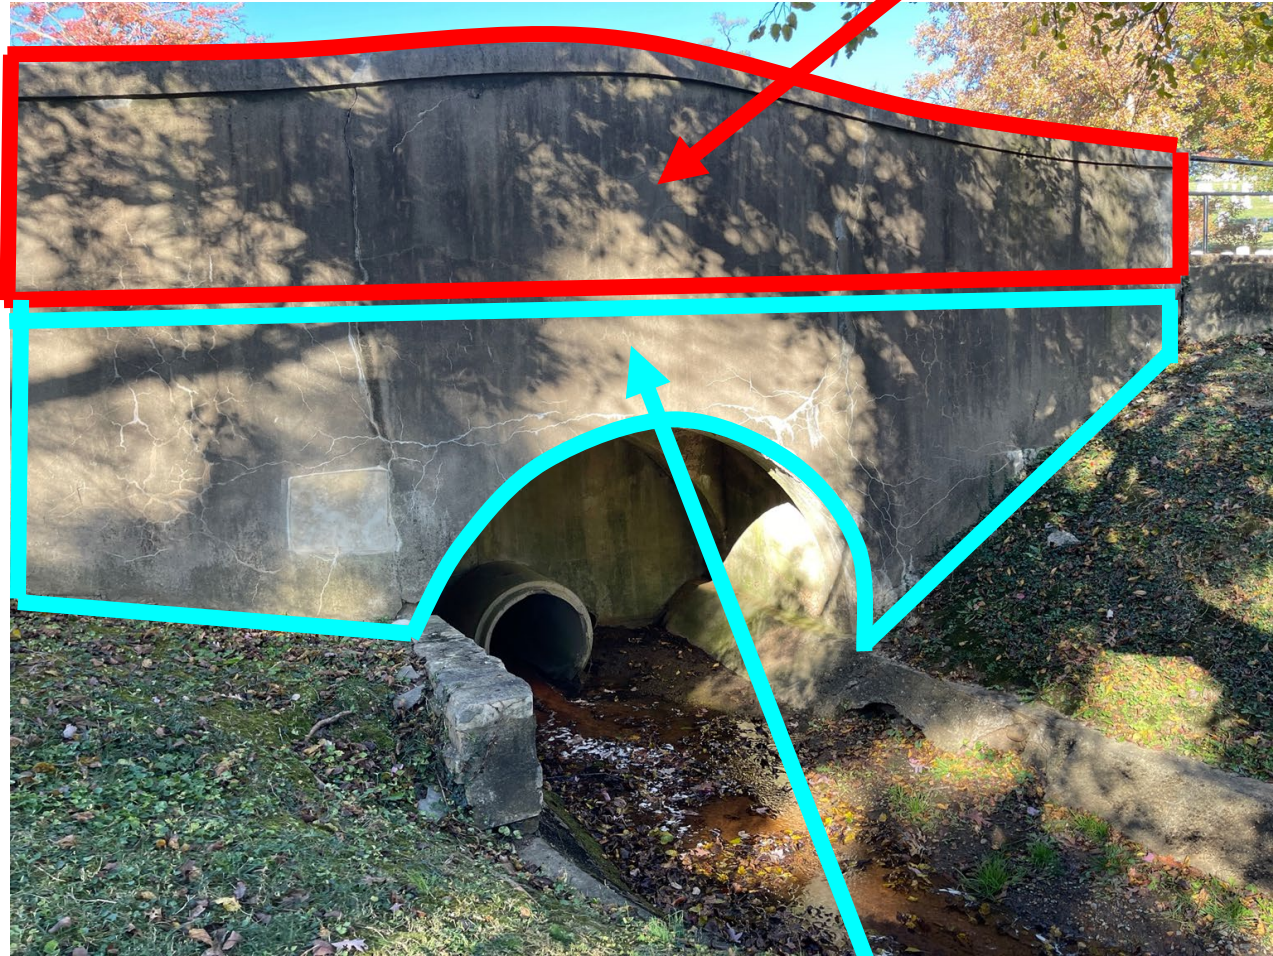
Location of parapet removal and new construction

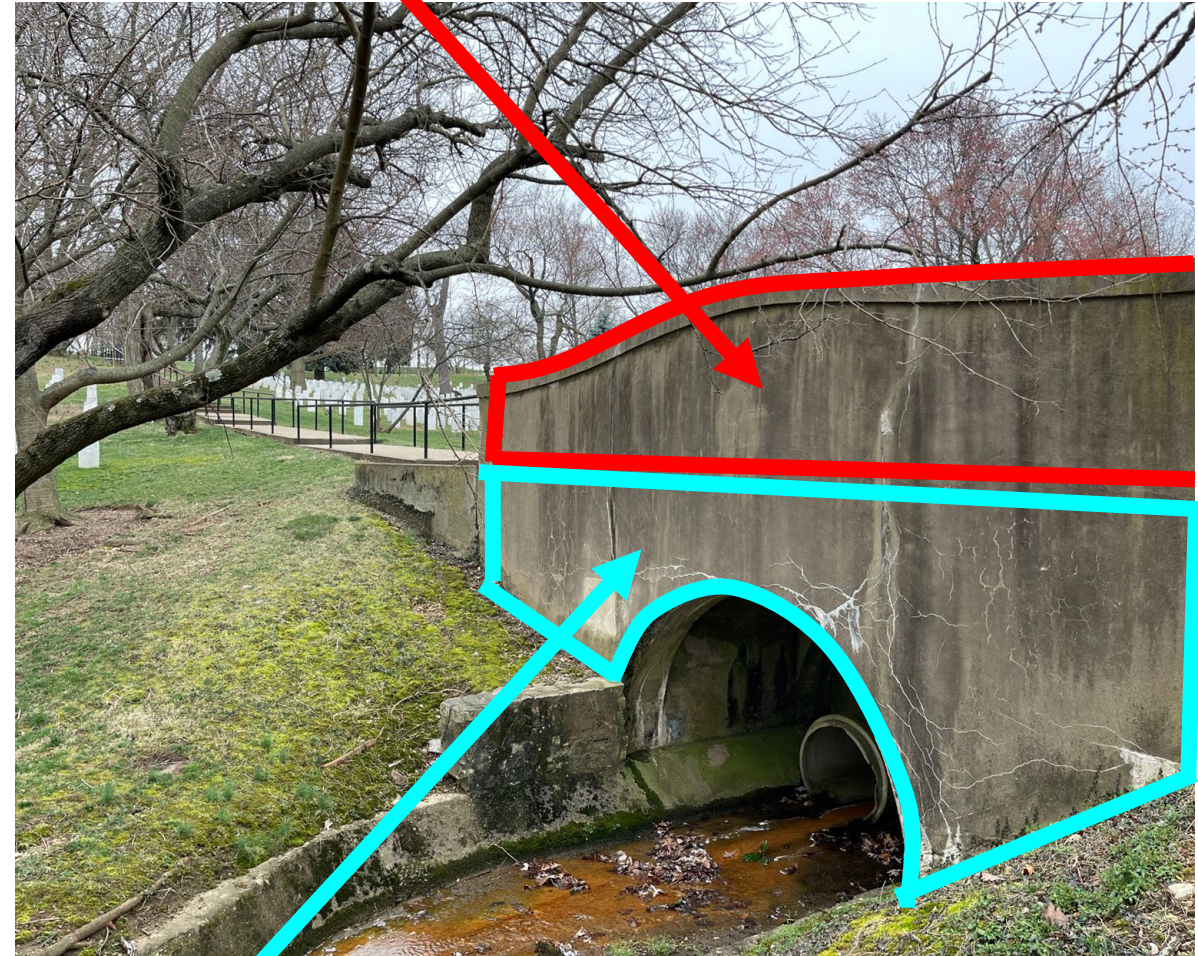
Portion of original bridge to remain and be rehabilitated

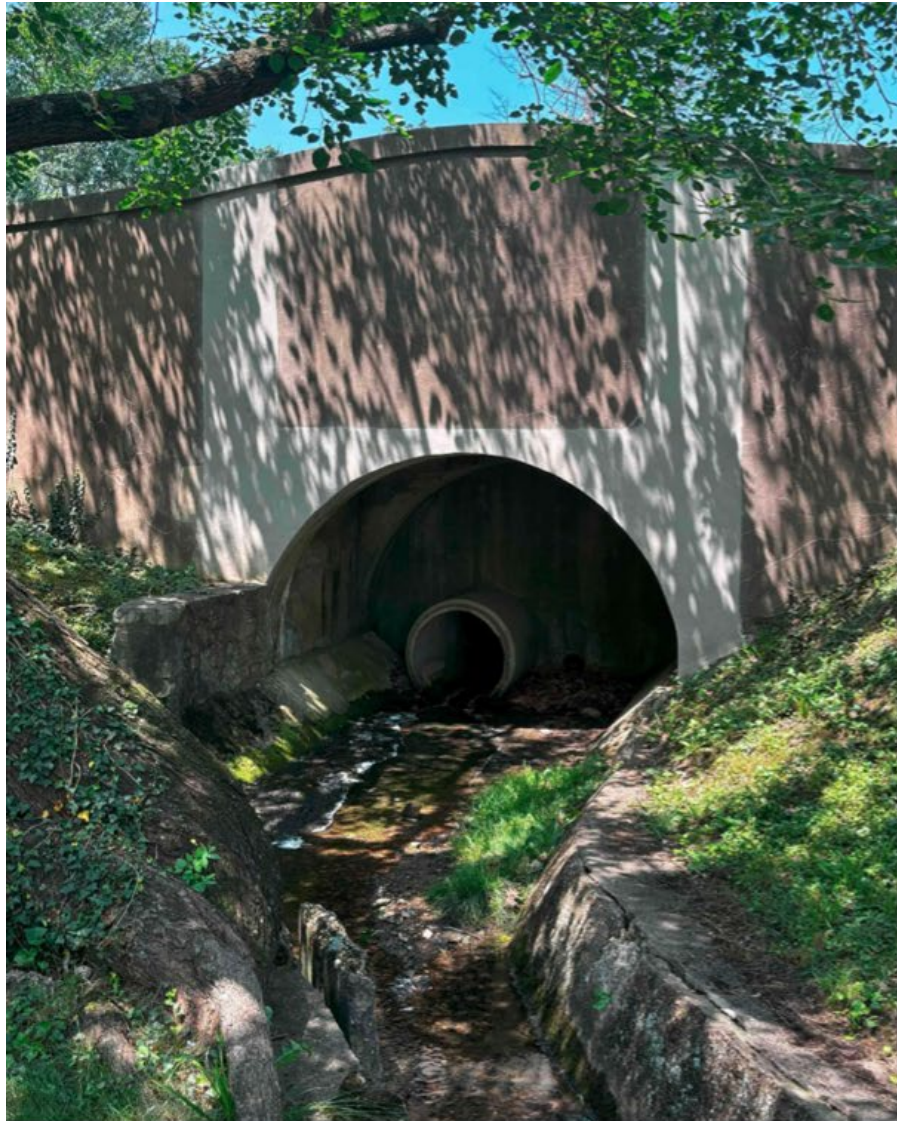
Existing conditions  
at Crook Walk bridge  
& culvert, before  
rehabilitation

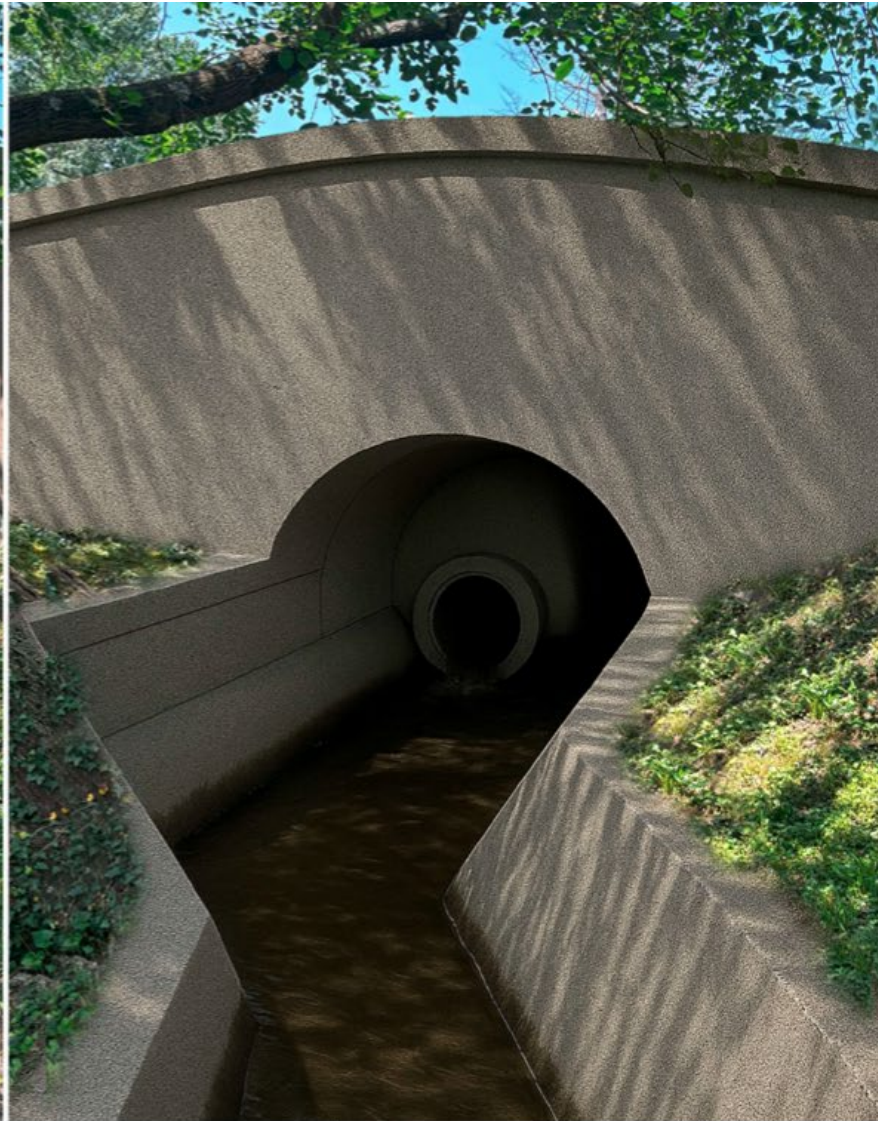
Rendering of Crook  
Walk bridge &  
culvert after  
proposed  
rehabilitation &  
reconstruction

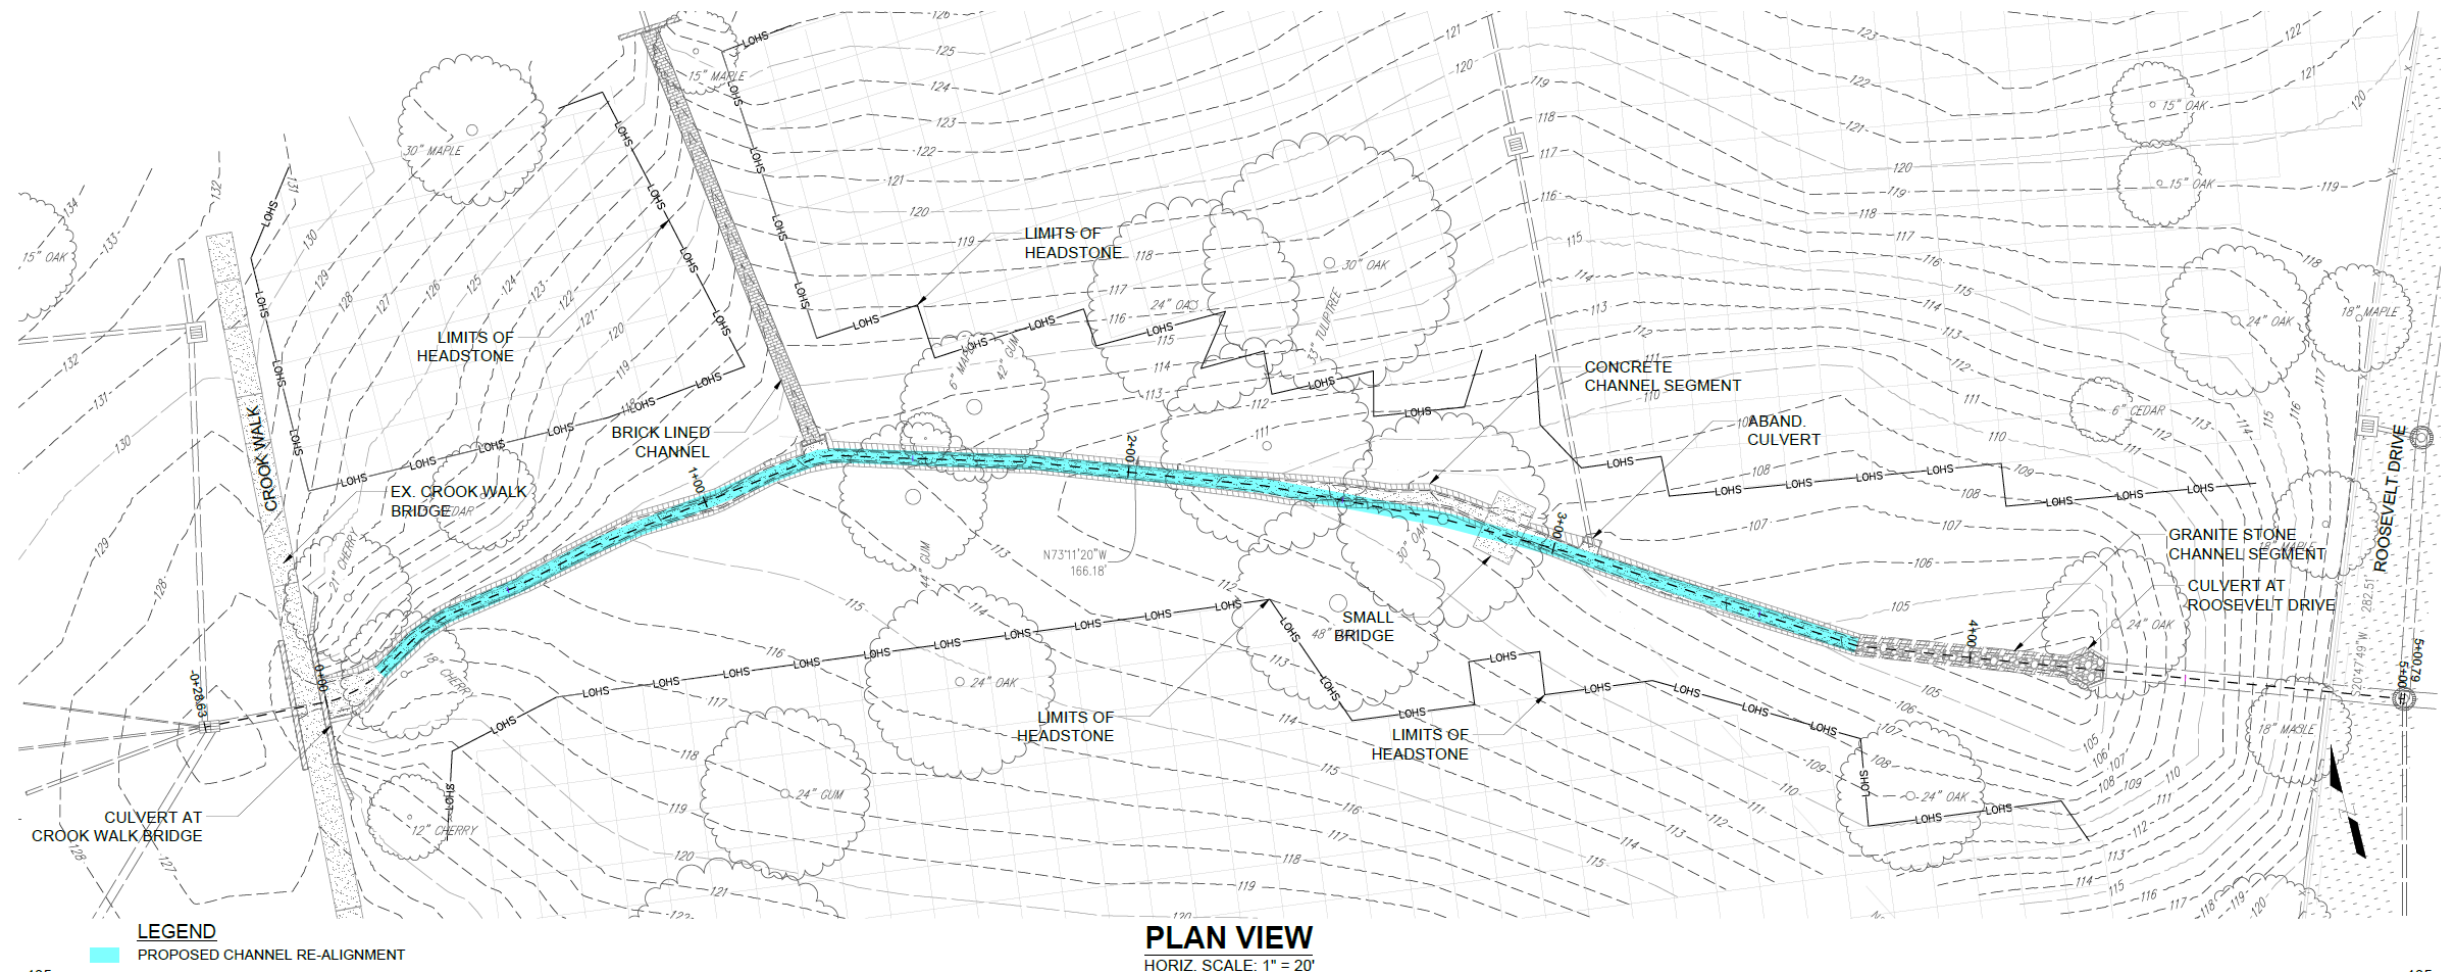
After a thorough inspection of the existing drainage infrastructure, it has been determined that the Section 37 channel is undergoing significant deterioration. The concrete sections have sustained severe damage, which undermines the channel's structural stability and disrupts proper water flow. The damage is widespread across multiple locations, making repair efforts impractical and costly. Additionally, the channel's current capacity is insufficient to handle a 10-year storm event, which increases the risk of erosion and potential overtopping. Therefore, the recommended approach is replacement of the concrete and realignment of the channel.

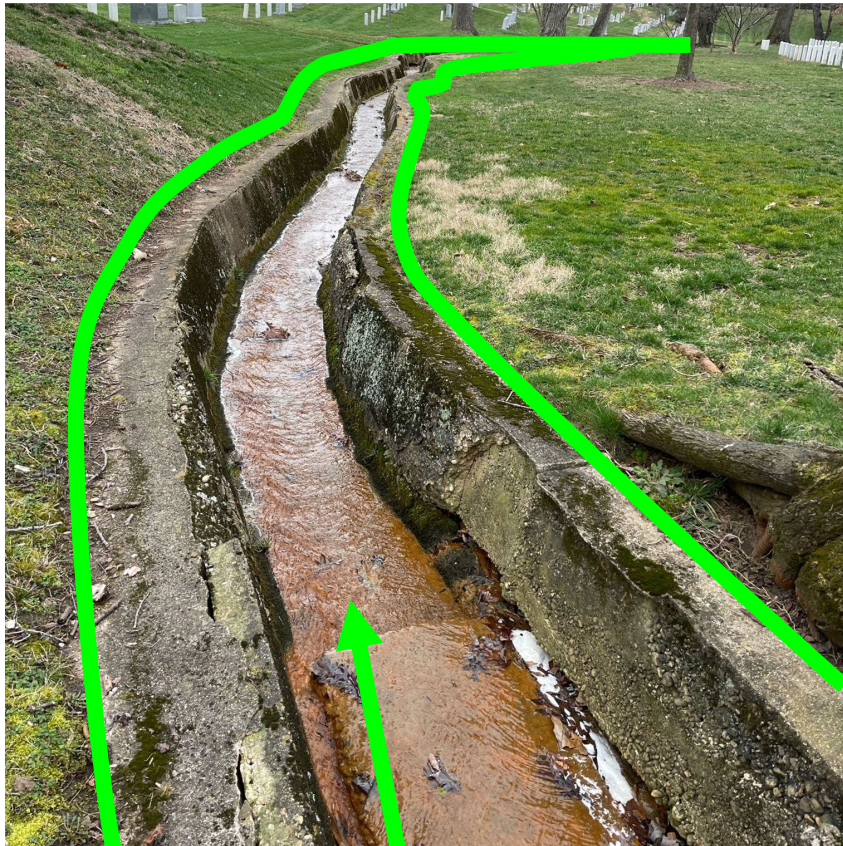
Entire concrete channel  
to be removed and  
replaced

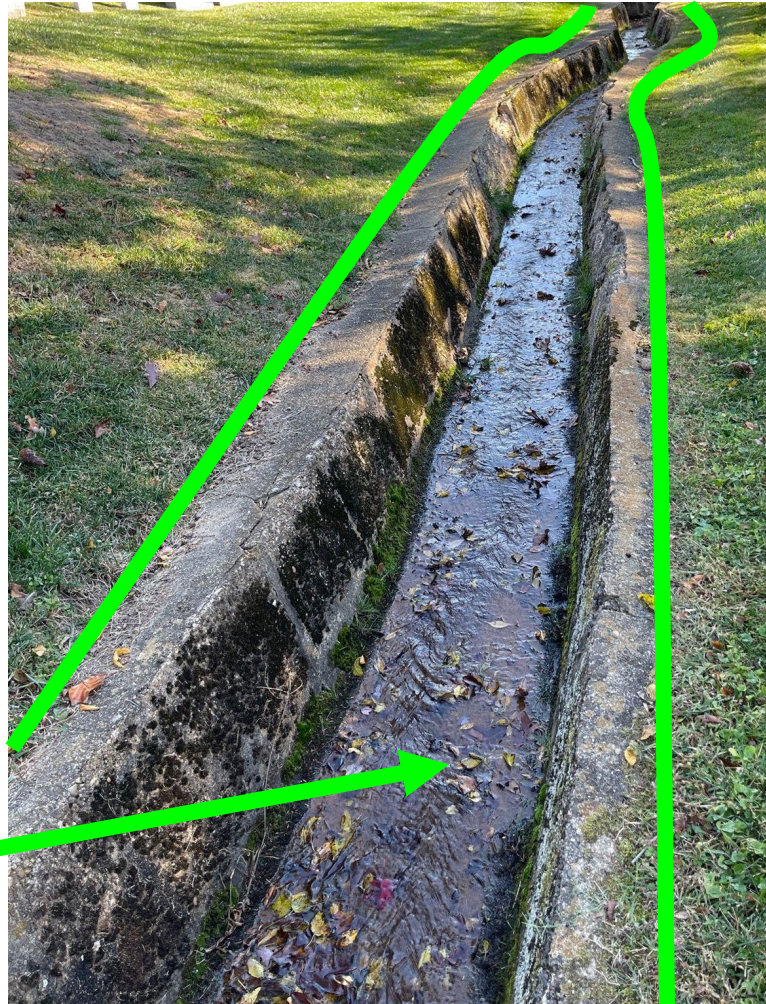
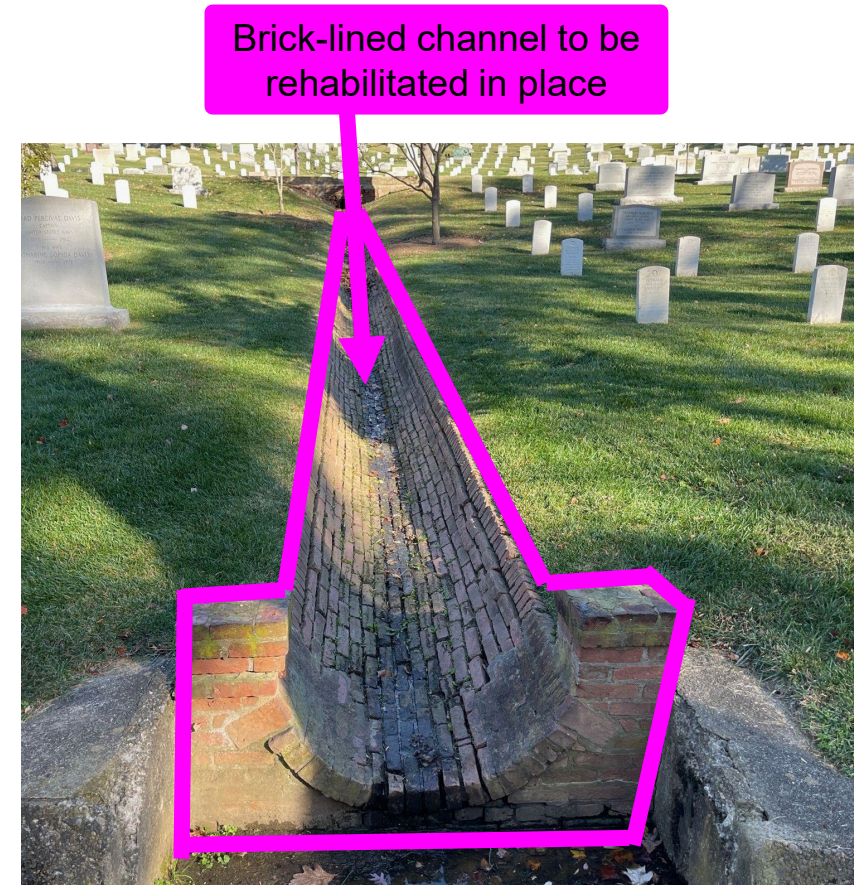
Brick-lined channel to be  
rehabilitated in place

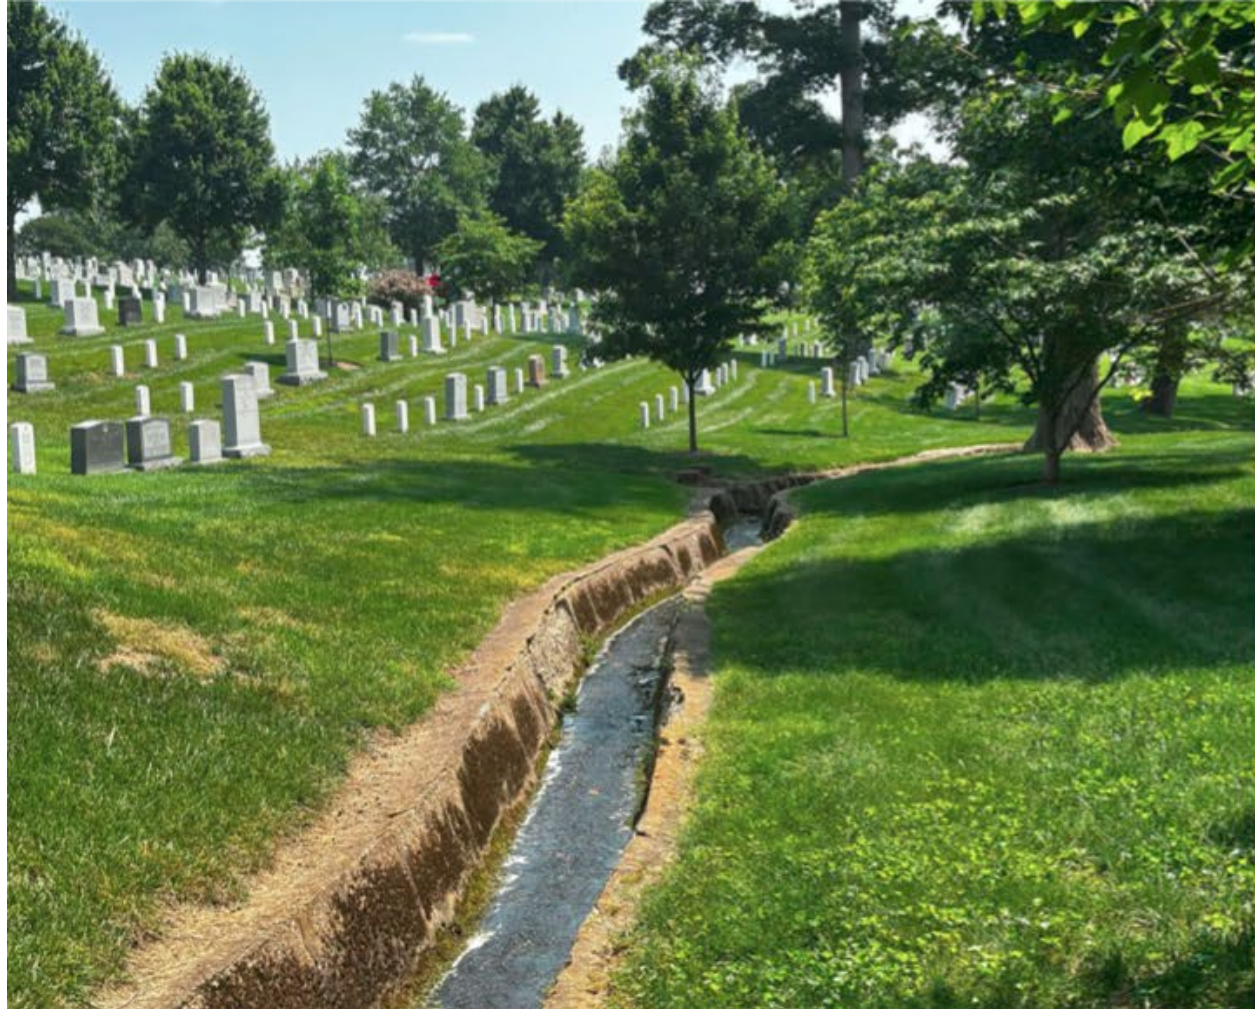
Existing Section 37 channel conditions, before rehabilitation

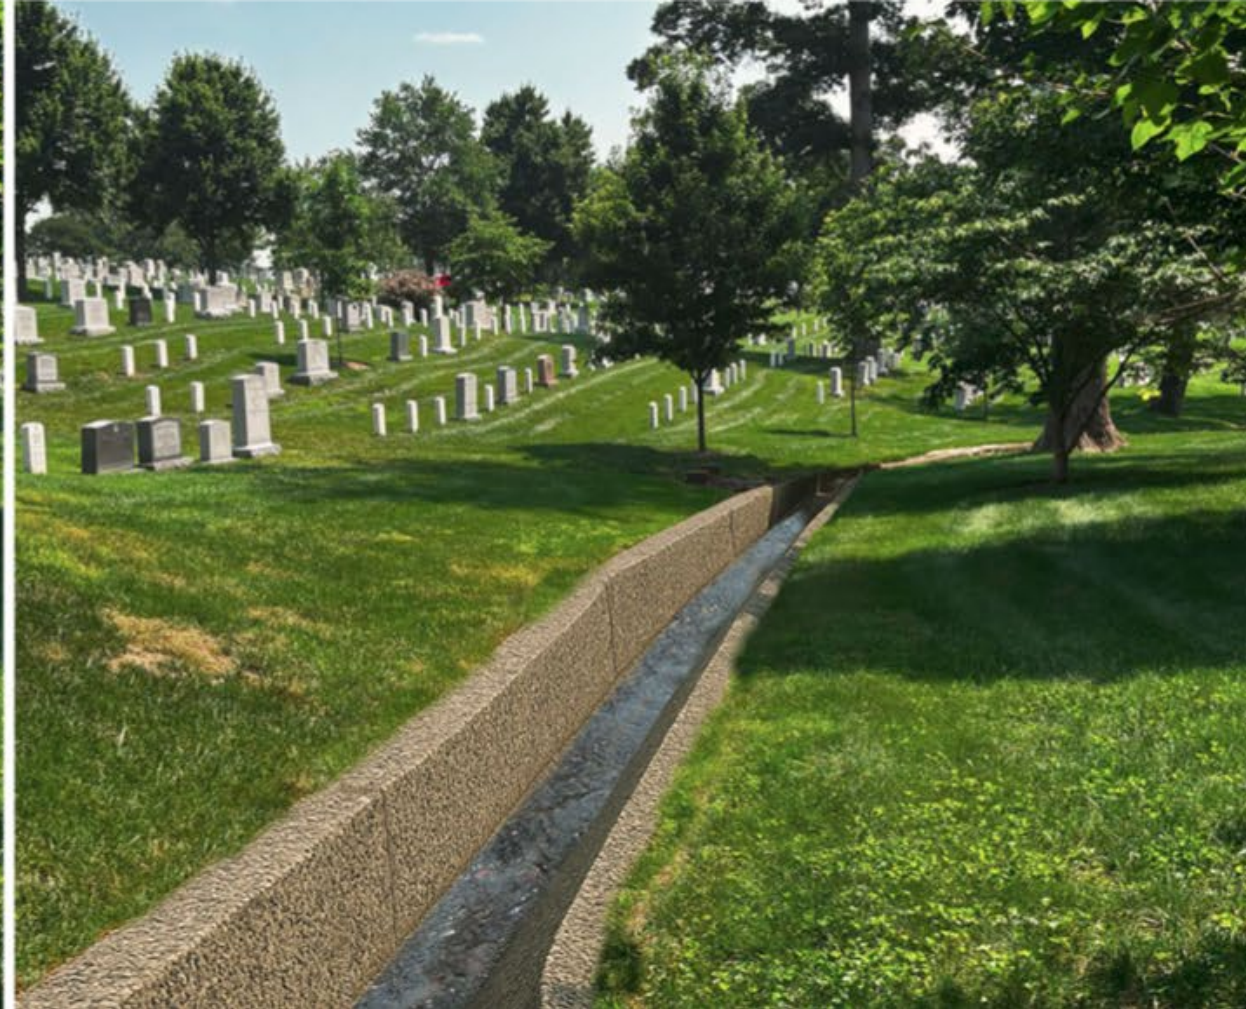
Rendering of Section 37 channel conditions after proposed reconstruction

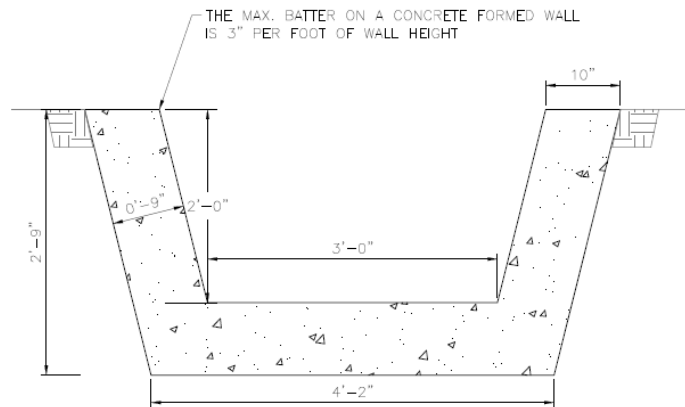
TYPICAL CONCRETE WALL  
SECTION (PRECAST OPTION)

Pre-Cast Concrete Wall Sections are recommended for the Section 37 Channel as the most durable and long-term solution due to its superior durability, expedited construction timeline, and long-term cost-efficiency.

- Requires less labor and can be installed more quickly, which is beneficial given the limitations of site access and the constrained available space.
- Maximizes efficient use of available land while maintaining structural integrity, requiring less space than cast-in-place concrete.
- Provides enhanced resistance to tree root intrusion.
- Is manufactured in a controlled environment, ensuring consistent quality, durability, and strength.
- Units are easy to transport and install, making them ideal for sites with limited or difficult access, unlike cast-in-place concrete which may require extensive site preparation.
- Is produced off-site, unlike cast-in-place concrete, minimizing delays and potential quality issues caused by weather conditions.
- Units are similar in design intent to the original individual Section 37 concrete channel elements.
