# **ARLINGTON NATIONAL CEMETERY**

**MS4 Permit Year 2017/2018**

## **Annual Report and Program Plan Update**

**July 1, 2017 through June 30, 2018  
(Due: October 1, 2018)**

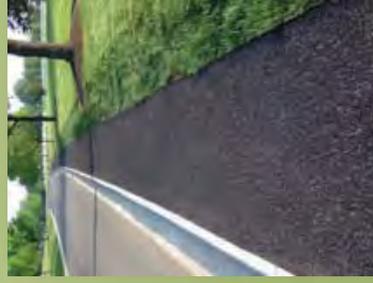
Permeable pavement reduces polluted runoff by allowing stormwater to seep through the surface, filtering out pollutants.

Permeable pavement is installed at the Millennium Site and used for sidewalks near the new Chapel Gate and along Eisenhower Avenue.
