Arlington National Cemetery Confederate Memorial Removal

Entitled Parties Meeting March 1, 2024

- Project Description: To remove the Confederate Memorial bronze elements in Arlington National Cemetery (ANC).
- The Naming Commission, established by Congress, recommended removal of the bronze elements of the monument, leaving the granite pedestal in place. This became law in 2022.
- There are no remains under the memorial. The remains of those buried near or in the section were protected throughout the process.
- ANC mandated to comply with the law by Jan.1, 2024.
- Removal occurred from December 17 22, 2023.
- Project website:

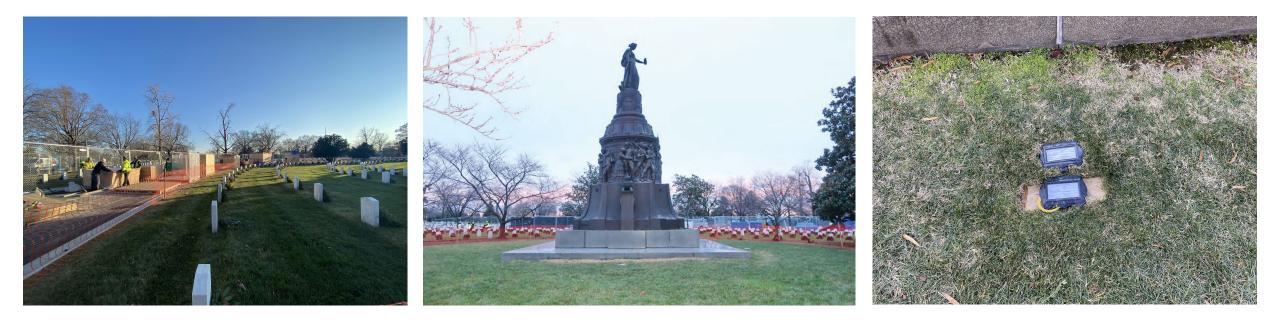
Sunday, December 17:

- Contractor arrived on-site
- Equipment mobilized: crane, aerial manlift, telehandler forklift, ground protection mats, crating materials
- Construction fencing installed around Section 16
- Hi-vis barrier installed around the government markers
- ANC Interment Operations removed four (4) grave markers adjacent to the base and installed temporary markers

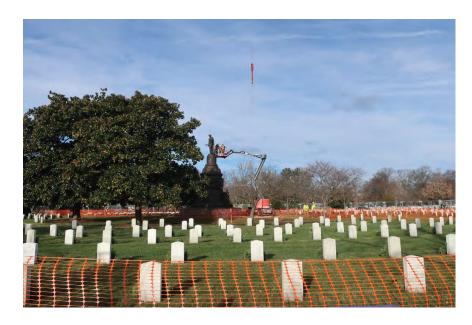
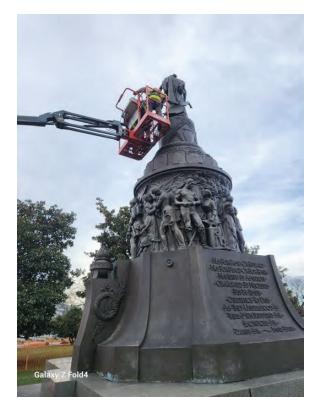
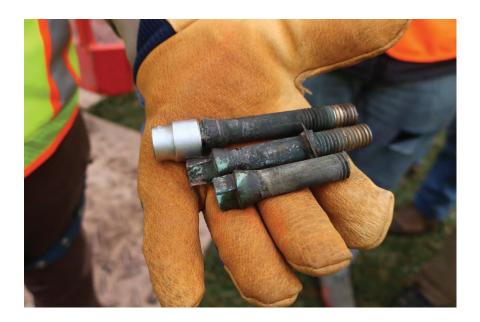
Monday, December 18:

- Contractor carpenters constructed crates throughout the first day
- Three (3) bolts removed from the base of the top sculptural element
- High wind gusts stopped disassembly work

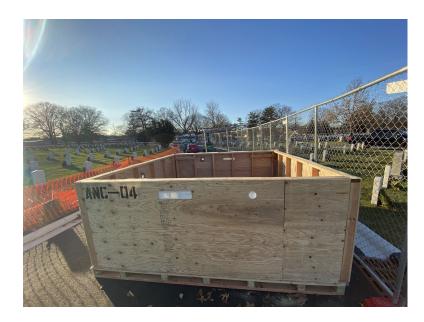
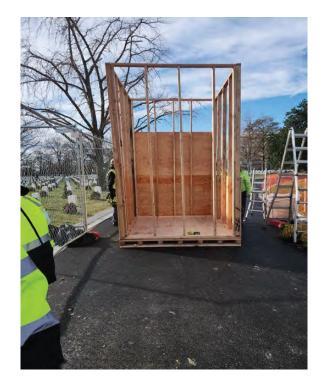
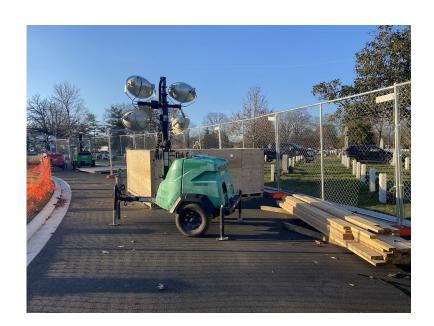
Tuesday, December 19:

- Carpenters continued crate construction
- Portable mast light towers installed to illuminate Section 16
- Conservator and architectural historian documented the existing condition of the bronze sculpture

- Riggers in the aerial manlift removed bolts and rigged the bronze elements for lifting
- 300-ton crane parked on the roadway boomed out to lift the bronze elements from the center of Section 16 to their respective crates, guided with taglines by riggers on the ground
- Statue of the South, bronze element ANC-01, removed and crated

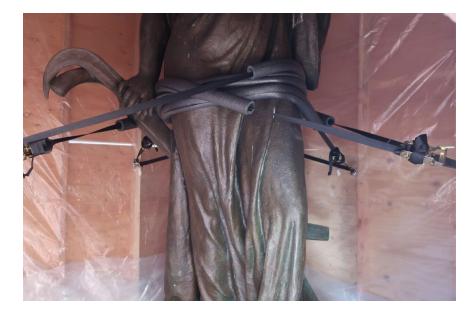
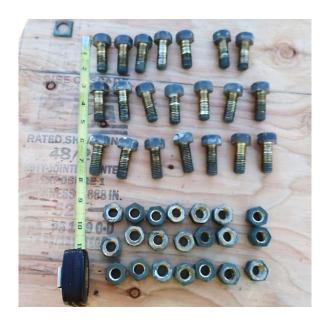
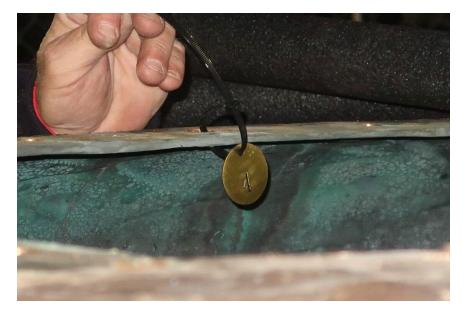
- Architectural historian marked each bronze element interior with a number, attached an ID tag, documented the condition, and completed the inventory form
- All bolts collected and documented
- Each bronze element individually secured in the crates with nylon rigging straps, metal bolts, and polyethylene foam

- Architectural historian documented sculpture interior existing conditions, including internal structure and connections
- Pedestal of cinerary urns, bronze element ANC-02, removed and crated
- Bronze element ANC-04 (consisting of the wreath plinth, biblical circle inscription, and frieze of shields) removed and crated

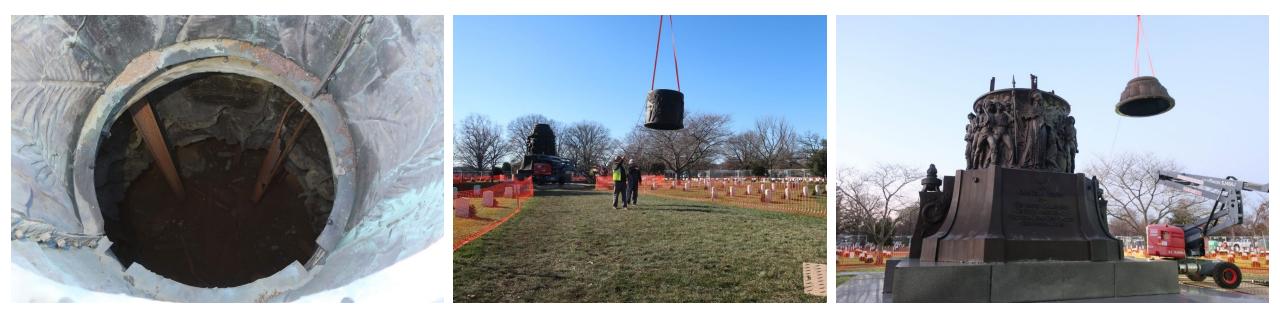
- Figural frieze, bronze element ANC-05, removed and crated
- Three (3) steel I-beams removed, documented, and crated
- The bronze sculpture had become a self-supporting, load-bearing structure; the steel I-beams were so deteriorated they
 no longer carried and distributed the bronze load.

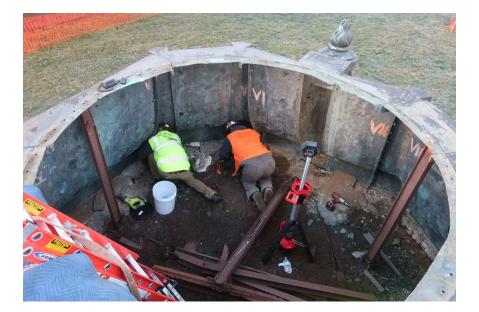
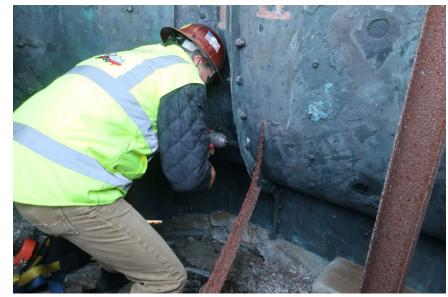
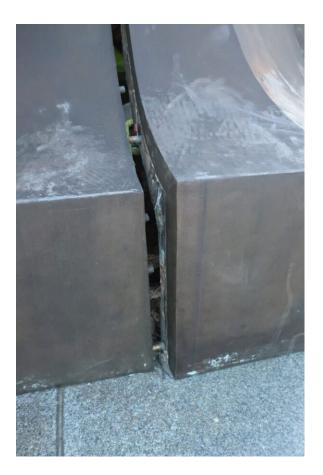
- Documentation and crate building continue
- Eight (8) bronze pieces resting directly on the granite base remain

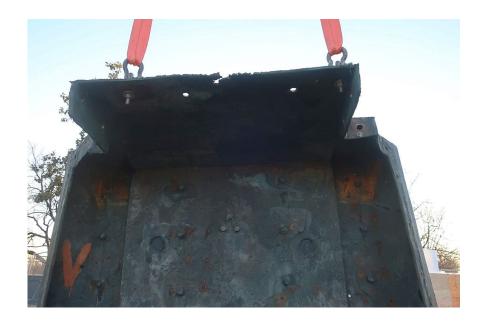
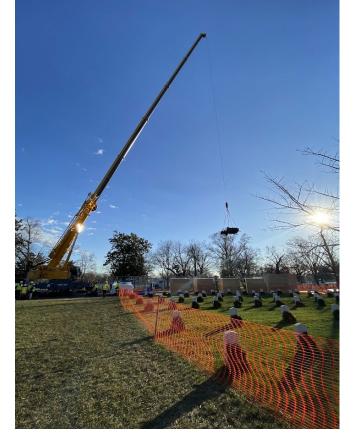
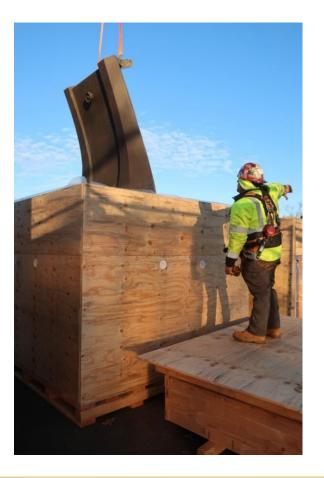
- Eight (8) bronze base pieces (ANC 06-ANC 13) removed, documented, and crated

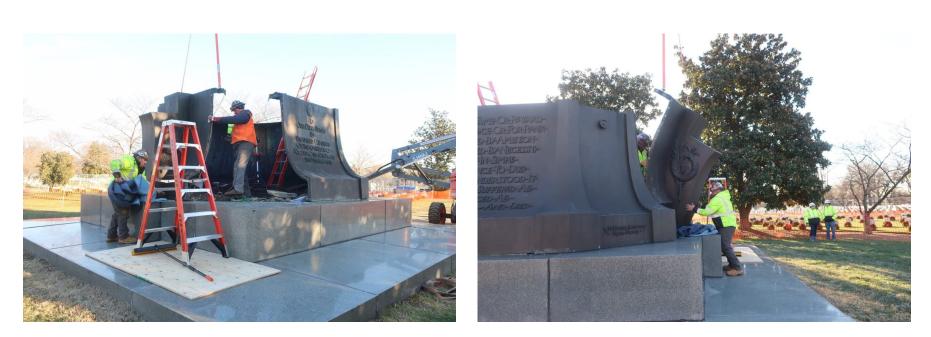
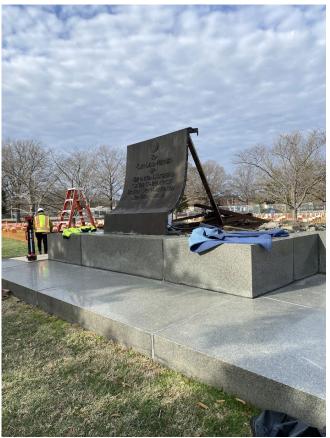
- Eight (8) bronze base pieces (ANC 06-ANC 13) removed, documented, and crated

- Steel I-beams numbered and labeled, documented, removed, and crated
- The east and west torches (ANC-03) removed, documented, and crated

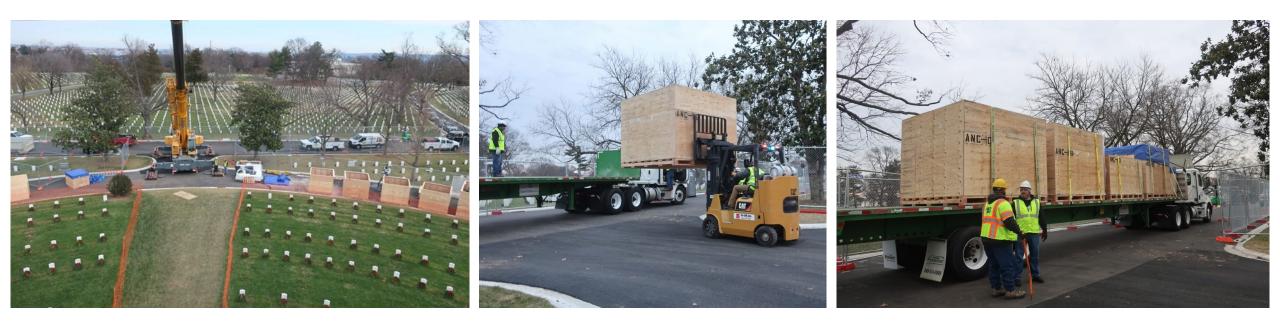
- All crates loaded onto flatbed trailers, secured and staged for delivery the next morning

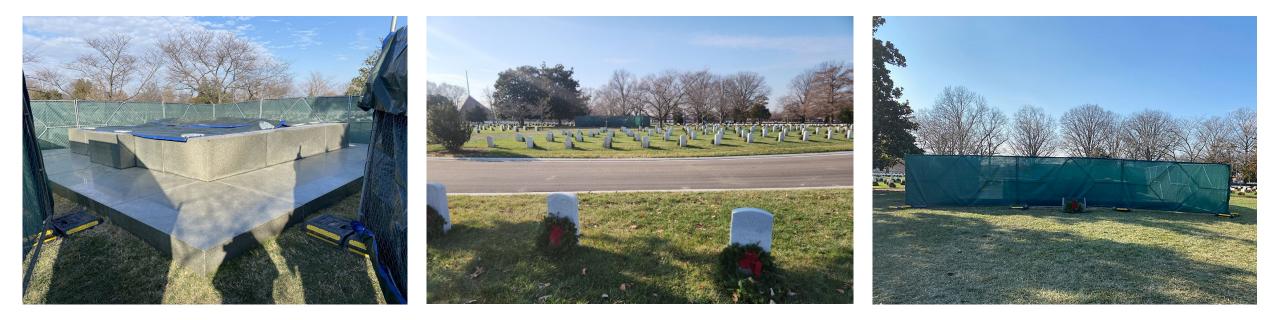
Friday, December 22:

- Confederate Memorial sculptural elements delivered to a federally owned storage facility
- Crates inspected by USACE and transfer documents signed
- All contractor equipment removed from ANC
- ANC staff inspected, cleaned, and secured the granite base
- ANC Interment Operations re-installed the four (4) grave markers adjacent to the granite base

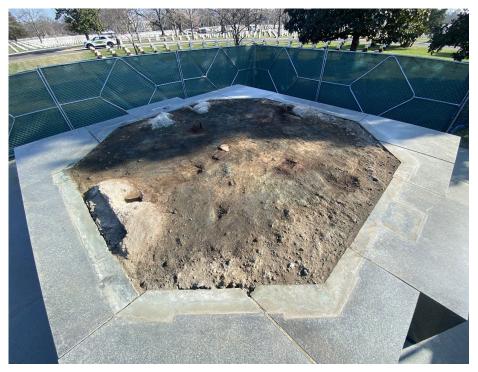
- ANC staff found the following conditions, post bronze removal:
 - Granite block base infilled in the center with a rough, uneven concrete fill. Steel I-beams embedded in the concrete surface were cut-off near their bases, leaving three sharp, corroded metal protrusions.

- ANC staff implemented short-term preservation treatments:
 - · Documentation of the as-found conditions.
 - Sifted through the debris for potential historic properties or unanticipated effects.

- Cleared the debris, cleaned the surface, and documented the conditions.
 - Due to safety hazards, the area immediately around the base was temporarily fenced and screened.

- The protruding I-beams were covered with buckets and the entire surface covered with heavy duty polyethylene tarps.

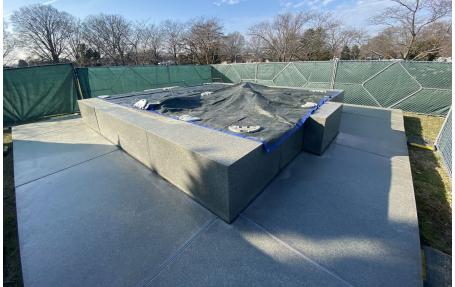
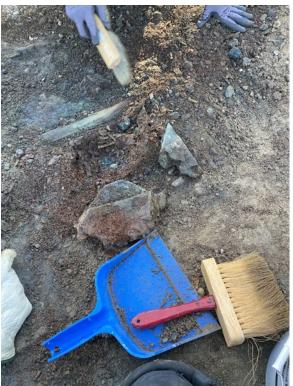
- For long-term preservation of the base, in the next five months, ANC will:
 - Create a weather-resistant, smooth surface at the top of the base. This will shed water, prevent water intrusion into the structure, and provide a stable walking surface, in the event visitors or staff attempt to climb the base.
 - Clean the base, document the condition, cut down the concrete below the granite surfaces, fill any voids, pour a
 new smooth layer of concrete (slightly domed to shed water), with a sealant joint
 at the perimeter as a barrier between the concrete and granite surfaces.
 - After the concrete us cured, remove fencing and restore the site.
 - Document the final conditions.
