November 30, 2021

RED SPRING, CROOK WALK, & KENNEDY GRAVESITES TRAM STOP REHABILITATION at Arlington National Cemetery, Arlington, Virginia

PROJECT DESCRIPTION, AREA OF POTENTIAL EFFECTS, & ASSESSMENT OF EFFECT

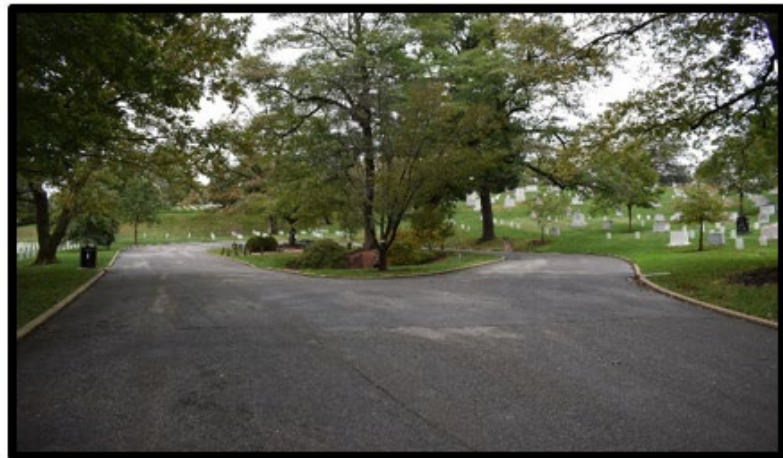
1 Red Spring Area in center of
McClellan Drive Cul-de-Sac
View to west, 2020

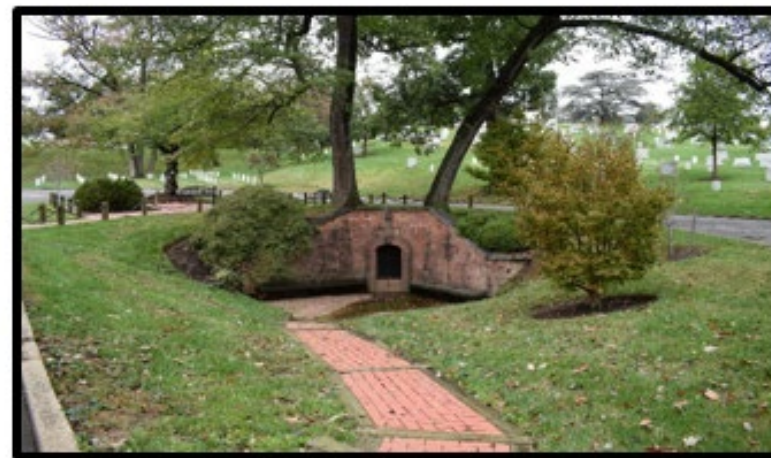
2 Red Spring Upper and
Lower Terrace shown along
with Spring Enclosure
View to west-northwest, 2020

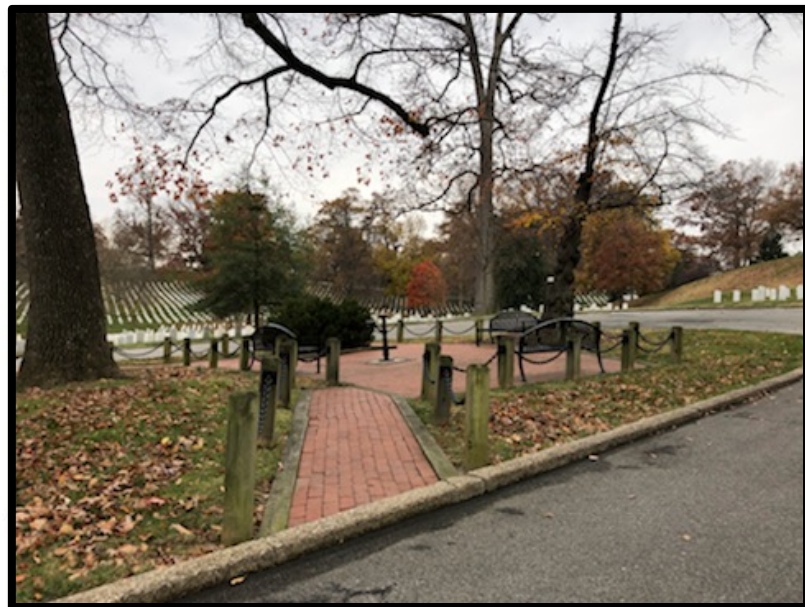
3 Existing Red Spring Upper
Terrace
View to southwest, 2021

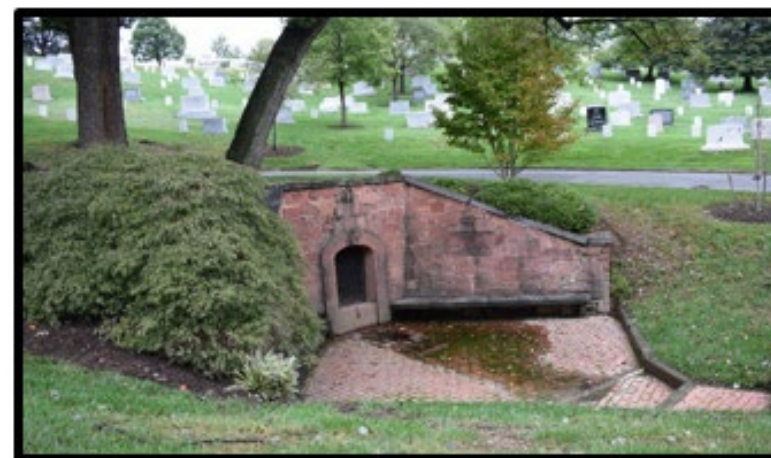
4 Red Spring Lower
Terrace and Spring
Enclosure
View north, 2020

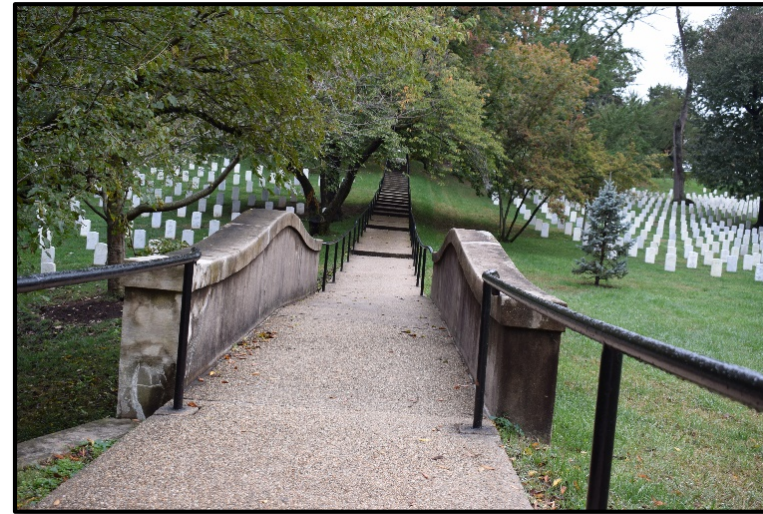
2 Crook Bridge midway
along Crook Walk between
McClellan and Wilson Drives
towards Memorial
Amphitheater (No changes
proposed to bridge as part of
this project.)
View south, 2019

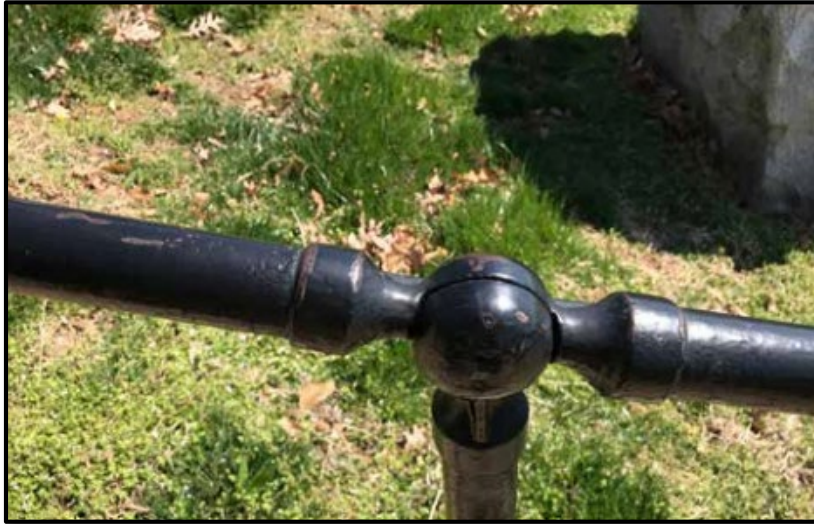
One of the types of
existing handrail /
barriers used along
Crook Walk
2019

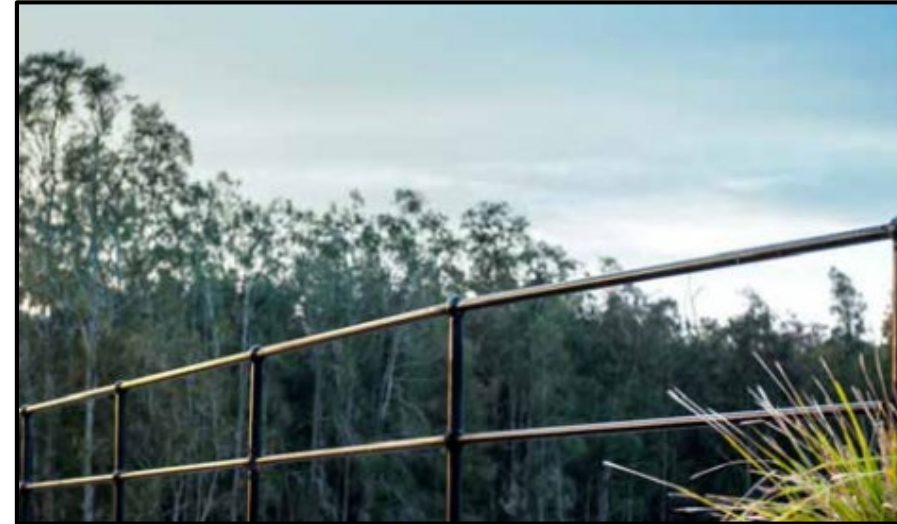
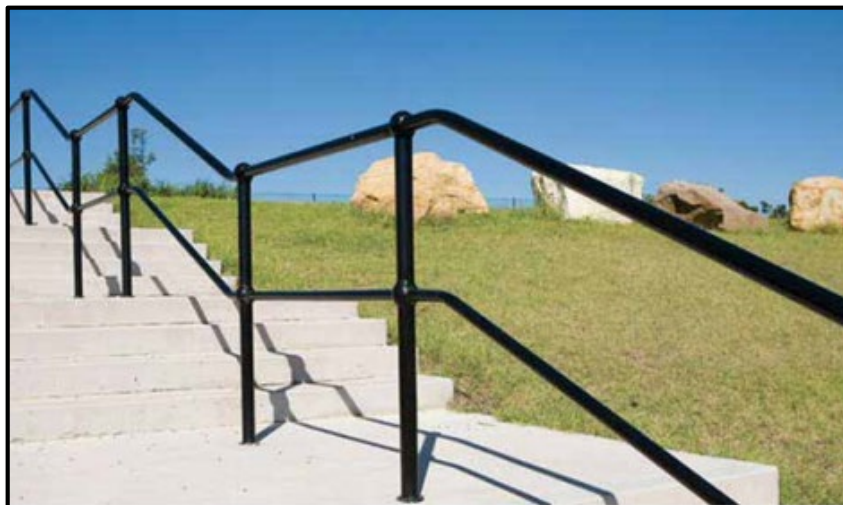
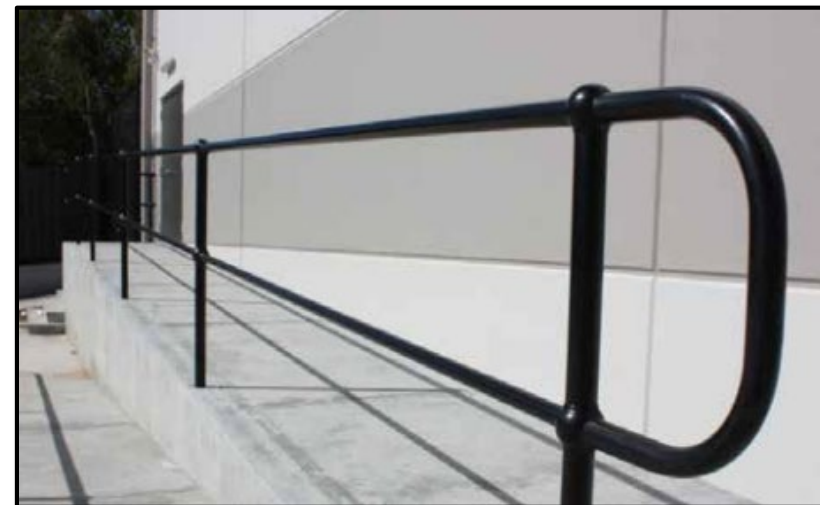
Proposed replacement
railing for Crook Walk -
black steel pipe and ball
design with the "knuckle"
at the joints

- Replacing the entire concrete Crook Walk (approximately 800 linear feet) from Lee to Wilson Drives with a new concrete sidewalk and steps to meet minimum accessibility, safety, and access requirements.
- Retaining existing historic alignment, width, overall form, materials, and finishes of the pathway.
- Retaining historic Crook Walk Bridge. (Patching the stucco finish on the bridge at voids resulting from removal of handrails extending into the bridge structure.)

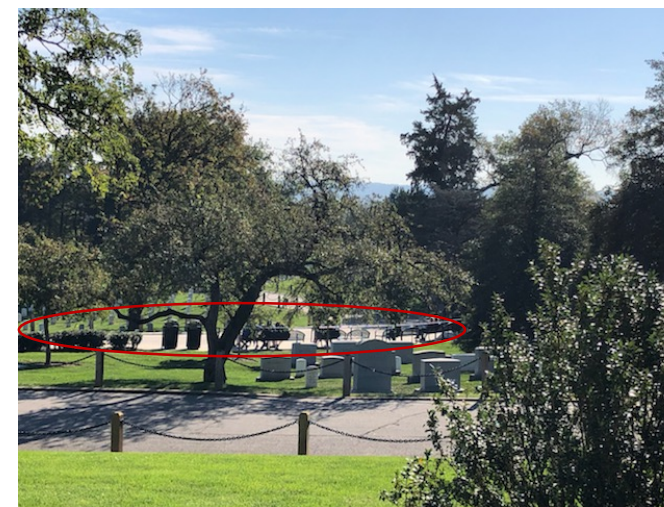
8 Existing Tram Stop from
Robert Kennedy Memorial
Grave (Low planting will
screen view of proposed
tram stop.)
View east 2020
