Arlington National Cemetery Southern Expansion – Boundary Wall Evaluation

October 28, 2016

Prepared by:

BELL Architects, PC
1228 9TH Street NW
Washington DC 20001

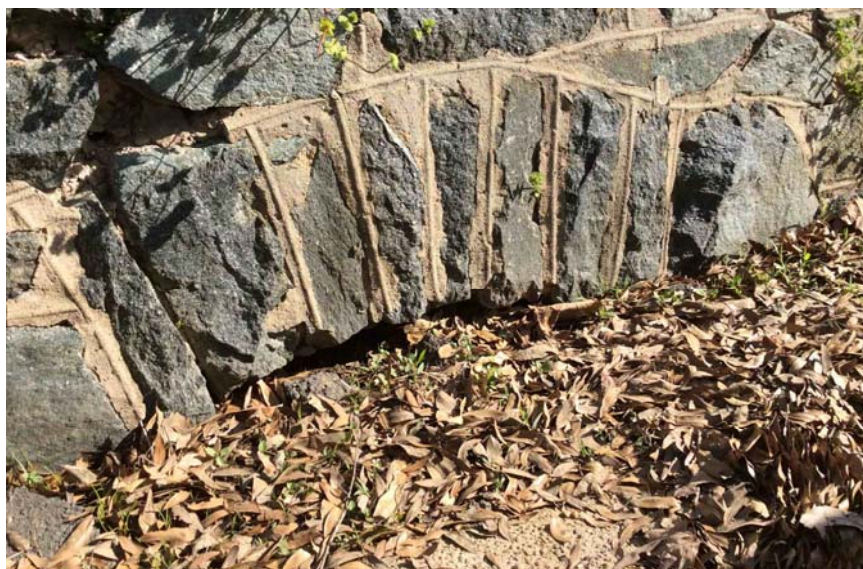
Figure 9- Stone Arch

Not far from the western end of the wall, near the intersection with the South/Clayton Gate is a small stone arch at the base of the wall (**Figure 9** and **Figure 10**). This was likely for drainage or below grade structure extending through the boundary.

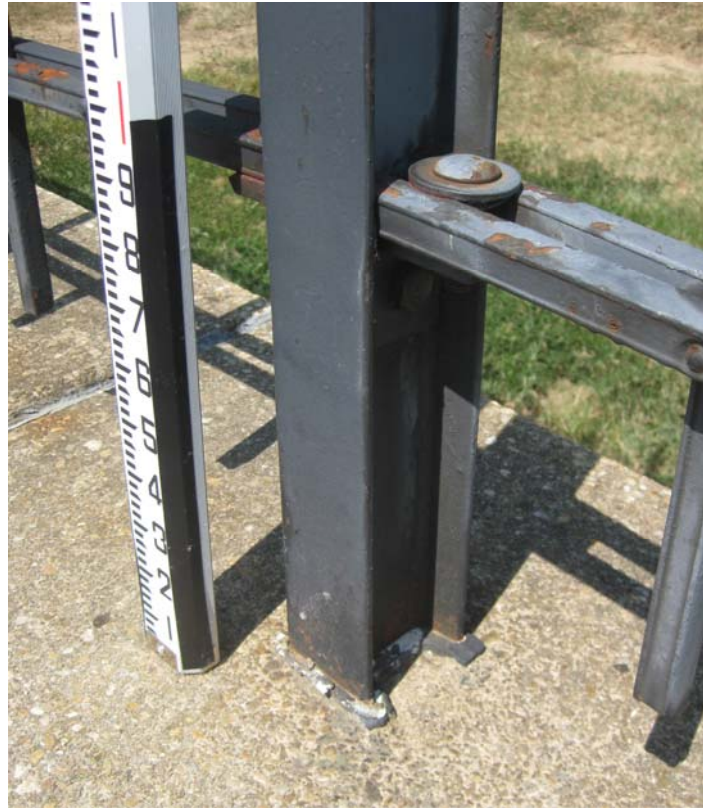
Figure 16- Detail of post connections

A single precast course concrete slab runs the length between the stone piers and a joint sealant fills the gaps between the cap stones. Black painted metal fence posts are embedded into the top of the wall at each pier. The fence is comprised of evenly spaced pickets held between two horizontal bars with a rivet near the top and bottom of the fence segments. Each fence panel spans approximately twenty feet from pier to pier with two pickets at third points that extend into the wall cap to provide support. The extended pickets are embedded into the precast concrete cap with grout. Each end of the fence panel is bolted to an angle that aligns with the horizontal bars, which in turn is bolted to the “H” shaped fence post (**Figure 16**), except at the gates where the fence panels bolt into the side of the stone pier. Running somewhat parallel inside the cemetery wall is a gently curving paved roadway (Patton Drive). Some of the lawn area between the wall and internal roadway (Patton Drive) has two rows of headstones running parallel to the wall (**Figure 17 and Figure 18**).

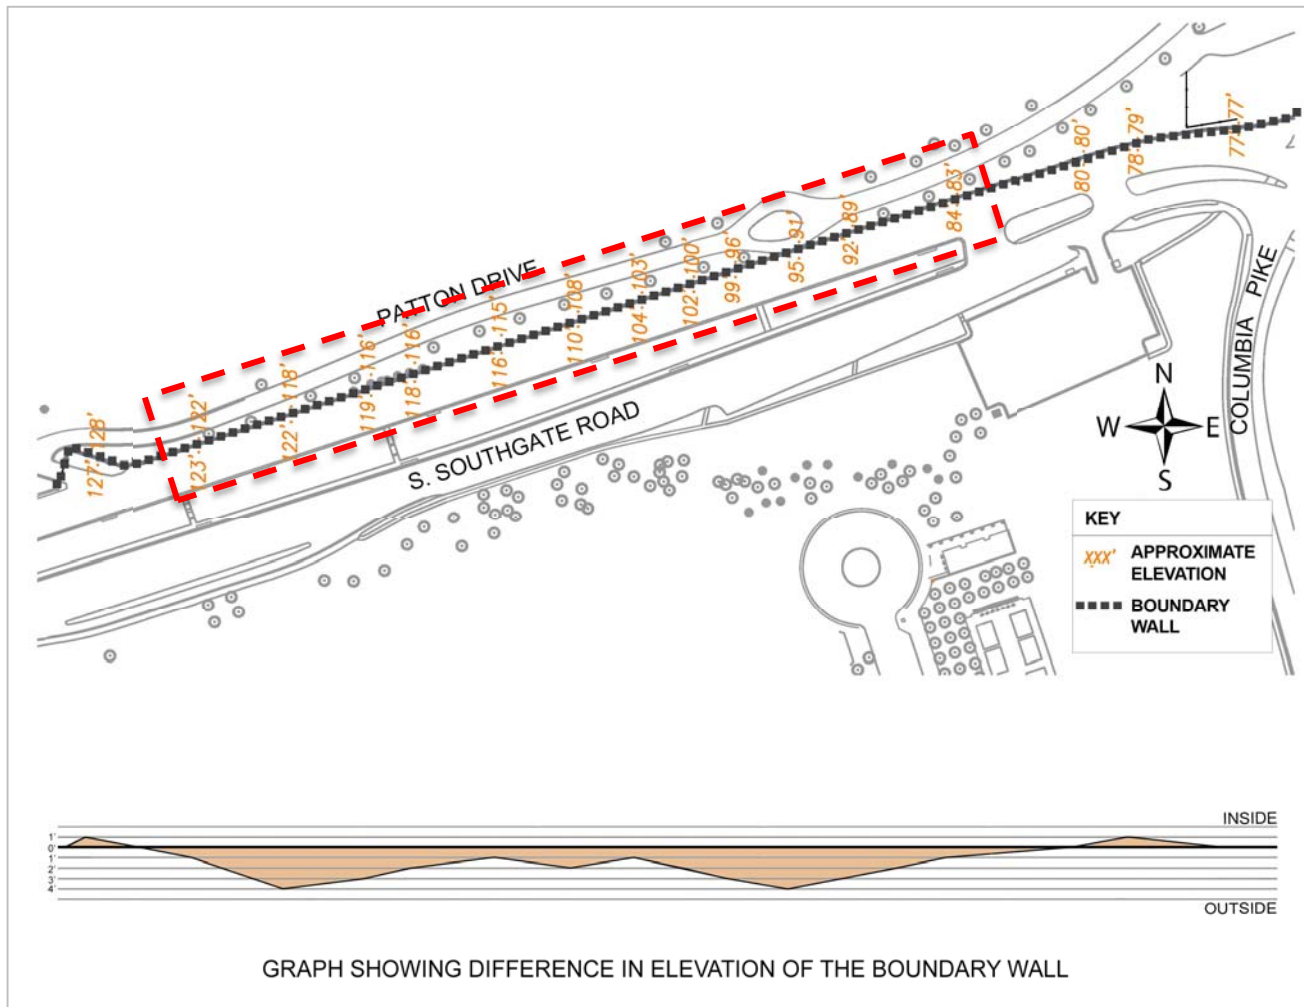
Figure 20- Area of boundary wall acting as a retaining wall with spot elevations

In some locations the wall is acting as a retaining wall as the cemetery side is typically lower than the sidewalk/street outside of the wall (**Figure 19**). There is a grade difference up to four feet between each side of the wall. **Figure 20** shows spot elevations on each side of the wall along the portion of the wall that currently serves as a retaining wall.

Parts of the existing boundary wall currently serve as a retaining wall (**Figure 19&20**). In addition, there are also two segments of retaining walls independent of the boundary wall along Patton Drive. With the removal and relocation of Patton Drive these retaining walls may no longer be required. The current diagram does not indicate how the grades will be altered to address these. These changes will likely involve the removal of historic resources and changes to the current contours, resulting in a potential adverse effect. The impact can be minimized if the expansion maintains the picturesque landscape of gentle rolling hills following the natural contours.

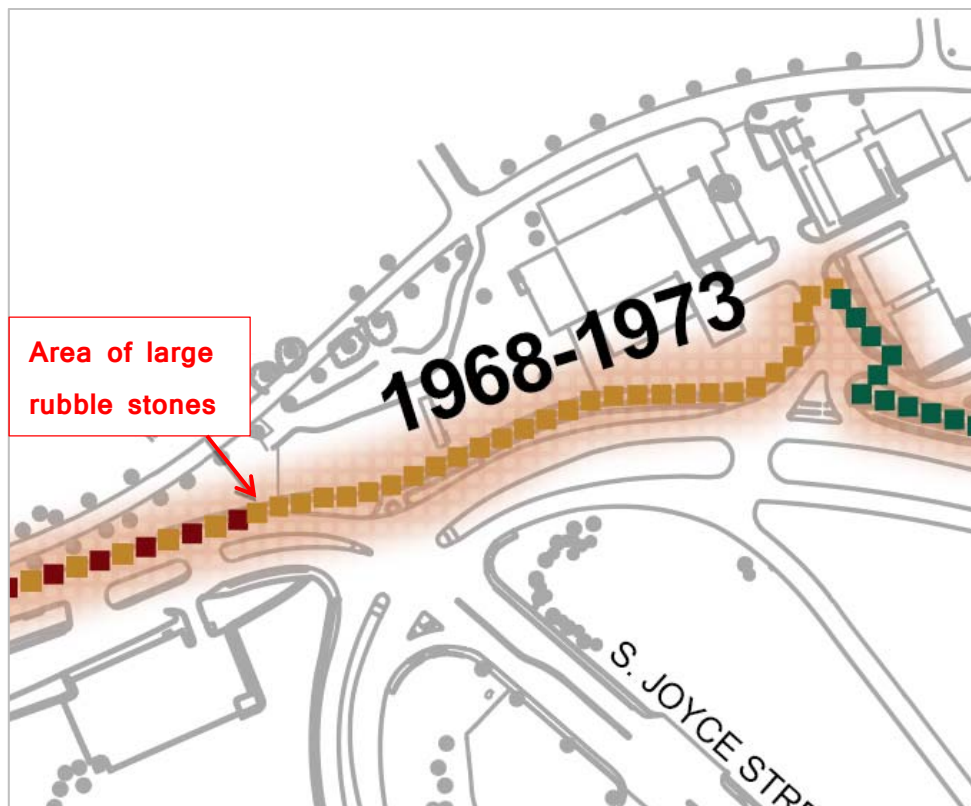
Figure 24- Location of large rubble stones

East of the Columbia Pike/Joyce Street intersection where the wall starts to undulate, the stone of the wall changes in color, shape, and size. Smaller rubble stones with a more brown color were used to construct this section of the wall. A approximately a third of the way through Section 3 near the edge of the Temporary Service Area the stones change in size to larger rubble stones, and the fence has welds from modifications (Figure 23 and Figure 24).

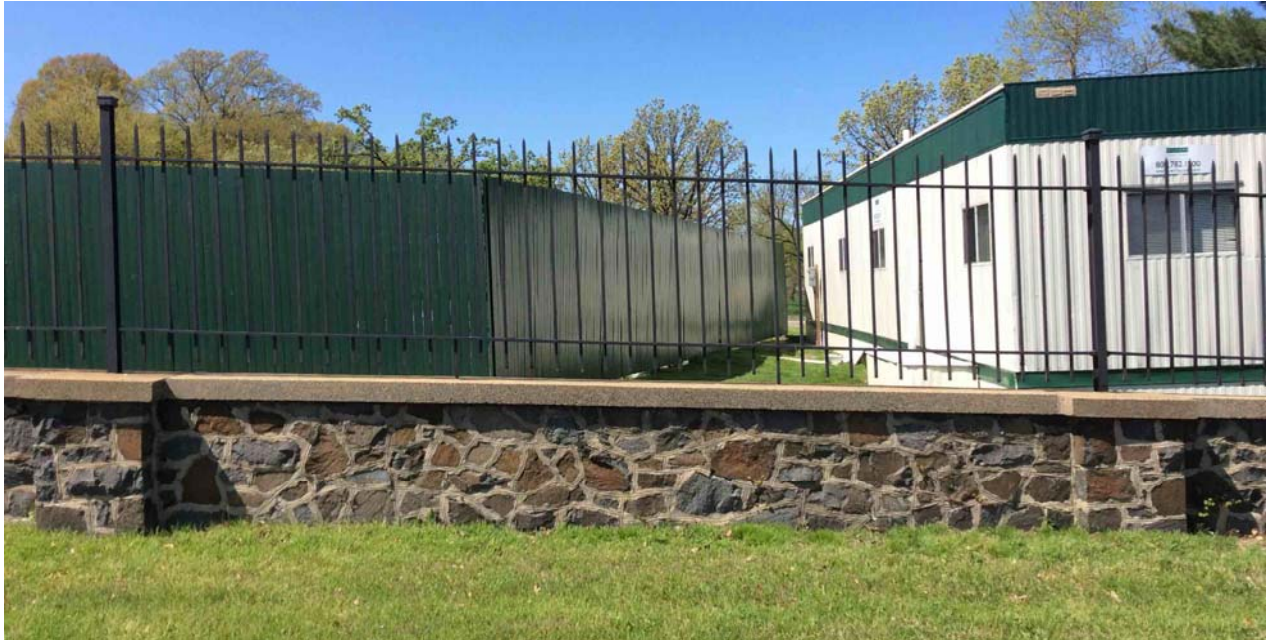
Figure 25- Service area within wooden screen and adjacent temporary work trailer

Adjacent to this area, inside the cemetery is a temporary service area enclosed with a temporary wooden screen. Next to it is a temporary work trailer (See **Figure 25** and **Figure 22** for location).

The last section of the wall starting at the Service Complex Gate, was recently constructed (See Figure 25, and Appendix A9.12 to A12.07). It has seen no modification and has no condition issues. This section retains a high degree of integrity, from its period of erection.

The portion of the fence starting at the Service Complex Gate is fairly new with no alterations or condition issues, maintaining all aspects that define its integrity (See Figure 25, and Appendix A9.12 to A12.07).

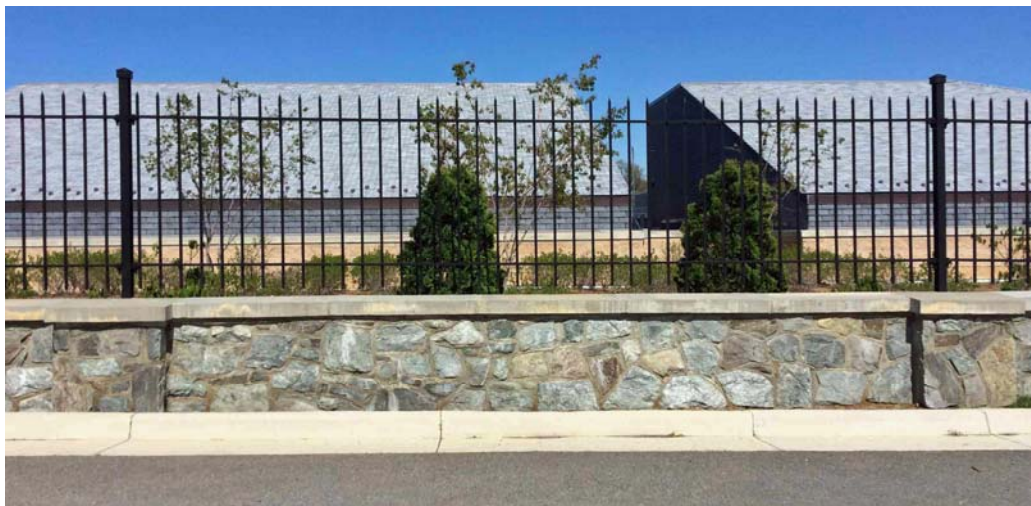
Figure 27- Boundary wall to the east of the Service Complex gate

The appearance of the boundary wall changes adjacent to the Main Gate to the Service Complex, with a combination of a slightly different stone and a pre-cast concrete cap (**Figure 27 and Figure 28**). The color of the stone is predominantly blue which varies from the predominate brown of the adjacent wall sections. Rubble stone with some shaping create joints that are fairly tight and consistent. The precast concrete cap has a slight peak in the center; it is composed of shorter segments in a light color with a smooth finish and a mortar joint between segments. The metal fence above remains the same in appearance as the other sections.

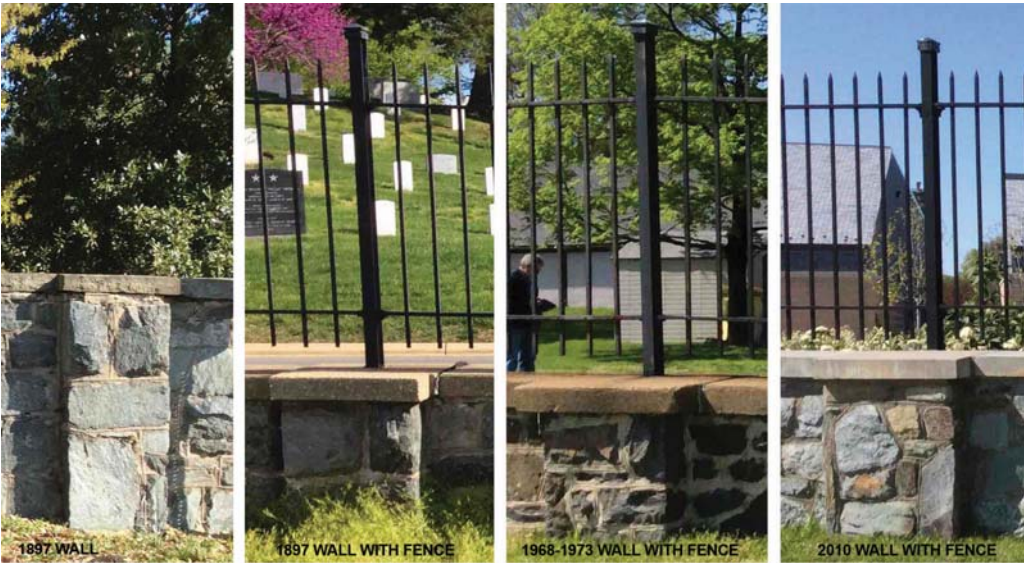
Figure 32- Typical Wall Types (Viewed from outside at piers)

The fourth type of boundary wall, built around 2010, starts adjacent to the Main Gate to the Service Complex. The color of the stone in this section is predominantly blue in color similar to the 1897 wall. A random rubble stone with some shaping is used allowing for consistently tight mortar joints. The precast concrete cap on top of the wall has a slight peak in the center. The cap is composed of short segments in a light color with a smooth finish and a mortar joint between segments. The metal fence above remains the same in appearance as the other sections of the wall (**Figure 32**).
