ANNUAL REPORT UPDATE

Arlington National Cemetery

VPDES Permit Number: VAR40139

FINAL – MS4 ANNUAL REPORT

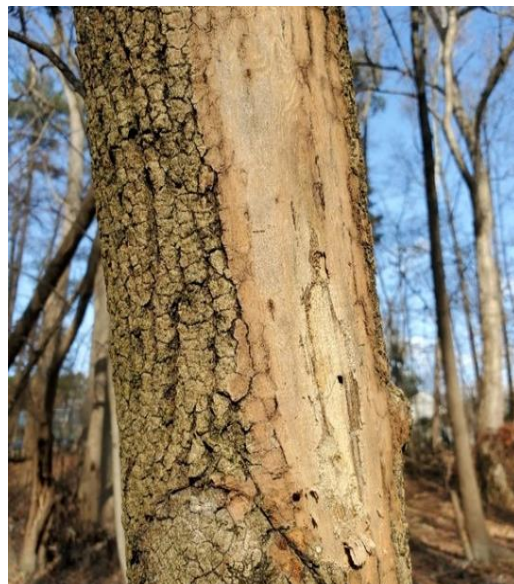
Ash tree tissue damage typically associated with emerald ash borer at JBLE-Langley's Big Bethel Reservoir.

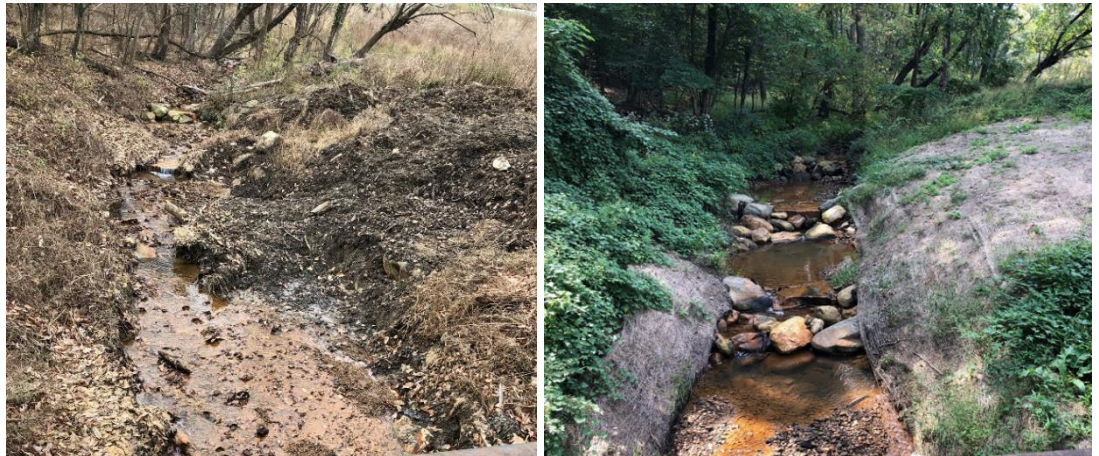
(Left) Excess sediment and debris inhibited stream flow, and lack of bank stabilization allowed for erosion upstream of the trash screen at Ord & Weitzel Drive. (Right) Removed sediment and debris, reconstructed stream plunge pools, and stabilized stream banks allow improved flow of water.

specifications. This effort required removal of accumulated sediment and debris from the step pools and stabilization of the streambank with seed mix and erosion control matting. The culvert trash screen was replaced with a larger screen with more surface area for capturing debris, increasing the amount of time between future maintenance activities. Ultimately, these actions enhanced water flow in the stream, mitigated flooding, and reduced future maintenance costs. For more information about this project, please contact Stacey Rosenquist at stacey.m.rosenquist.civ@army.mil.

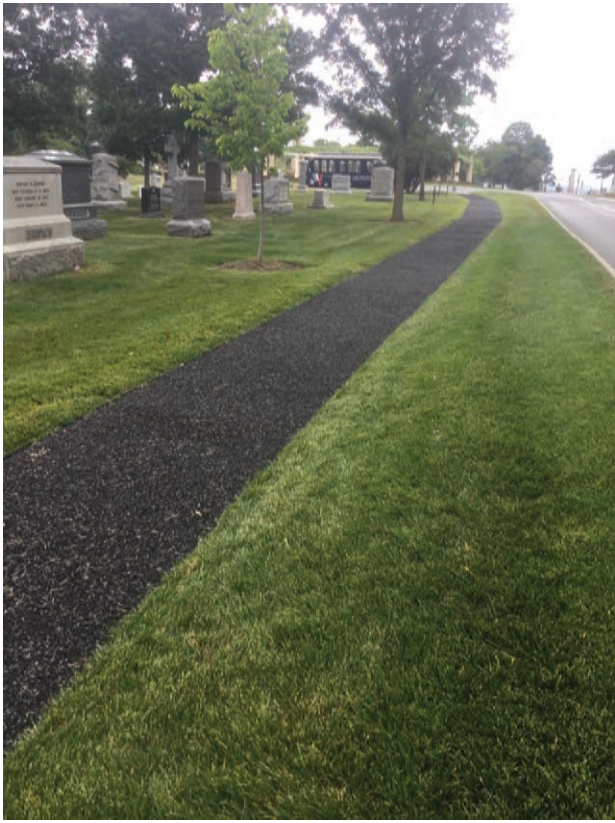
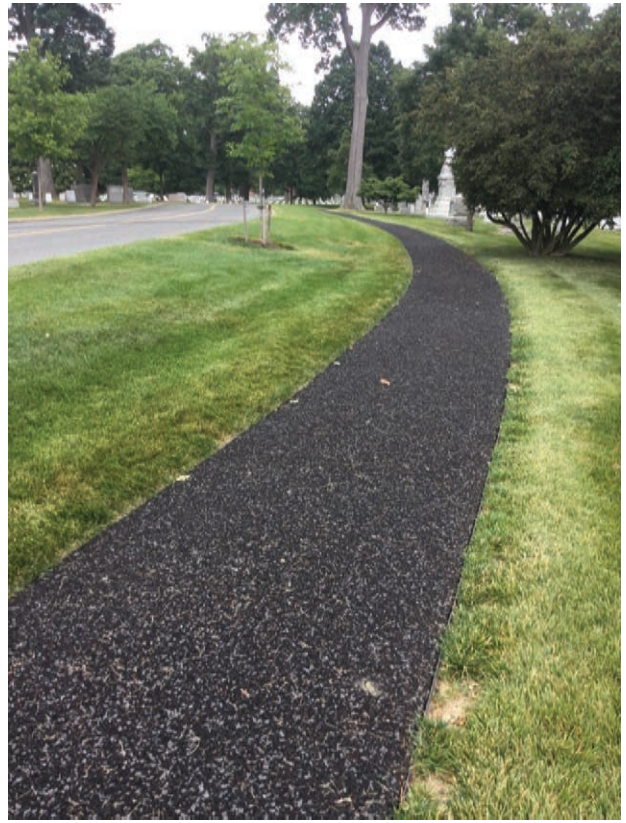
Arlington National Cemetery Post-Construction Inspection Checklist			PERMEABLE/POROUS PAVEMENT	
Inspector Name, Title, Affiliation: Renee Lavinsky, Liz Shepherd (Bluestone)		Date: 6/12/2023	Date of last inspection: 6/28/2022	
Weather/site conditions: Cloudy, 70		Time since last rainfall: 72+		
BMP INFORMATION				
BMP Installation Date: 2014		Underdrain Present: <input type="checkbox"/> Yes <input checked="" type="checkbox"/> No		
BMP #: PP-2	Location: Sidewalk along Megis Drive	As-Built Plans available: <input type="checkbox"/> Yes <input checked="" type="checkbox"/> No		
ROUTINE MAINTENANCE ACTIVITIES				
Activity		Frequency		Completed
Dry-weather vacuum sweeping		Annually		<input checked="" type="checkbox"/> Yes <input type="checkbox"/> No
FIELD INSPECTION CHECKLIST				
Criteria	Maintenance Required?	ANC or Professional fix	Comments	Date Repaired
Surface				
Deterioration (e.g., sinking, spalling, cracking, broken pavers)	<input type="checkbox"/> Yes <input checked="" type="checkbox"/> No

Erosion and/or bare or exposed soil in grid paver areas	<input type="checkbox"/> Yes <input checked="" type="checkbox"/> No			
Presence of loose material, sediment deposits, or ponding	<input type="checkbox"/> Yes <input checked="" type="checkbox"/> No			
Drainage and Adjacent Upstream Areas				
Vegetation encroachment	<input type="checkbox"/> Yes <input checked="" type="checkbox"/> No			
Trash, debris, bare soil, and/or erosion	<input type="checkbox"/> Yes <input checked="" type="checkbox"/> No			
Inlets/Outlets				
Erosion	<input type="checkbox"/> Yes <input checked="" type="checkbox"/> No <input type="checkbox"/> N/A			
Clogged or obstructed	<input type="checkbox"/> Yes <input checked="" type="checkbox"/> No <input type="checkbox"/> N/A			
Observation Wells				
Caps present	<input type="checkbox"/> Yes <input checked="" type="checkbox"/> No <input type="checkbox"/> N/A			
Standing water in well (3 days after storm event >½ inch)	<input type="checkbox"/> Yes <input checked="" type="checkbox"/> No <input type="checkbox"/> N/A

Additional Observations or Comments:				
ANNUAL REPORTING				
Are significant maintenance activities required for the stormwater management facility to perform as designed? (does not activities such as grass mowing or trash collection)				<input type="checkbox"/> Yes <input checked="" type="checkbox"/> No

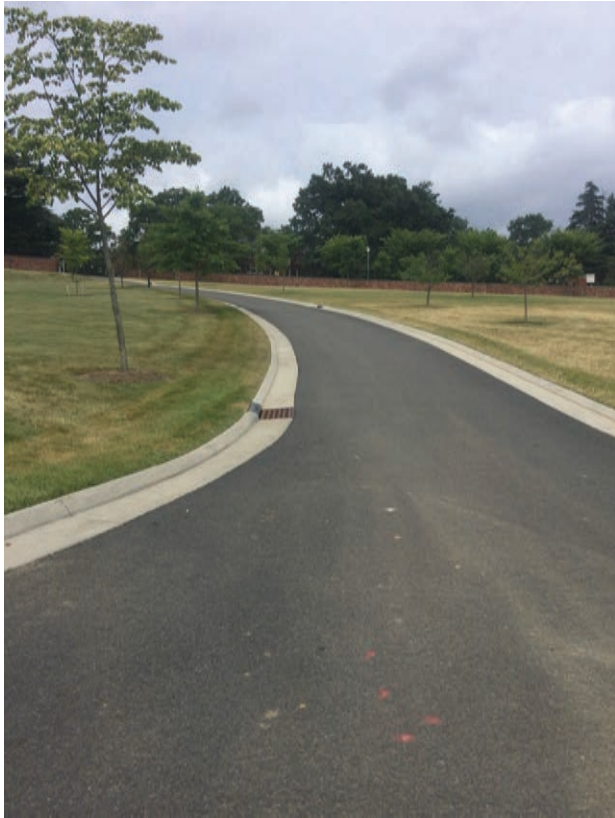
Arlington National Cemetery Post-Construction Inspection Checklist			PERMEABLE/POROUS PAVEMENT	
Inspector Name, Title, Affiliation: Renee Lavinsky, Liz Shepherd (Bluestone)		Date: 6/12/2023	Date of last inspection: 6/28/2022	
Weather/site conditions: Cloudy, 80		Time since last rainfall: 72+		
BMP INFORMATION				
BMP Installation Date: 2018		Underdrain Present: <input type="checkbox"/> Yes <input checked="" type="checkbox"/> No		
BMP #: PP-3	Location: Millenium	As-Built Plans available: <input type="checkbox"/> Yes <input checked="" type="checkbox"/> No		
ROUTINE MAINTENANCE ACTIVITIES				
Activity		Frequency		Completed
Dry-weather vacuum sweeping		Annually		<input checked="" type="checkbox"/> Yes <input type="checkbox"/> No
FIELD INSPECTION CHECKLIST				
Criteria	Maintenance Required?	ANC or Professional fix	Comments	Date Repaired
Surface				
Deterioration (e.g., sinking, spalling, cracking, broken pavers)	<input type="checkbox"/> Yes <input checked="" type="checkbox"/> No

Erosion and/or bare or exposed soil in grid paver areas	<input type="checkbox"/> Yes <input checked="" type="checkbox"/> No			
Presence of loose material, sediment deposits, or ponding	<input type="checkbox"/> Yes <input checked="" type="checkbox"/> No			
Drainage and Adjacent Upstream Areas				
Vegetation encroachment	<input type="checkbox"/> Yes <input checked="" type="checkbox"/> No			
Trash, debris, bare soil, and/or erosion	<input type="checkbox"/> Yes <input checked="" type="checkbox"/> No			
Inlets/Outlets				
Erosion	<input type="checkbox"/> Yes <input checked="" type="checkbox"/> No <input type="checkbox"/> N/A			
Clogged or obstructed	<input type="checkbox"/> Yes <input checked="" type="checkbox"/> No <input type="checkbox"/> N/A			
Observation Wells				
Caps present	<input type="checkbox"/> Yes <input checked="" type="checkbox"/> No <input type="checkbox"/> N/A			
Standing water in well (3 days after storm event >½ inch)	<input type="checkbox"/> Yes <input checked="" type="checkbox"/> No <input type="checkbox"/> N/A

Additional Observations or Comments:				
ANNUAL REPORTING				
Are significant maintenance activities required for the stormwater management facility to perform as designed? (does not activities such as grass mowing or trash collection)				<input type="checkbox"/> Yes <input checked="" type="checkbox"/> No

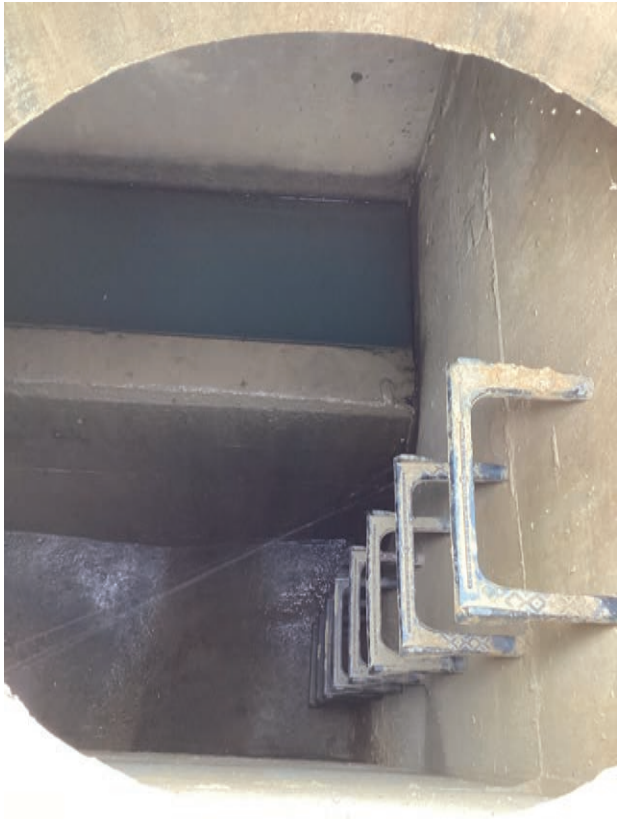
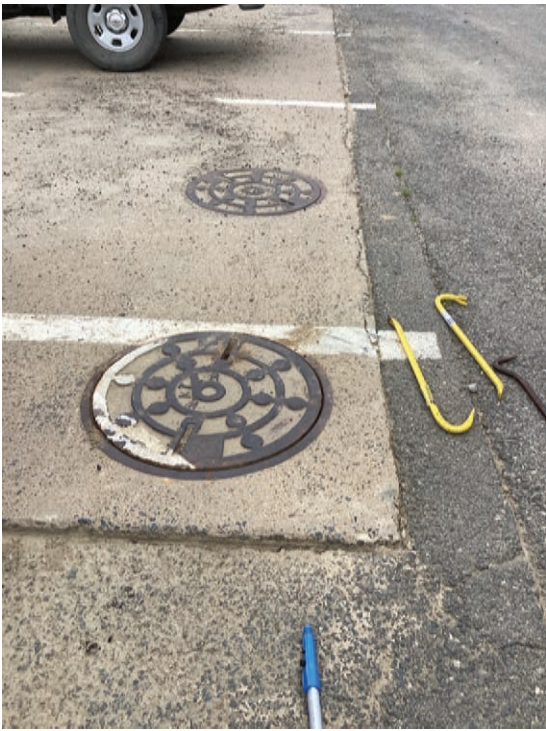
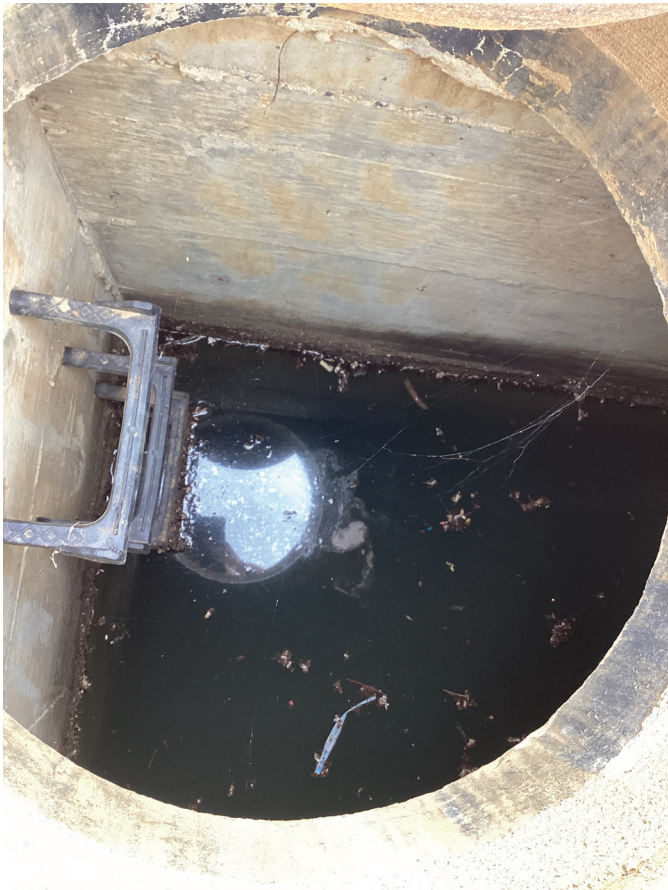
Arlington National Cemetery Post-Construction Inspection Checklist			UNDERGROUND CHAMBER/INFILTRATION CHAMBER	
Inspector Name, Title, Affiliation: Renee Lavinsky, Liz Shepherd (Bluestone)		Date: 6/12/2023	Date of last inspection: 6/28/2022	
Weather/site conditions: Cloudy, humid, 80 degrees		Time since last rainfall: 72+		
BMP INFORMATION				
BMP Installation Date: 1996		Type: <input checked="" type="checkbox"/> Pre-Treatment <input type="checkbox"/> Storage <input type="checkbox"/> Other		
BMP #: PT-UTD	Location: Bldg 123	As-Built Plans available: <input type="checkbox"/> Yes <input checked="" type="checkbox"/> No		
ROUTINE MAINTENANCE ACTIVITIES				
Activity		Frequency		Completed
None		NA		NA
FIELD INSPECTION CHECKLIST				
Criteria	Maintenance Required?	ANC or Professional fix	Comments	Date Repaired
Inlet/Outlet/Access				
Pipe blockages	<input type="checkbox"/> Yes <input checked="" type="checkbox"/> No

Pipe or joint breaks or cracks	<input type="checkbox"/> Yes <input checked="" type="checkbox"/> No			
Access cover missing, cracked, damaged, or unable to open	<input type="checkbox"/> Yes <input checked="" type="checkbox"/> No			
Sediment Level				
Sediment accumulation in forebay	<input type="checkbox"/> Yes <input checked="" type="checkbox"/> No <input type="checkbox"/> N/A			
Sediment depth on vault floor greater than 15% of diameter or interior depth of vault	<input type="checkbox"/> Yes <input checked="" type="checkbox"/> No			
Standing water inside chamber for more than 24 hours after storm	<input type="checkbox"/> Yes <input checked="" type="checkbox"/> No			
Scum line present	<input type="checkbox"/> Yes <input checked="" type="checkbox"/> No			
Chamber cracked (cracks wider than ½ inch), collapsed, or bent out of shape	<input type="checkbox"/> Yes <input checked="" type="checkbox"/> No

Upstream and Drainage Area				
Oil, fuel, or chemical spills	<input type="checkbox"/> Yes <input checked="" type="checkbox"/> No <input type="checkbox"/> N/A			
Sediment on pavement	<input type="checkbox"/> Yes <input checked="" type="checkbox"/> No <input type="checkbox"/> N/A			
Trash, debris, bare soil, and/or erosion	<input type="checkbox"/> Yes <input checked="" type="checkbox"/> No <input type="checkbox"/> N/A			
Additional Observations or Comments:				
ANNUAL REPORTING				
Are significant maintenance activities required for the stormwater management facility to perform as designed? (does not activities such as grass mowing or trash collection)				<input type="checkbox"/> Yes <input checked="" type="checkbox"/> No

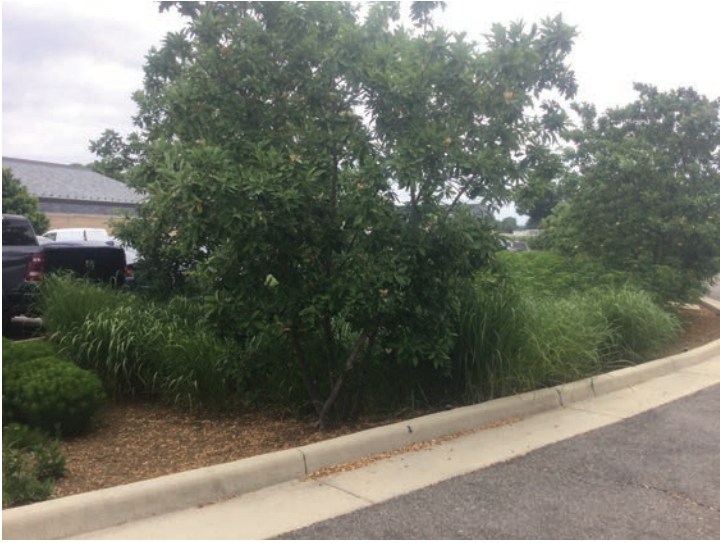
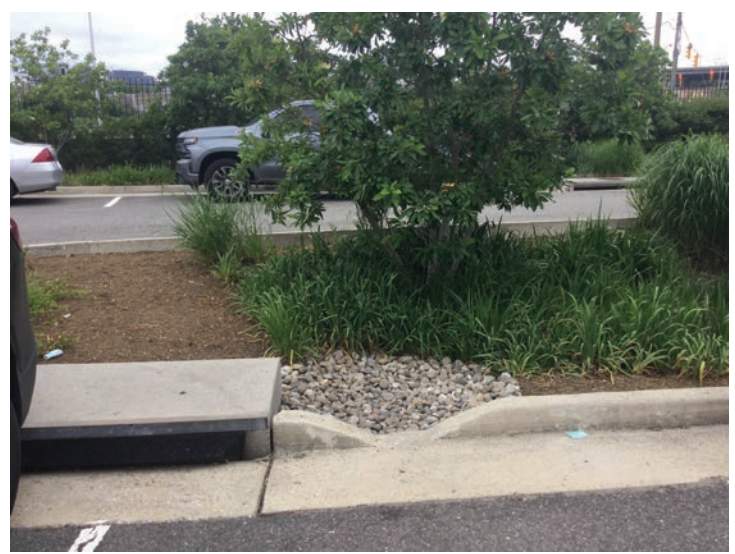
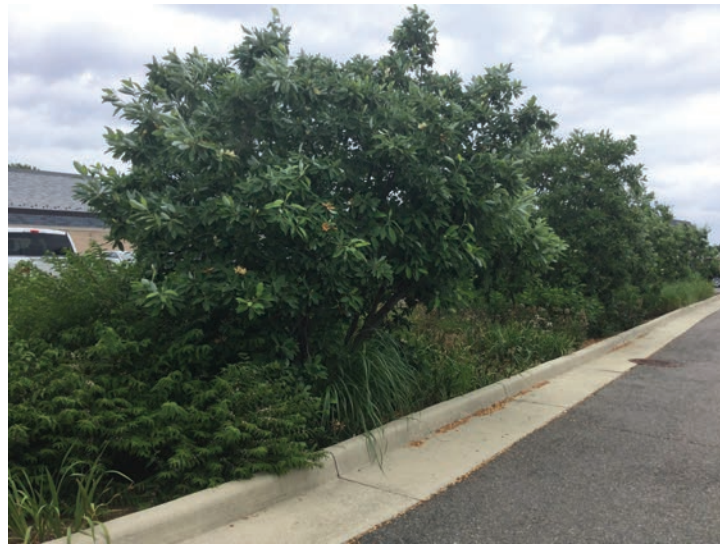
Arlington National Cemetery Post-Construction Inspection Checklist			BIORETENTION/RAIN GARDEN (with or without underdrain)	
Inspector Name, Title, Affiliation: Renee Lavinsky, Liz Shepherd (Bluestone)		Date: 6/12/2023	Date of last inspection: 6/28/2022	
Weather/site conditions: Cloudy, 75		Time since last rainfall: 72+		
BMP INFORMATION				
BMP Installation Date: 2012		Underdrain Present: <input checked="" type="checkbox"/> Yes <input type="checkbox"/> No		
BMP #: RG-1	Location: Bldg 123	As-Built Plans available: <input type="checkbox"/> Yes <input checked="" type="checkbox"/> No		
ROUTINE MAINTENANCE ACTIVITIES				
Activity		Frequency		Completed
Mowing grass filter strips and bioretention turf cover		At least 4 times a year		<input checked="" type="checkbox"/> Yes <input type="checkbox"/> No
Spot weeding, erosion repair, trash removal, and mulch raking		Twice during growing season		<input checked="" type="checkbox"/> Yes <input type="checkbox"/> No

<ul style="list-style-type: none"> Spring visual inspection and cleanup Supplement mulch to maintain a 3" layer Prune trees and shrubs 		Annually		<input checked="" type="checkbox"/> Yes <input type="checkbox"/> No
Remove sediment in pre-treatment cells and inflow points		Once every 2 to 3 years		<input checked="" type="checkbox"/> Yes <input type="checkbox"/> No <input type="checkbox"/> Not due
Replace the mulch layer		Every 3 years		<input checked="" type="checkbox"/> Yes <input type="checkbox"/> No <input type="checkbox"/> Not due
FIELD INSPECTION CHECKLIST				
Criteria	Maintenance Required?	ANC or Professional fix	Comments	Date Repaired
Surface				
Vegetation <ul style="list-style-type: none"> Vegetation species inconsistent with design specs Less than 75-90% cover (mulch plus vegetation) High grass Dying or dead vegetation Vegetation killed by salt or winter elements 	<input type="checkbox"/> Yes <input checked="" type="checkbox"/> No

Filter Media/Mulch Layer <ul style="list-style-type: none"> Too low, too compacted, and/or clogged Older than 3 years and/or in poor condition Ponding Chemicals, fertilizers, oil, grease, trash, debris, sediment, sand Erosion, exposed soil Topsoil in poor condition 	<input type="checkbox"/> Yes <input checked="" type="checkbox"/> No

FIELD INSPECTION CHECKLIST				
Criteria	Maintenance Required?	ANC or Professional fix	Comments	Date Repaired
Pre-treatment <ul style="list-style-type: none"> • Trash, sediment, debris, oil, grease • Clogging, standing water • Odor, algae, floating vegetation • Dead vegetation or exposed soil 	<input type="checkbox"/> Yes <input checked="" type="checkbox"/> No			
Outlet				
Erosion or sediment build-up	<input type="checkbox"/> Yes <input checked="" type="checkbox"/> No			
Grate or spillway condition	<input type="checkbox"/> Yes <input checked="" type="checkbox"/> No			
Proper Drainage, Underdrains and Observation Wells				
Does not dewater between storms or ponding for more than 48 hours after rain event	<input type="checkbox"/> Yes <input checked="" type="checkbox"/> No			
Clogged underdrains	<input type="checkbox"/> Yes <input checked="" type="checkbox"/> No			
Observation well caps present	<input type="checkbox"/> Yes <input type="checkbox"/> No <input checked="" type="checkbox"/> N/A

Inlets				
Sediment build-up, trash, debris, or erosion at curb cuts, pavement edges, and/or bypassing	<input type="checkbox"/> Yes <input checked="" type="checkbox"/> No			
Inflow hindered by vegetation	<input type="checkbox"/> Yes <input checked="" type="checkbox"/> No			
Drainage and Adjacent Upstream Areas				
Adequate vegetation	<input type="checkbox"/> Yes <input checked="" type="checkbox"/> No			
Trash, debris, bare soil, signs of scour, oil, grease, and/or erosion	<input type="checkbox"/> Yes <input checked="" type="checkbox"/> No			
Additional Observations or Comments:				
ANNUAL REPORTING				
Are significant maintenance activities required for the stormwater management facility to perform as designed? (does not activities such as grass mowing or trash collection)				<input type="checkbox"/> Yes <input checked="" type="checkbox"/> No

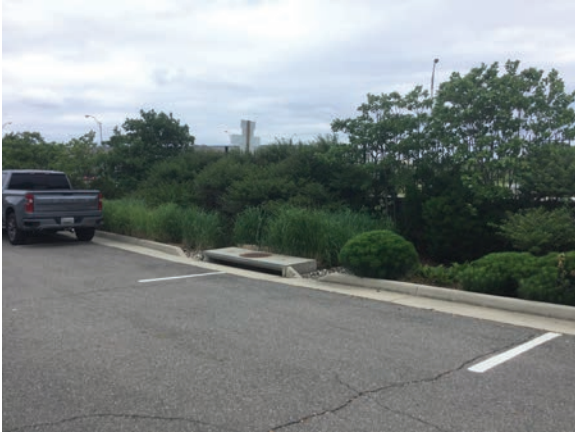
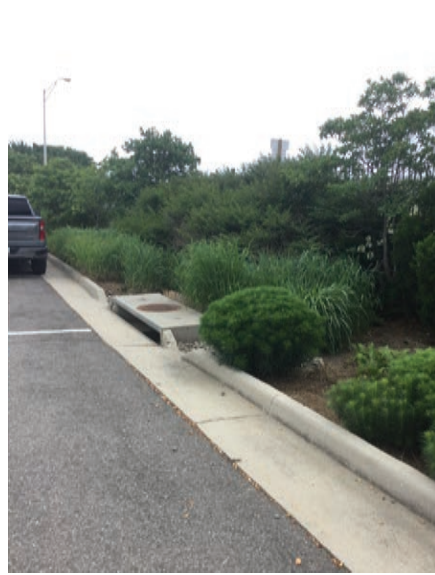
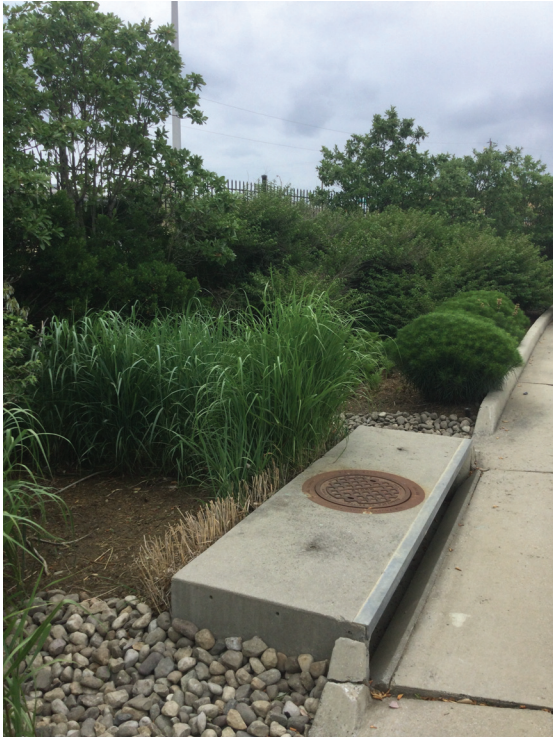
Arlington National Cemetery Post-Construction Inspection Checklist			BIORETENTION/RAIN GARDEN (with or without underdrain)	
Inspector Name, Title, Affiliation: Renee Lavinsky, Liz Shepherd (Bluestone)		Date: 6/12/2023	Date of last inspection: 6/28/2022	
Weather/site conditions: Cloudy, 75		Time since last rainfall: 72+		
BMP INFORMATION				
BMP Installation Date: 2012		Underdrain Present: <input checked="" type="checkbox"/> Yes <input type="checkbox"/> No		
BMP #: RG-2	Location: Bldg 123	As-Built Plans available: <input type="checkbox"/> Yes <input checked="" type="checkbox"/> No		
ROUTINE MAINTENANCE ACTIVITIES				
Activity		Frequency	Completed	
Mowing grass filter strips and bioretention turf cover		At least 4 times a year	<input checked="" type="checkbox"/> Yes <input type="checkbox"/> No	
Spot weeding, erosion repair, trash removal, and mulch raking		Twice during growing season	<input checked="" type="checkbox"/> Yes <input type="checkbox"/> No

<ul style="list-style-type: none"> Spring visual inspection and cleanup Supplement mulch to maintain a 3" layer Prune trees and shrubs 		Annually	<input checked="" type="checkbox"/> Yes <input type="checkbox"/> No	
Remove sediment in pre-treatment cells and inflow points		Once every 2 to 3 years	<input checked="" type="checkbox"/> Yes <input type="checkbox"/> No <input type="checkbox"/> Not due	
Replace the mulch layer		Every 3 years	<input checked="" type="checkbox"/> Yes <input type="checkbox"/> No <input type="checkbox"/> Not due	
FIELD INSPECTION CHECKLIST				
Criteria	Maintenance Required?	ANC or Professional fix	Comments	Date Repaired
Surface				
Vegetation <ul style="list-style-type: none"> Vegetation species inconsistent with design specs Less than 75-90% cover (mulch plus vegetation) High grass Dying or dead vegetation Vegetation killed by salt or winter elements 	<input type="checkbox"/> Yes <input checked="" type="checkbox"/> No

Filter Media/Mulch Layer <ul style="list-style-type: none"> Too low, too compacted, and/or clogged Older than 3 years and/or in poor condition Ponding Chemicals, fertilizers, oil, grease, trash, debris, sediment, sand Erosion, exposed soil Topsoil in poor condition 	<input type="checkbox"/> Yes <input checked="" type="checkbox"/> No

FIELD INSPECTION CHECKLIST				
Criteria	Maintenance Required?	ANC or Professional fix	Comments	Date Repaired
Pre-treatment <ul style="list-style-type: none"> • Trash, sediment, debris, oil, grease • Clogging, standing water • Odor, algae, floating vegetation • Dead vegetation or exposed soil 	<input type="checkbox"/> Yes <input checked="" type="checkbox"/> No			
Outlet				
Erosion or sediment build-up	<input type="checkbox"/> Yes <input checked="" type="checkbox"/> No			
Grate or spillway condition	<input type="checkbox"/> Yes <input checked="" type="checkbox"/> No			
Proper Drainage, Underdrains and Observation Wells				
Does not dewater between storms or ponding for more than 48 hours after rain event	<input type="checkbox"/> Yes <input checked="" type="checkbox"/> No			
Clogged underdrains	<input type="checkbox"/> Yes <input checked="" type="checkbox"/> No			
Observation well caps present	<input type="checkbox"/> Yes <input checked="" type="checkbox"/> No <input type="checkbox"/> N/A

Inlets				
Sediment build-up, trash, debris, or erosion at curb cuts, pavement edges, and/or bypassing	<input type="checkbox"/> Yes <input checked="" type="checkbox"/> No			
Inflow hindered by vegetation	<input type="checkbox"/> Yes <input checked="" type="checkbox"/> No			
Drainage and Adjacent Upstream Areas				
Adequate vegetation	<input type="checkbox"/> Yes <input checked="" type="checkbox"/> No			
Trash, debris, bare soil, signs of scour, oil, grease, and/or erosion	<input type="checkbox"/> Yes <input checked="" type="checkbox"/> No			
Additional Observations or Comments: 				
ANNUAL REPORTING				
Are significant maintenance activities required for the stormwater management facility to perform as designed? (does not activities such as grass mowing or trash collection)				<input type="checkbox"/> Yes <input checked="" type="checkbox"/> No

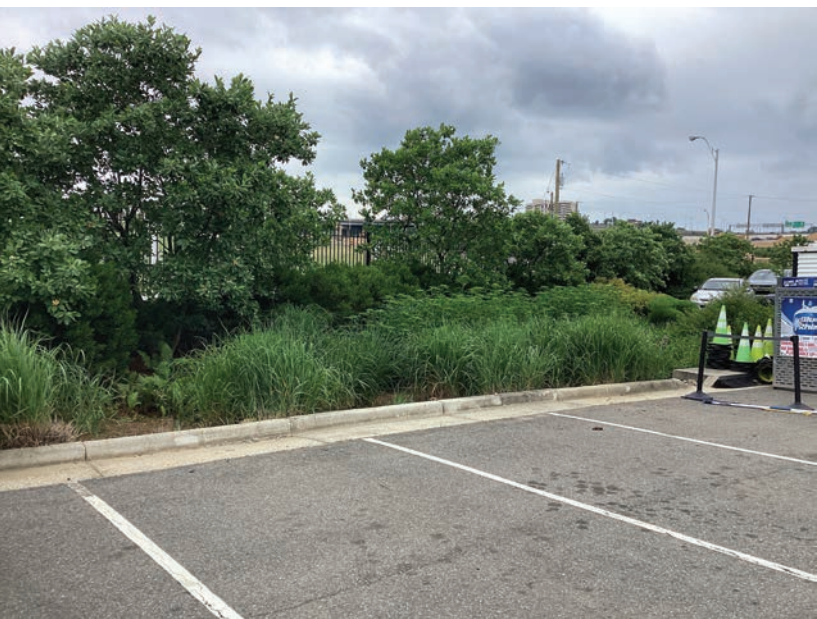
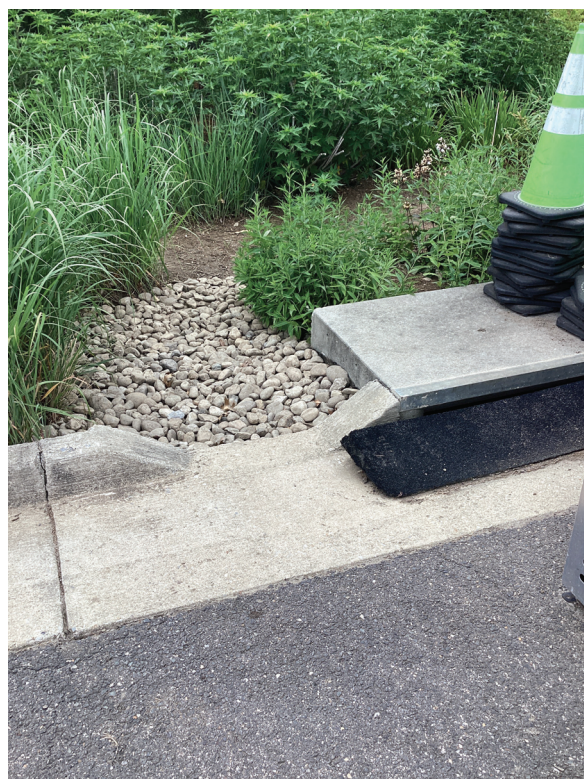
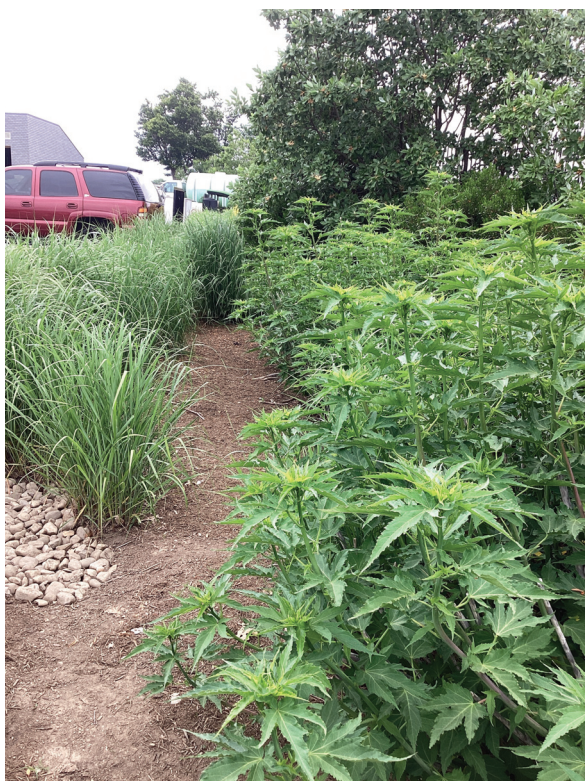
Arlington National Cemetery Post-Construction Inspection Checklist			BIORETENTION/RAIN GARDEN (with or without underdrain)	
Inspector Name, Title, Affiliation: Renee Lavinsky, Liz Shepherd (Bluestone)		Date: 6/12/2023	Date of last inspection: 6/28/2022	
Weather/site conditions: Cloudy, humid, 80 degrees		Time since last rainfall: 72+		
BMP INFORMATION				
BMP Installation Date: 2012		Underdrain Present: <input checked="" type="checkbox"/> Yes <input type="checkbox"/> No		
BMP #: RG-3	Location: Bldg 123	As-Built Plans available: <input type="checkbox"/> Yes <input checked="" type="checkbox"/> No		
ROUTINE MAINTENANCE ACTIVITIES				
Activity		Frequency		Completed
Mowing grass filter strips and bioretention turf cover		At least 4 times a year		<input checked="" type="checkbox"/> Yes <input type="checkbox"/> No
Spot weeding, erosion repair, trash removal, and mulch raking		Twice during growing season		<input checked="" type="checkbox"/> Yes <input type="checkbox"/> No

<ul style="list-style-type: none"> Spring visual inspection and cleanup Supplement mulch to maintain a 3" layer Prune trees and shrubs 		Annually		<input checked="" type="checkbox"/> Yes <input type="checkbox"/> No
Remove sediment in pre-treatment cells and inflow points		Once every 2 to 3 years		<input checked="" type="checkbox"/> Yes <input type="checkbox"/> No <input type="checkbox"/> Not due
Replace the mulch layer		Every 3 years		<input checked="" type="checkbox"/> Yes <input type="checkbox"/> No <input type="checkbox"/> Not due
FIELD INSPECTION CHECKLIST				
Criteria	Maintenance Required?	ANC or Professional fix	Comments	Date Repaired
Surface				
Vegetation <ul style="list-style-type: none"> Vegetation species inconsistent with design specs Less than 75-90% cover (mulch plus vegetation) High grass Dying or dead vegetation Vegetation killed by salt or winter elements 	<input type="checkbox"/> Yes <input checked="" type="checkbox"/> No

Filter Media/Mulch Layer <ul style="list-style-type: none"> Too low, too compacted, and/or clogged Older than 3 years and/or in poor condition Ponding Chemicals, fertilizers, oil, grease, trash, debris, sediment, sand Erosion, exposed soil Topsoil in poor condition 	<input type="checkbox"/> Yes <input checked="" type="checkbox"/> No

FIELD INSPECTION CHECKLIST				
Criteria	Maintenance Required?	ANC or Professional fix	Comments	Date Repaired
Pre-treatment <ul style="list-style-type: none"> • Trash, sediment, debris, oil, grease • Clogging, standing water • Odor, algae, floating vegetation • Dead vegetation or exposed soil 	<input type="checkbox"/> Yes <input checked="" type="checkbox"/> No			
Outlet				
Erosion or sediment build-up	<input type="checkbox"/> Yes <input checked="" type="checkbox"/> No			
Grate or spillway condition	<input type="checkbox"/> Yes <input checked="" type="checkbox"/> No			
Proper Drainage, Underdrains and Observation Wells				
Does not dewater between storms or ponding for more than 48 hours after rain event	<input type="checkbox"/> Yes <input checked="" type="checkbox"/> No			
Clogged underdrains	<input type="checkbox"/> Yes <input checked="" type="checkbox"/> No			
Observation well caps present	<input type="checkbox"/> Yes <input type="checkbox"/> No <input checked="" type="checkbox"/> N/A

Inlets				
Sediment build-up, trash, debris, or erosion at curb cuts, pavement edges, and/or bypassing	<input checked="" type="checkbox"/> Yes <input type="checkbox"/> No			
Inflow hindered by vegetation	<input type="checkbox"/> Yes <input checked="" type="checkbox"/> No			
Drainage and Adjacent Upstream Areas				
Adequate vegetation	<input type="checkbox"/> Yes <input checked="" type="checkbox"/> No			
Trash, debris, bare soil, signs of scour, oil, grease, and/or erosion	<input type="checkbox"/> Yes <input checked="" type="checkbox"/> No			
Additional Observations or Comments:				
ANNUAL REPORTING				
Are significant maintenance activities required for the stormwater management facility to perform as designed? (does not activities such as grass mowing or trash collection)				<input type="checkbox"/> Yes <input checked="" type="checkbox"/> No

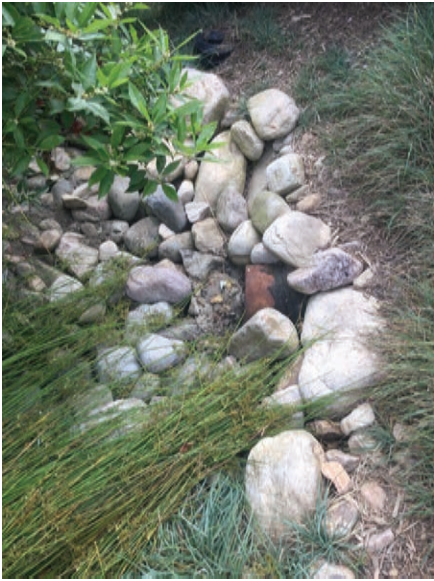
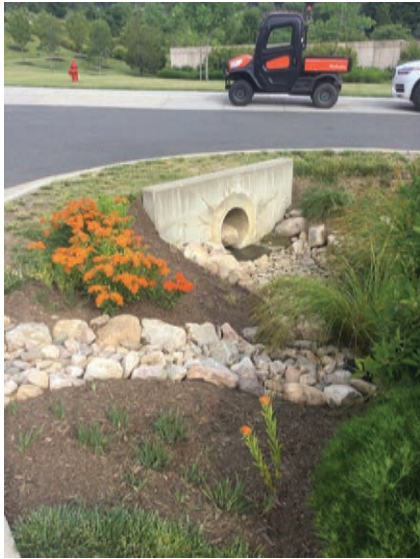
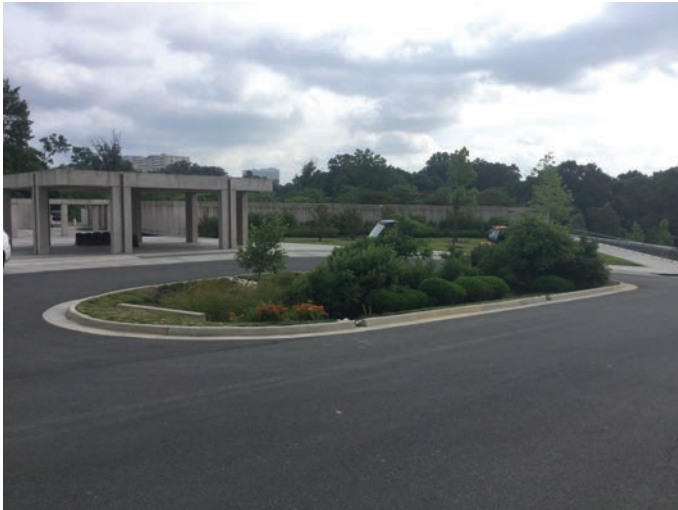
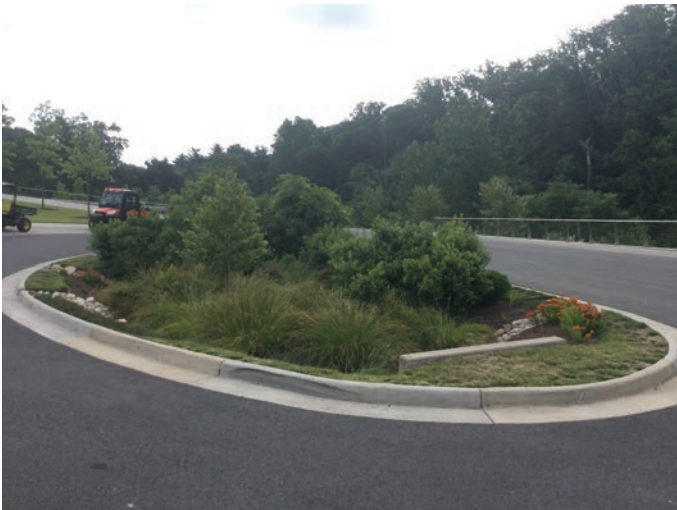
Arlington National Cemetery Post-Construction Inspection Checklist			BIORETENTION/RAIN GARDEN (with or without underdrain)	
Inspector Name, Title, Affiliation: Renee Lavinsky, Liz Shepherd (Bluestone)		Date: 6/12/2023	Date of last inspection: 6/28/2022	
Weather/site conditions: Cloudy, 70		Time since last rainfall: 72+		
BMP INFORMATION				
BMP Installation Date: 2018		Underdrain Present: <input checked="" type="checkbox"/> Yes <input type="checkbox"/> No		
BMP #: RG-4	Location: Lewis Shelter	As-Built Plans available: <input type="checkbox"/> Yes <input checked="" type="checkbox"/> No		
ROUTINE MAINTENANCE ACTIVITIES				
Activity		Frequency		Completed
Mowing grass filter strips and bioretention turf cover		At least 4 times a year		<input checked="" type="checkbox"/> Yes <input type="checkbox"/> No
Spot weeding, erosion repair, trash removal, and mulch raking		Twice during growing season		<input checked="" type="checkbox"/> Yes <input type="checkbox"/> No

<ul style="list-style-type: none"> Spring visual inspection and cleanup Supplement mulch to maintain a 3" layer Prune trees and shrubs 		Annually		<input checked="" type="checkbox"/> Yes <input type="checkbox"/> No
Remove sediment in pre-treatment cells and inflow points		Once every 2 to 3 years		<input type="checkbox"/> Yes <input type="checkbox"/> No <input checked="" type="checkbox"/> Not due
Replace the mulch layer		Every 3 years		<input type="checkbox"/> Yes <input type="checkbox"/> No <input checked="" type="checkbox"/> Not due
FIELD INSPECTION CHECKLIST				
Criteria	Maintenance Required?	ANC or Professional fix	Comments	Date Repaired
Surface				
Vegetation <ul style="list-style-type: none"> Vegetation species inconsistent with design specs Less than 75-90% cover (mulch plus vegetation) High grass Dying or dead vegetation Vegetation killed by salt or winter elements 	<input type="checkbox"/> Yes <input checked="" type="checkbox"/> No

Filter Media/Mulch Layer <ul style="list-style-type: none"> Too low, too compacted, and/or clogged Older than 3 years and/or in poor condition Ponding Chemicals, fertilizers, oil, grease, trash, debris, sediment, sand Erosion, exposed soil Topsoil in poor condition 	<input type="checkbox"/> Yes <input checked="" type="checkbox"/> No

FIELD INSPECTION CHECKLIST				
Criteria	Maintenance Required?	ANC or Professional fix	Comments	Date Repaired
Pre-treatment <ul style="list-style-type: none"> • Trash, sediment, debris, oil, grease • Clogging, standing water • Odor, algae, floating vegetation • Dead vegetation or exposed soil 	<input type="checkbox"/> Yes <input checked="" type="checkbox"/> No			
Outlet				
Erosion or sediment build-up	<input type="checkbox"/> Yes <input checked="" type="checkbox"/> No			
Grate or spillway condition	<input type="checkbox"/> Yes <input checked="" type="checkbox"/> No			
Proper Drainage, Underdrains and Observation Wells				
Does not dewater between storms or ponding for more than 48 hours after rain event	<input type="checkbox"/> Yes <input checked="" type="checkbox"/> No			
Clogged underdrains	<input type="checkbox"/> Yes <input checked="" type="checkbox"/> No			
Observation well caps present	<input type="checkbox"/> Yes <input checked="" type="checkbox"/> No <input type="checkbox"/> N/A

Inlets				
Sediment build-up, trash, debris, or erosion at curb cuts, pavement edges, and/or bypassing	<input type="checkbox"/> Yes <input checked="" type="checkbox"/> No			
Inflow hindered by vegetation	<input type="checkbox"/> Yes <input checked="" type="checkbox"/> No			
Drainage and Adjacent Upstream Areas				
Adequate vegetation	<input type="checkbox"/> Yes <input checked="" type="checkbox"/> No			
Trash, debris, bare soil, signs of scour, oil, grease, and/or erosion	<input type="checkbox"/> Yes <input checked="" type="checkbox"/> No			
Additional Observations or Comments: 				
ANNUAL REPORTING				
Are significant maintenance activities required for the stormwater management facility to perform as designed? (does not activities such as grass mowing or trash collection)				<input type="checkbox"/> Yes <input checked="" type="checkbox"/> No

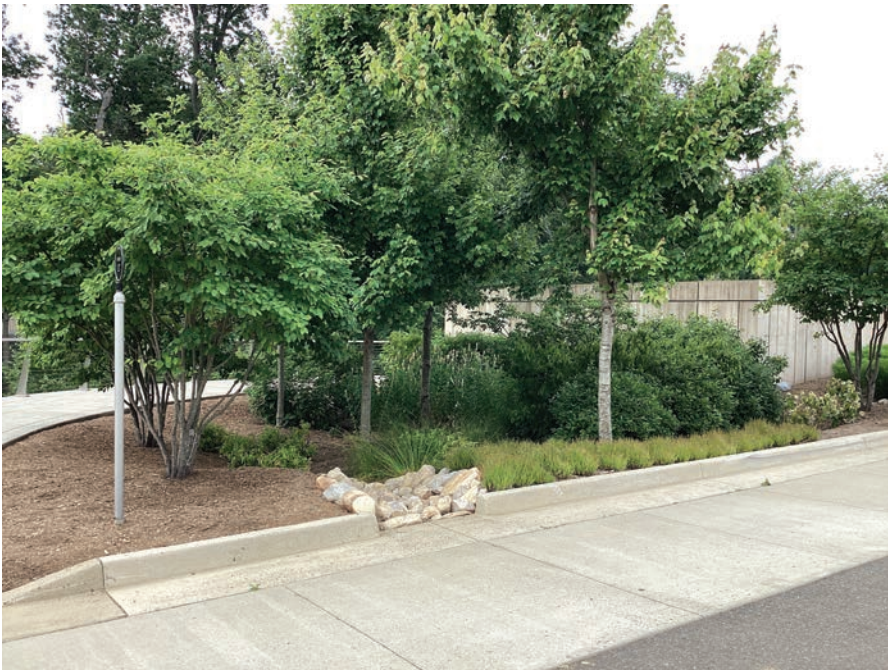
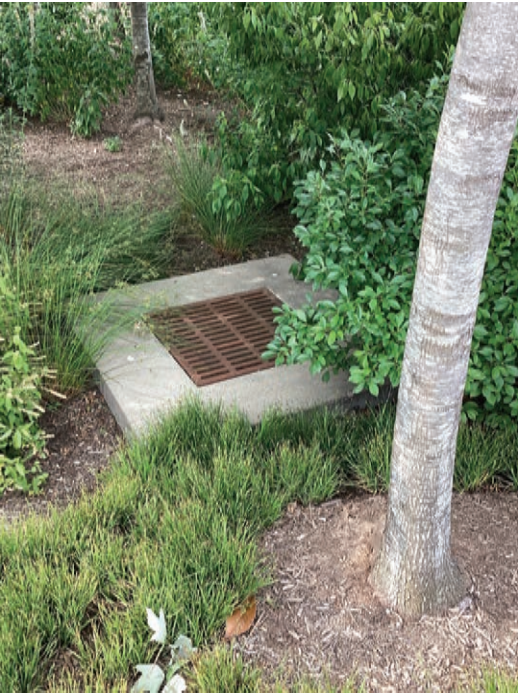
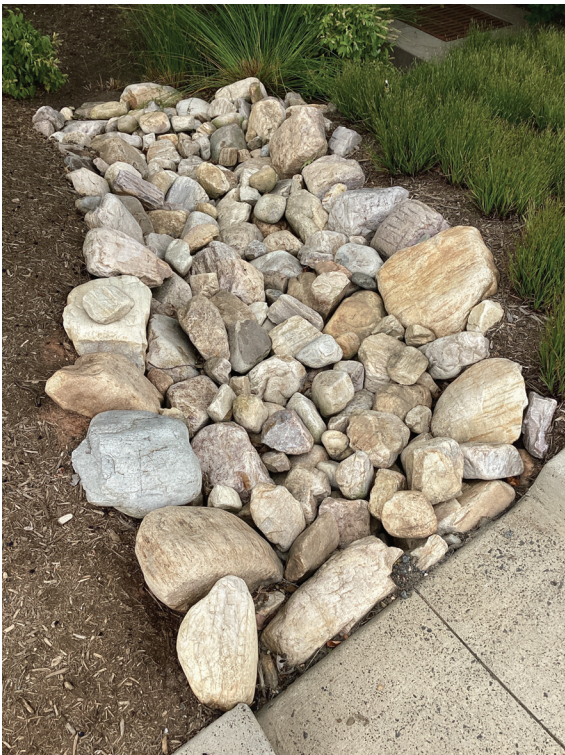
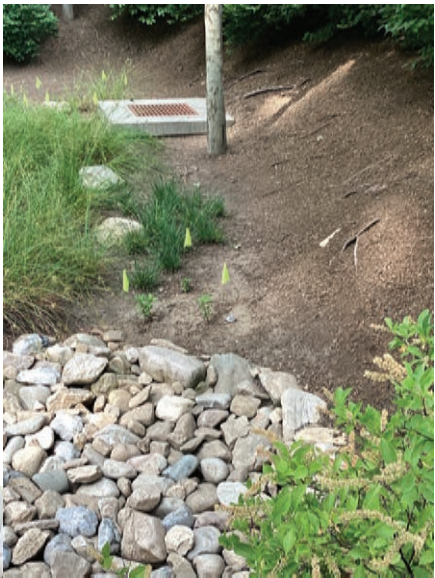
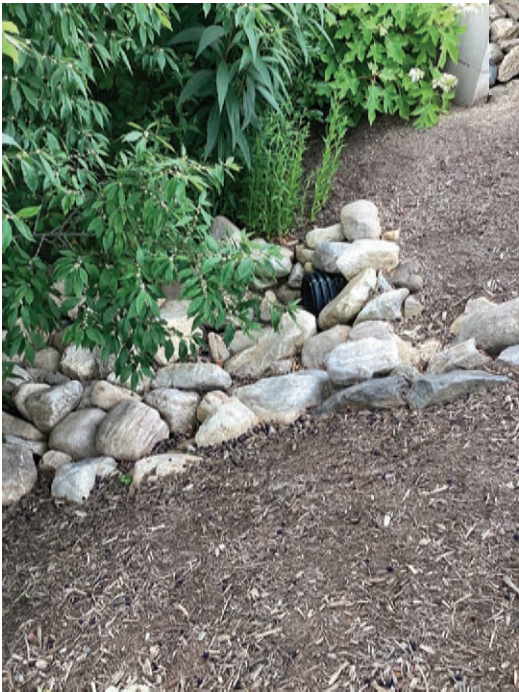
Arlington National Cemetery Post-Construction Inspection Checklist			BIORETENTION/RAIN GARDEN (with or without underdrain)	
Inspector Name, Title, Affiliation: Renee Lavinsky, Liz Shepherd (Bluestone)		Date: 6/12/2023	Date of last inspection: 6/28/22	
Weather/site conditions: Cloudy, 80 degrees		Time since last rainfall: 72+		
BMP INFORMATION				
BMP Installation Date: 2018		Underdrain Present: <input checked="" type="checkbox"/> Yes <input type="checkbox"/> No		
BMP #: RG-5	Location: Columbarium 12	As-Built Plans available: <input type="checkbox"/> Yes <input checked="" type="checkbox"/> No		
ROUTINE MAINTENANCE ACTIVITIES				
Activity		Frequency	Completed	
Mowing grass filter strips and bioretention turf cover		At least 4 times a year	<input checked="" type="checkbox"/> Yes <input type="checkbox"/> No	
Spot weeding, erosion repair, trash removal, and mulch raking		Twice during growing season	<input checked="" type="checkbox"/> Yes <input type="checkbox"/> No

<ul style="list-style-type: none"> Spring visual inspection and cleanup Supplement mulch to maintain a 3" layer Prune trees and shrubs 		Annually	<input checked="" type="checkbox"/> Yes <input type="checkbox"/> No	
Remove sediment in pre-treatment cells and inflow points		Once every 2 to 3 years	<input checked="" type="checkbox"/> Yes <input type="checkbox"/> No <input type="checkbox"/> Not due	
Replace the mulch layer		Every 3 years	<input type="checkbox"/> Yes <input type="checkbox"/> No <input checked="" type="checkbox"/> Not due	
FIELD INSPECTION CHECKLIST				
Criteria	Maintenance Required?	ANC or Professional fix	Comments	Date Repaired
Surface				
Vegetation <ul style="list-style-type: none"> Vegetation species inconsistent with design specs Less than 75-90% cover (mulch plus vegetation) High grass Dying or dead vegetation Vegetation killed by salt or winter elements 	<input type="checkbox"/> Yes <input checked="" type="checkbox"/> No

Filter Media/Mulch Layer <ul style="list-style-type: none"> Too low, too compacted, and/or clogged Older than 3 years and/or in poor condition Ponding Chemicals, fertilizers, oil, grease, trash, debris, sediment, sand Erosion, exposed soil Topsoil in poor condition 	<input type="checkbox"/> Yes <input checked="" type="checkbox"/> No

FIELD INSPECTION CHECKLIST				
Criteria	Maintenance Required?	ANC or Professional fix	Comments	Date Repaired
Pre-treatment <ul style="list-style-type: none"> • Trash, sediment, debris, oil, grease • Clogging, standing water • Odor, algae, floating vegetation • Dead vegetation or exposed soil 	<input type="checkbox"/> Yes <input checked="" type="checkbox"/> No			
Outlet				
Erosion or sediment build-up	<input type="checkbox"/> Yes <input checked="" type="checkbox"/> No			
Grate or spillway condition	<input type="checkbox"/> Yes <input checked="" type="checkbox"/> No			
Proper Drainage, Underdrains and Observation Wells				
Does not dewater between storms or ponding for more than 48 hours after rain event	<input type="checkbox"/> Yes <input checked="" type="checkbox"/> No			
Clogged underdrains	<input type="checkbox"/> Yes <input checked="" type="checkbox"/> No			
Observation well caps present	<input type="checkbox"/> Yes <input checked="" type="checkbox"/> No <input type="checkbox"/> N/A		Built on an angle, present

Inlets				
Sediment build-up, trash, debris, or erosion at curb cuts, pavement edges, and/or bypassing	<input type="checkbox"/> Yes <input checked="" type="checkbox"/> No			
Inflow hindered by vegetation	<input type="checkbox"/> Yes <input checked="" type="checkbox"/> No			
Drainage and Adjacent Upstream Areas				
Adequate vegetation	<input type="checkbox"/> Yes <input checked="" type="checkbox"/> No			
Trash, debris, bare soil, signs of scour, oil, grease, and/or erosion	<input type="checkbox"/> Yes <input checked="" type="checkbox"/> No			
Additional Observations or Comments: 				
ANNUAL REPORTING				
Are significant maintenance activities required for the stormwater management facility to perform as designed? (does not activities such as grass mowing or trash collection)				<input type="checkbox"/> Yes <input checked="" type="checkbox"/> No

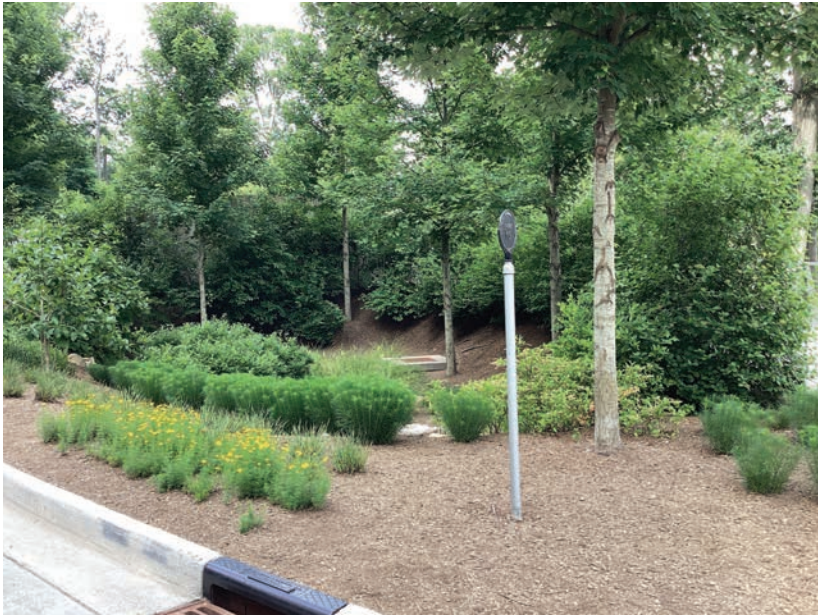
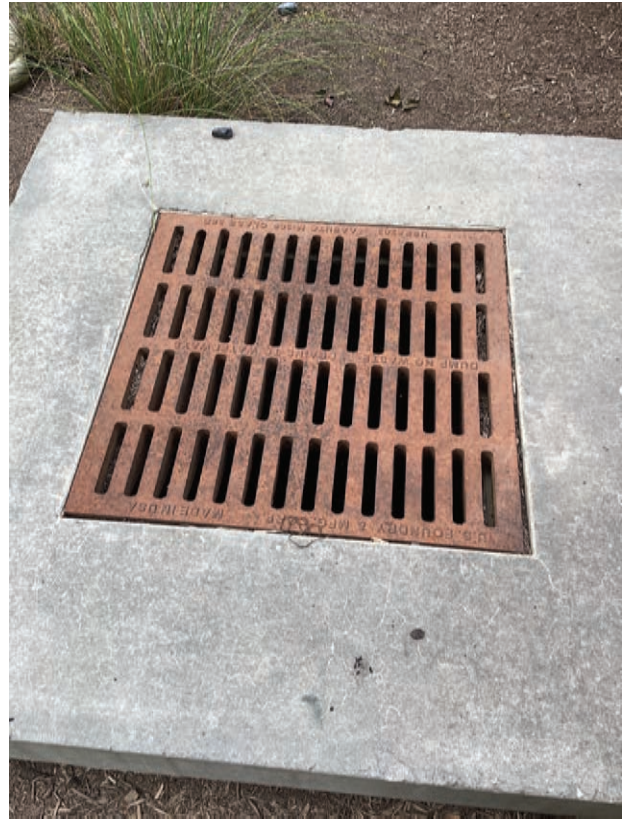
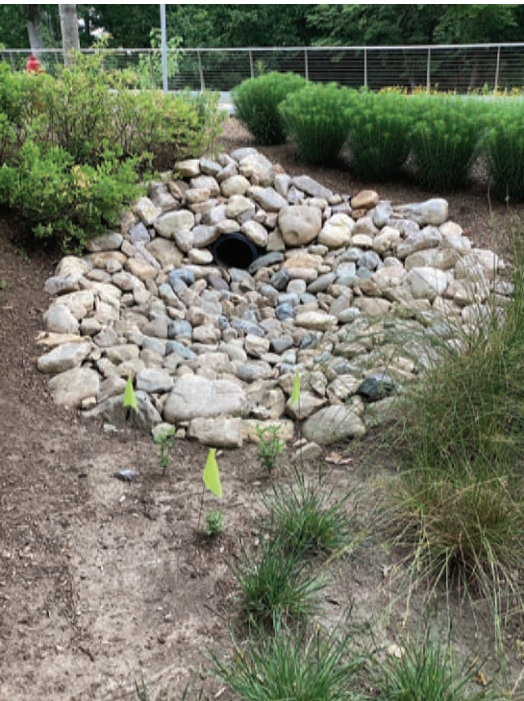
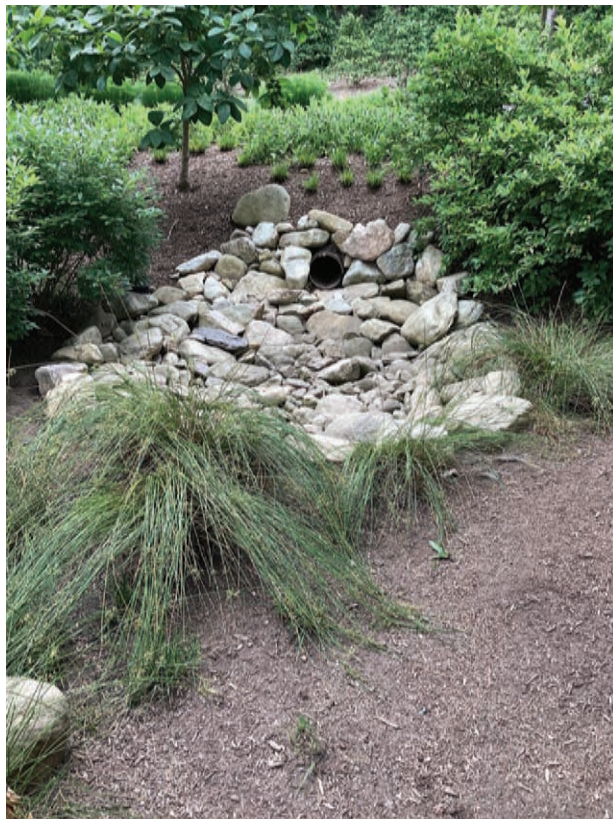
Arlington National Cemetery Post-Construction Inspection Checklist			BIORETENTION/RAIN GARDEN (with or without underdrain)	
Inspector Name, Title, Affiliation: Renee Lavinsky, Liz Shepherd (Bluestone)		Date: 6/12/2023	Date of last inspection: 6/28/2022	
Weather/site conditions: Cloudy, 80 degrees		Time since last rainfall: 72+		
BMP INFORMATION				
BMP Installation Date: 2018		Underdrain Present: <input checked="" type="checkbox"/> Yes <input type="checkbox"/> No		
BMP #: RG-6	Location: Columbarium 13	As-Built Plans available: <input type="checkbox"/> Yes <input checked="" type="checkbox"/> No		
ROUTINE MAINTENANCE ACTIVITIES				
Activity		Frequency	Completed	
Mowing grass filter strips and bioretention turf cover		At least 4 times a year	<input checked="" type="checkbox"/> Yes <input type="checkbox"/> No	
Spot weeding, erosion repair, trash removal, and mulch raking		Twice during growing season	<input checked="" type="checkbox"/> Yes <input type="checkbox"/> No

<ul style="list-style-type: none"> Spring visual inspection and cleanup Supplement mulch to maintain a 3" layer Prune trees and shrubs 		Annually	<input type="checkbox"/> Yes <input checked="" type="checkbox"/> No	
Remove sediment in pre-treatment cells and inflow points		Once every 2 to 3 years	<input type="checkbox"/> Yes <input type="checkbox"/> No <input checked="" type="checkbox"/> Not due	
Replace the mulch layer		Every 3 years	<input type="checkbox"/> Yes <input type="checkbox"/> No <input checked="" type="checkbox"/> Not due	
FIELD INSPECTION CHECKLIST				
Criteria	Maintenance Required?	ANC or Professional fix	Comments	Date Repaired
Surface				
Vegetation <ul style="list-style-type: none"> Vegetation species inconsistent with design specs Less than 75-90% cover (mulch plus vegetation) High grass Dying or dead vegetation Vegetation killed by salt or winter elements 	<input type="checkbox"/> Yes <input checked="" type="checkbox"/> No		Flags used to show where new plants are growing

Filter Media/Mulch Layer <ul style="list-style-type: none"> Too low, too compacted, and/or clogged Older than 3 years and/or in poor condition Ponding Chemicals, fertilizers, oil, grease, trash, debris, sediment, sand Erosion, exposed soil Topsoil in poor condition 	<input checked="" type="checkbox"/> Yes <input type="checkbox"/> No	ANC	Low in some areas

FIELD INSPECTION CHECKLIST				
Criteria	Maintenance Required?	ANC or Professional fix	Comments	Date Repaired
Pre-treatment <ul style="list-style-type: none"> • Trash, sediment, debris, oil, grease • Clogging, standing water • Odor, algae, floating vegetation • Dead vegetation or exposed soil 	<input type="checkbox"/> Yes <input checked="" type="checkbox"/> No			
Outlet				
Erosion or sediment build-up	<input type="checkbox"/> Yes <input checked="" type="checkbox"/> No			
Grate or spillway condition	<input type="checkbox"/> Yes <input checked="" type="checkbox"/> No			
Proper Drainage, Underdrains and Observation Wells				
Does not dewater between storms or ponding for more than 48 hours after rain event	<input type="checkbox"/> Yes <input checked="" type="checkbox"/> No			
Clogged underdrains	<input type="checkbox"/> Yes <input checked="" type="checkbox"/> No			
Observation well caps present	<input type="checkbox"/> Yes <input checked="" type="checkbox"/> No <input type="checkbox"/> N/A		Observed 4

Inlets				
Sediment build-up, trash, debris, or erosion at curb cuts, pavement edges, and/or bypassing	<input type="checkbox"/> Yes <input checked="" type="checkbox"/> No			
Inflow hindered by vegetation	<input type="checkbox"/> Yes <input checked="" type="checkbox"/> No			
Drainage and Adjacent Upstream Areas				
Adequate vegetation	<input type="checkbox"/> Yes <input checked="" type="checkbox"/> No			
Trash, debris, bare soil, signs of scour, oil, grease, and/or erosion	<input type="checkbox"/> Yes <input checked="" type="checkbox"/> No			
Additional Observations or Comments: 				
ANNUAL REPORTING				
Are significant maintenance activities required for the stormwater management facility to perform as designed? (does not activities such as grass mowing or trash collection)				<input type="checkbox"/> Yes <input checked="" type="checkbox"/> No
