ANNUAL REPORT UPDATE

Arlington National Cemetery

VPDES Permit Number: VAR40139

FINAL – MS4 ANNUAL REPORT

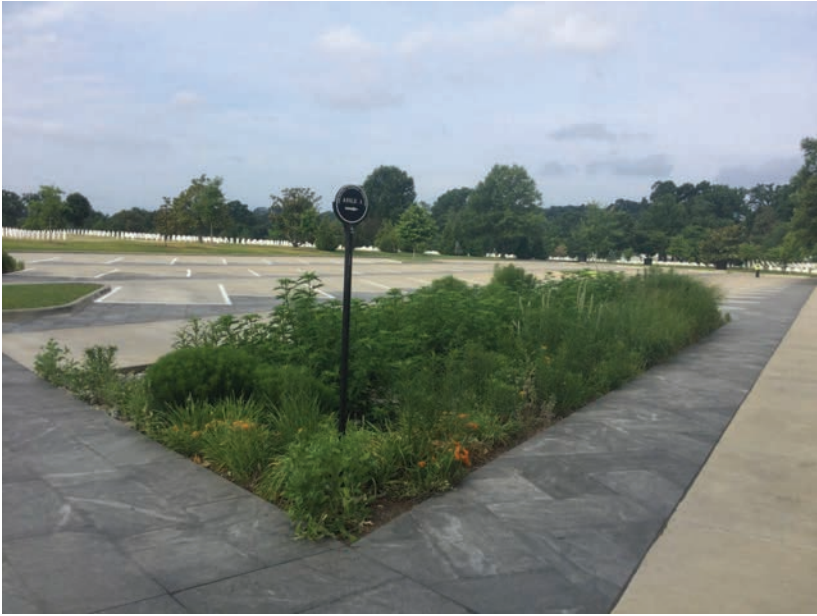
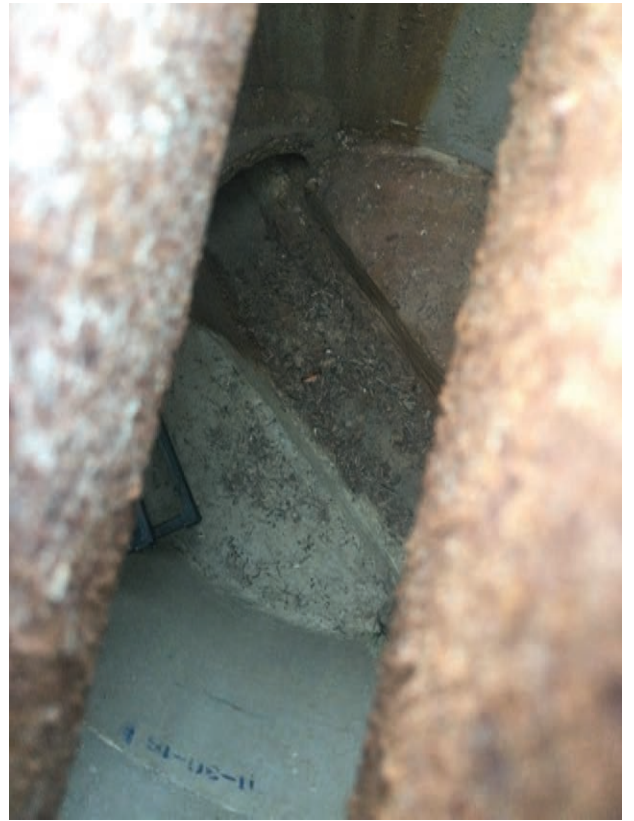
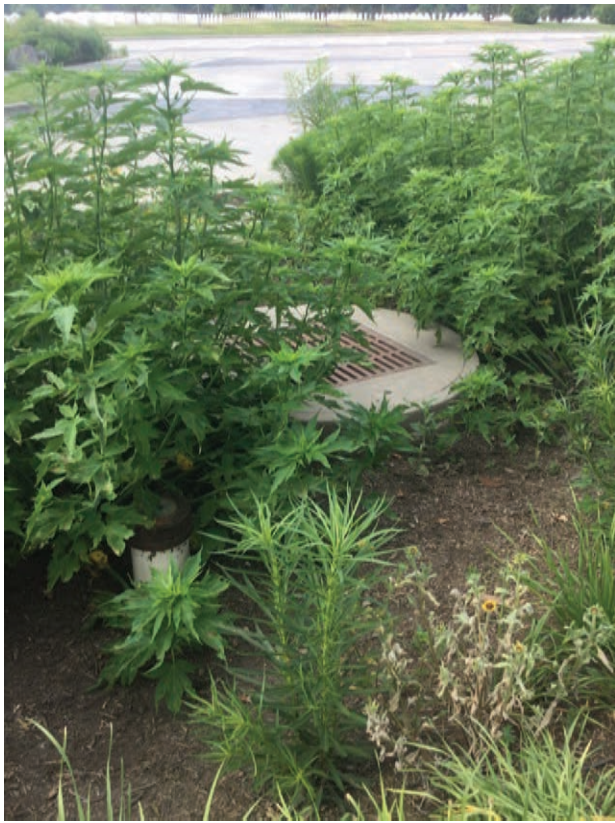
FIELD INSPECTION CHECKLIST				
Criteria	Maintenance Required?	ANC or Professional fix	Comments	Date Repaired
Pre-treatment <ul style="list-style-type: none"> • Trash, sediment, debris, oil, grease • Clogging, standing water • Odor, algae, floating vegetation • Dead vegetation or exposed soil 	<input type="checkbox"/> Yes <input checked="" type="checkbox"/> No			
Outlet				
Erosion or sediment build-up	<input type="checkbox"/> Yes <input checked="" type="checkbox"/> No			
Grate or spillway condition	<input type="checkbox"/> Yes <input checked="" type="checkbox"/> No			
Proper Drainage, Underdrains and Observation Wells				
Does not dewater between storms or ponding for more than 48 hours after rain event	<input type="checkbox"/> Yes <input checked="" type="checkbox"/> No			
Clogged underdrains	<input type="checkbox"/> Yes <input checked="" type="checkbox"/> No			
Observation well caps present	<input type="checkbox"/> Yes <input checked="" type="checkbox"/> No <input type="checkbox"/> N/A		Clean out clean

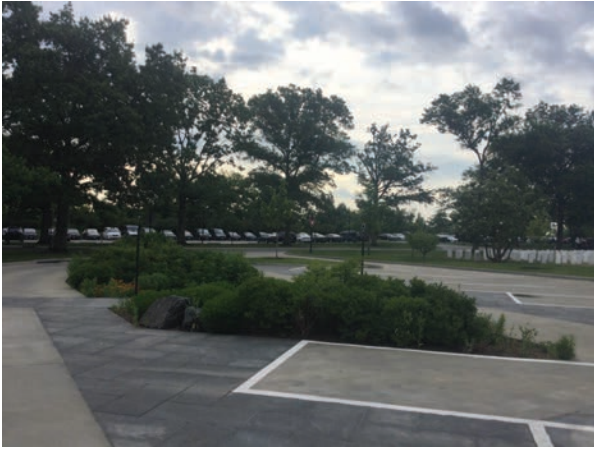
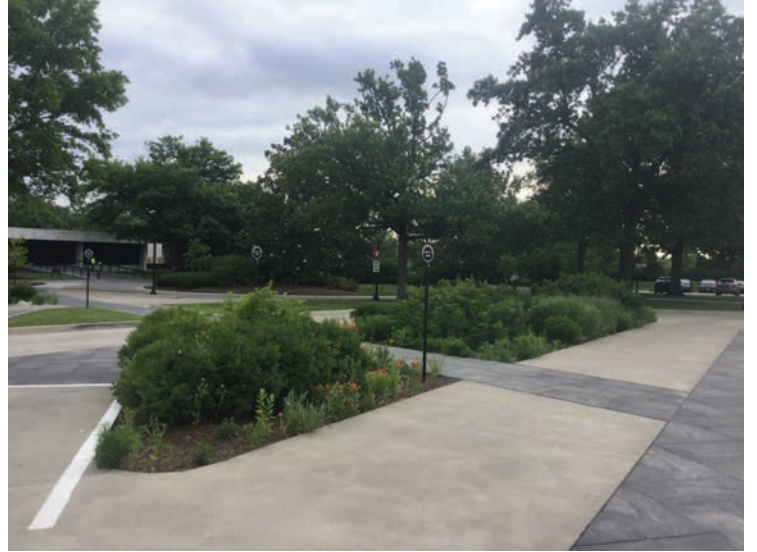
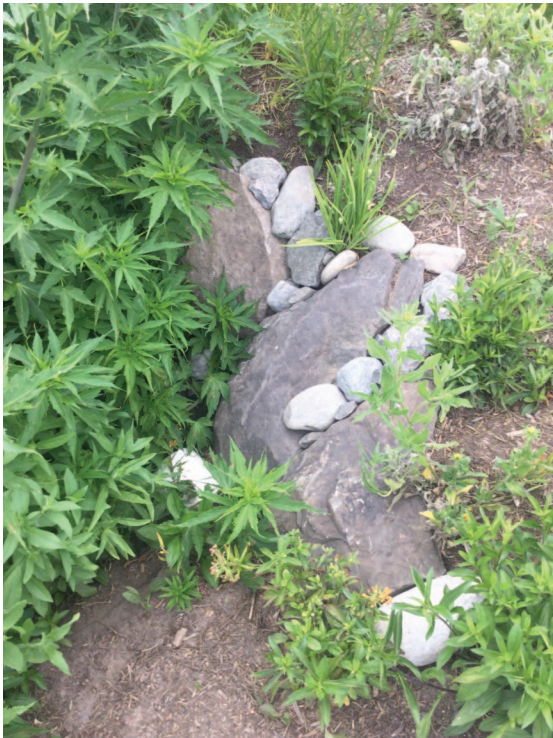
Filter Media/Mulch Layer <ul style="list-style-type: none"> Too low, too compacted, and/or clogged Older than 3 years and/or in poor condition Ponding Chemicals, fertilizers, oil, grease, trash, debris, sediment, sand Erosion, exposed soil Topsoil in poor condition 	<input checked="" type="checkbox"/> Yes <input type="checkbox"/> No	ANC	More mulch needed

FIELD INSPECTION CHECKLIST				
Criteria	Maintenance Required?	ANC or Professional fix	Comments	Date Repaired
Pre-treatment <ul style="list-style-type: none"> • Trash, sediment, debris, oil, grease • Clogging, standing water • Odor, algae, floating vegetation • Dead vegetation or exposed soil 	<input type="checkbox"/> Yes <input checked="" type="checkbox"/> No			
Outlet				
Erosion or sediment build-up	<input type="checkbox"/> Yes <input checked="" type="checkbox"/> No			
Grate or spillway condition	<input type="checkbox"/> Yes <input checked="" type="checkbox"/> No			
Proper Drainage, Underdrains and Observation Wells				
Does not dewater between storms or ponding for more than 48 hours after rain event	<input type="checkbox"/> Yes <input checked="" type="checkbox"/> No			
Clogged underdrains	<input type="checkbox"/> Yes <input checked="" type="checkbox"/> No			
Observation well caps present	<input type="checkbox"/> Yes <input checked="" type="checkbox"/> No <input type="checkbox"/> N/A		Cleanouts present, couldn't open caps. No concerns.

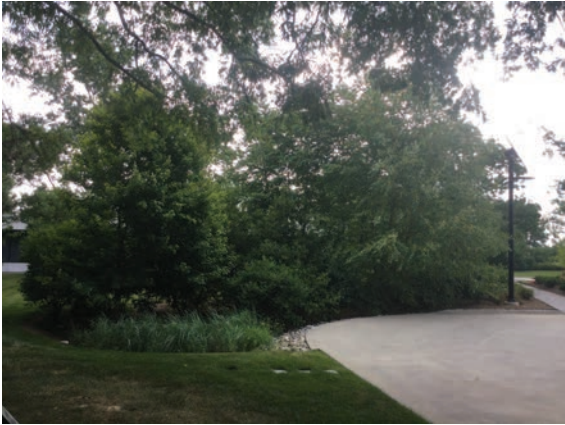
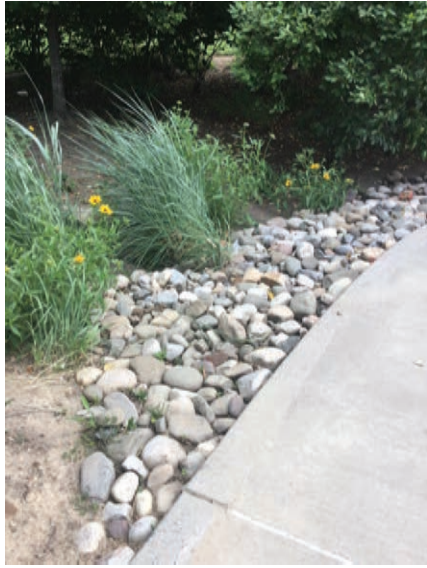
Filter Media/Mulch Layer <ul style="list-style-type: none"> Too low, too compacted, and/or clogged Older than 3 years and/or in poor condition Ponding Chemicals, fertilizers, oil, grease, trash, debris, sediment, sand Erosion, exposed soil Topsoil in poor condition 	<input checked="" type="checkbox"/> Yes <input type="checkbox"/> No	ANC	Mulch needed throughout center

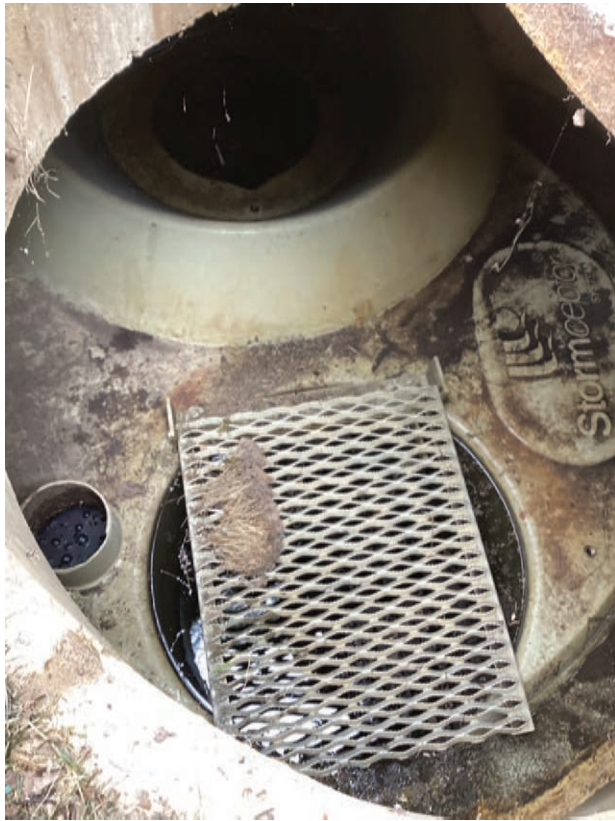
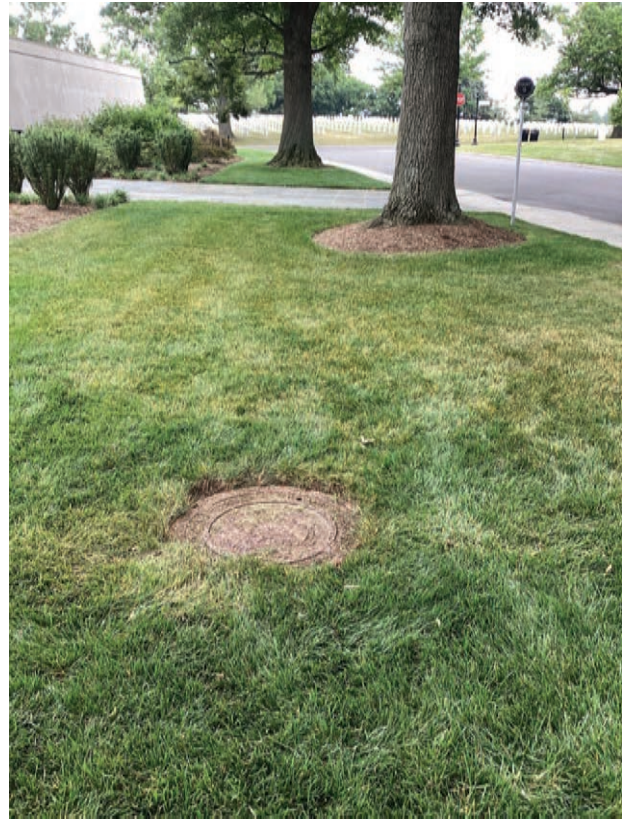
Pipe or joint breaks or cracks	<input type="checkbox"/> Yes <input checked="" type="checkbox"/> No			
Access portals cracked, damaged, or unable to open	<input type="checkbox"/> Yes <input checked="" type="checkbox"/> No		Grass covered around the edge	
Sediment Levels				
Sediment depth of the following values (sampling procedures provided below):		<input type="checkbox"/> Yes <input checked="" type="checkbox"/> No	No sediment, no sheen on water	
<i>Model #</i>	<i>Depth (in.)</i>			
STC 900	6			
STC 1200	7			
STC 1800	12			
STC 2400	12			
FD-6	18			
DD 8-ft	30			
Oil Levels				
Oil greater than 1" (sampling procedures provided below):	<input type="checkbox"/> Yes <input checked="" type="checkbox"/> No			
Upstream and Drainage Area				
Oil, fuel, or chemical spills	<input type="checkbox"/> Yes <input checked="" type="checkbox"/> No <input type="checkbox"/> N/A			
Sediment on pavement	<input type="checkbox"/> Yes <input checked="" type="checkbox"/> No <input type="checkbox"/> N/A

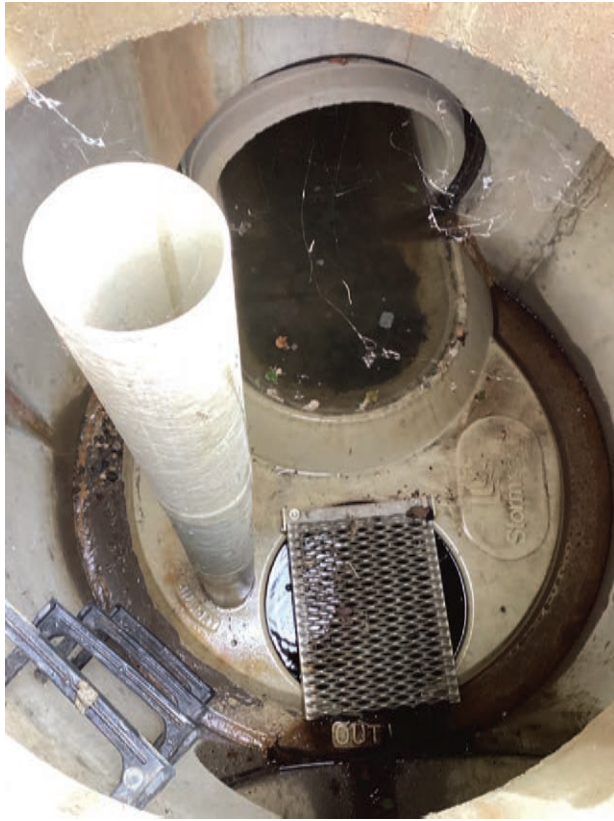
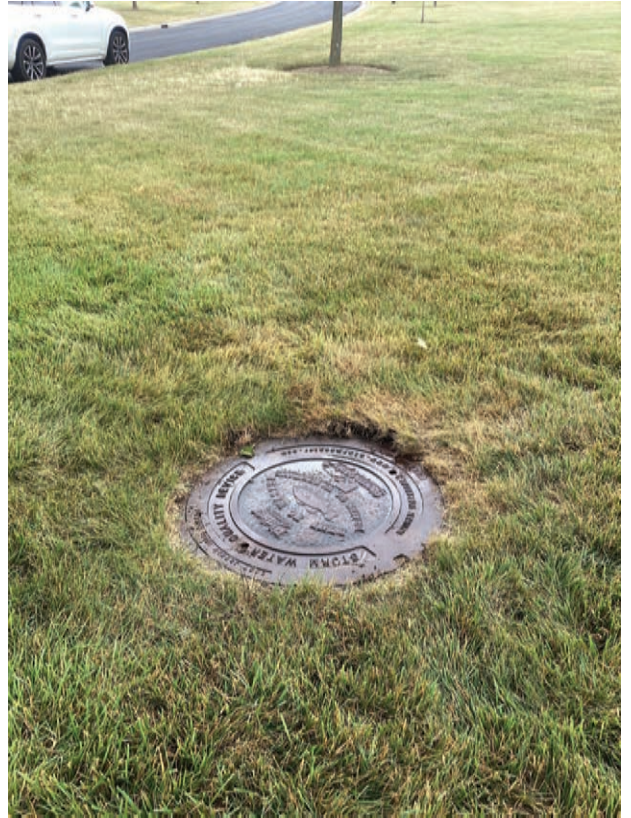
Arlington National Cemetery Post-Construction Inspection Checklist			HYDRODYNAMIC SEPARATOR															
Inspector Name, Title, Affiliation: Renee Lavinsky, Liz Shepherd (Bluestone)		Date: 6/12/2023	Date of last inspection: 6/28/2022															
Weather/site conditions: Cloudy, 80 degrees		Time since last rainfall: 72+																
BMP INFORMATION																		
BMP Installation Date: 2006		Model: <input type="checkbox"/> 900 <input type="checkbox"/> 1200 <input checked="" type="checkbox"/> 1800 <input type="checkbox"/> 2400																
BMP #: STC-6	Location: Section 73	As-Built Plans available: <input checked="" type="checkbox"/> Yes <input type="checkbox"/> No																
ROUTINE MAINTENANCE ACTIVITIES																		
Activity		Frequency		Completed														
None		NA		NA														
FIELD INSPECTION CHECKLIST																		
Criteria	Maintenance Required?	ANC or Professional fix	Comments	Date Repaired														
Inlet/Outlet/Access																		
Pipe blockages	<input type="checkbox"/> Yes <input checked="" type="checkbox"/> No																	
Pipe or joint breaks or cracks	<input type="checkbox"/> Yes <input checked="" type="checkbox"/> No																	
Access portals cracked, damaged, or unable to open	<input type="checkbox"/> Yes <input checked="" type="checkbox"/> No																	
Sediment Levels																		
Sediment depth of the following values (sampling procedures provided below):			Approximately twelve inches of sediment, will need clean out

Model #	Depth (in.)	STC 900	6	STC 1200	7	STC 1800	12	STC 2400	12	FD-6	18	DD 8-ft	30	<input checked="" type="checkbox"/> Yes <input type="checkbox"/> No	Professional		
Model #	Depth (in.)																	
STC 900	6																	
STC 1200	7																	
STC 1800	12																	
STC 2400	12																	
FD-6	18																	
DD 8-ft	30																	
Oil Levels																		
Oil greater than 1" (sampling procedures provided below):	<input type="checkbox"/> Yes <input checked="" type="checkbox"/> No																	
Upstream and Drainage Area																		
Oil, fuel, or chemical spills	<input type="checkbox"/> Yes <input checked="" type="checkbox"/> No <input type="checkbox"/> N/A																	
Sediment on pavement	<input type="checkbox"/> Yes <input checked="" type="checkbox"/> No <input type="checkbox"/> N/A																	
Trash, debris, bare soil, and/or erosion	<input type="checkbox"/> Yes <input checked="" type="checkbox"/> No <input type="checkbox"/> N/A																	
Additional Observations or Comments: Sprinklers were on when we got here, there is water flowing in the manhole structure																		
ANNUAL REPORTING																		
Are significant maintenance activities required for the stormwater management facility to perform as designed? (does not activities such as grass mowing or trash collection)				<input checked="" type="checkbox"/> Yes <input type="checkbox"/> No

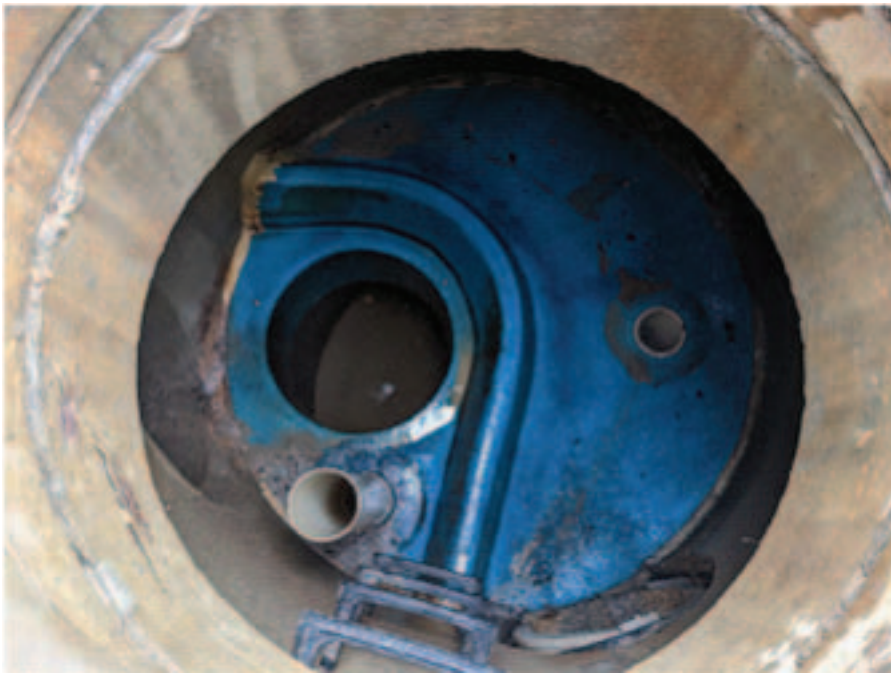
Arlington National Cemetery Post-Construction Inspection Checklist			HYDRODYNAMIC SEPARATOR	
Inspector Name, Title, Affiliation: Renee Lavinsky, Liz Shepherd (Bluestone)		Date: 09/12/2022	Date of last inspection: 6/28/2022	
Weather/site conditions: Unknown		Time since last rainfall: Unknown		
BMP INFORMATION				
BMP Installation Date: 1998		Model: <input type="checkbox"/> 900 <input checked="" type="checkbox"/> 1200 <input type="checkbox"/> 1800 <input type="checkbox"/> 2400		
BMP #: STC-7	Location: York Dr/Marshall Dr	As-Built Plans available: <input type="checkbox"/> Yes <input checked="" type="checkbox"/> No		
ROUTINE MAINTENANCE ACTIVITIES				
Activity		Frequency		Completed
None		NA		NA
FIELD INSPECTION CHECKLIST				
Criteria	Maintenance Required?	ANC or Professional fix	Comments	Date Repaired
Inlet/Outlet/Access				
Pipe blockages	<input type="checkbox"/> Yes <input checked="" type="checkbox"/> No

Pipe or joint breaks or cracks	<input type="checkbox"/> Yes <input checked="" type="checkbox"/> No			
Access portals cracked, damaged, or unable to open	<input type="checkbox"/> Yes <input checked="" type="checkbox"/> No			
Sediment Levels				
Sediment depth of the following values (sampling procedures provided below):		<input type="checkbox"/> Yes <input checked="" type="checkbox"/> No		
<i>Model #</i>	<i>Depth (in.)</i>			
STC 900	6			
STC 1200	7			
STC 1800	12			
STC 2400	12			
FD-6	18			
DD 8-ft	30			
Oil Levels				
Oil greater than 1" (sampling procedures provided below):	<input type="checkbox"/> Yes <input checked="" type="checkbox"/> No			
Upstream and Drainage Area				
Oil, fuel, or chemical spills	<input type="checkbox"/> Yes <input checked="" type="checkbox"/> No <input type="checkbox"/> N/A			
Sediment on pavement	<input type="checkbox"/> Yes <input checked="" type="checkbox"/> No <input type="checkbox"/> N/A

Trash, debris, bare soil, and/or erosion	<input type="checkbox"/> Yes <input checked="" type="checkbox"/> No <input type="checkbox"/> N/A			
Additional Observations or Comments:				
All sediment removed 12 September 2022. Photos are following cleaning, no structural damage observed.				
ANNUAL REPORTING				
Are significant maintenance activities required for the stormwater management facility to perform as designed? (does not activities such as grass mowing or trash collection)				<input type="checkbox"/> Yes <input checked="" type="checkbox"/> No

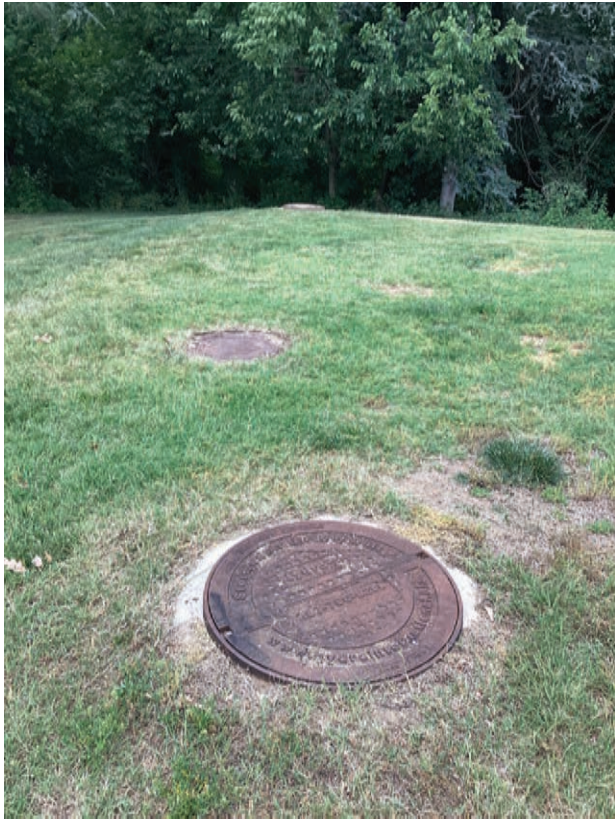
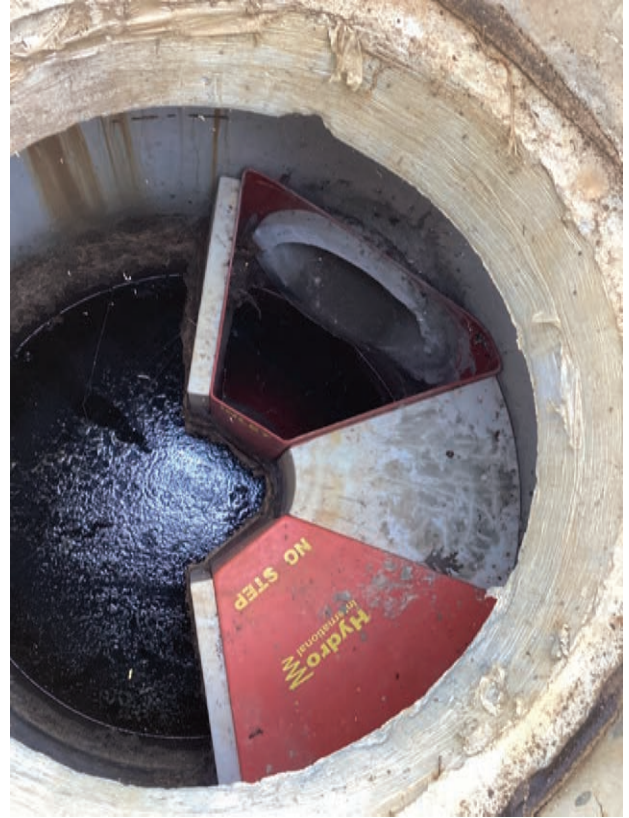
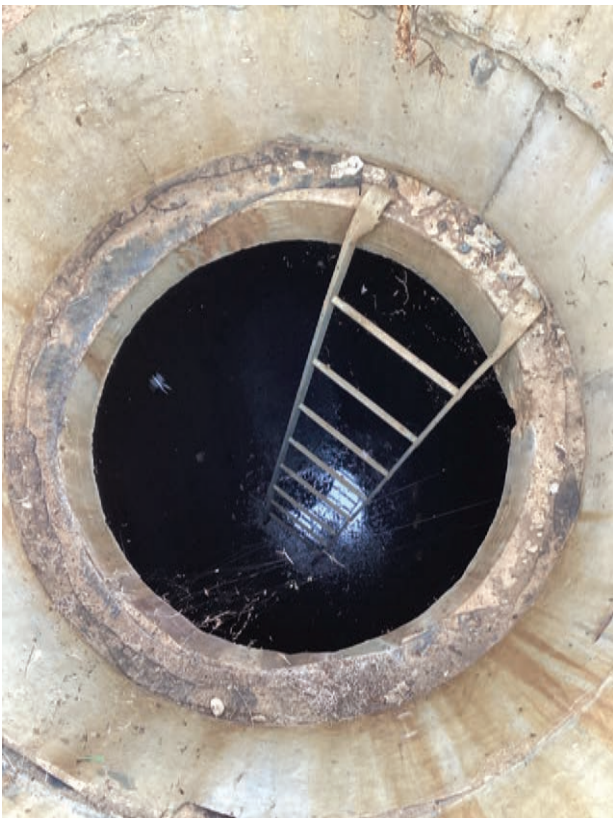
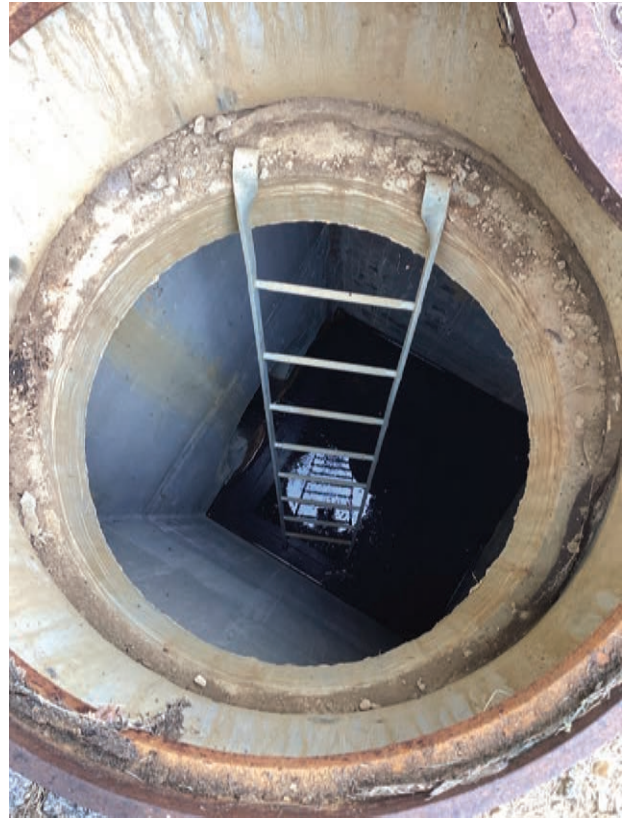
Arlington National Cemetery Post-Construction Inspection Checklist				HYDRODYNAMIC SEPARATOR	
Inspector Name, Title, Affiliation: Renee Lavinsky, Liz Shepherd (Bluestone)			Date: 6/12/2023	Date of last inspection: 6/28/2022	
Weather/site conditions: Cloudy, humid, 80 degrees			Time since last rainfall: 72+		
BMP INFORMATION					
BMP Installation Date: 2018			Model: Hydro Int'l First Defense FD-6		
BMP #: STC-8	Location: Chaffee Parking Lot		As-Built Plans available: <input type="checkbox"/> Yes <input checked="" type="checkbox"/> No		
ROUTINE MAINTENANCE ACTIVITIES					
Activity			Frequency		Completed
None			NA		NA
FIELD INSPECTION CHECKLIST					
Criteria	Maintenance Required?	ANC or Professional fix	Comments		Date Repaired
Inlet/Outlet/Access					
Pipe blockages	<input type="checkbox"/> Yes <input checked="" type="checkbox"/> No				
Pipe or joint breaks or cracks	<input type="checkbox"/> Yes <input checked="" type="checkbox"/> No

Access portals cracked, damaged, or unable to open	<input type="checkbox"/> Yes <input checked="" type="checkbox"/> No				
Sediment Levels					
Sediment depth of the following values (sampling procedures provided below):		<input type="checkbox"/> Yes <input checked="" type="checkbox"/> No	One inch of water, no sediment		
<i>Model #</i>	<i>Depth (in.)</i>				
STC 900	6				
STC 1200	7				
STC 1800	12				
STC 2400	12				
FD-6	18				
DD 8-ft	30				
Oil Levels					
Oil greater than 1" (sampling procedures provided below):	<input type="checkbox"/> Yes <input checked="" type="checkbox"/> No				
Upstream and Drainage Area					
Oil, fuel, or chemical spills	<input type="checkbox"/> Yes <input checked="" type="checkbox"/> No <input type="checkbox"/> N/A				
Sediment on pavement	<input type="checkbox"/> Yes <input checked="" type="checkbox"/> No <input type="checkbox"/> N/A				
Trash, debris, bare soil, and/or erosion	<input type="checkbox"/> Yes <input checked="" type="checkbox"/> No <input type="checkbox"/> N/A

Additional Observations or Comments:					
ANNUAL REPORTING					
Are significant maintenance activities required for the stormwater management facility to perform as designed? (does not activities such as grass mowing or trash collection)					<input type="checkbox"/> Yes <input checked="" type="checkbox"/> No

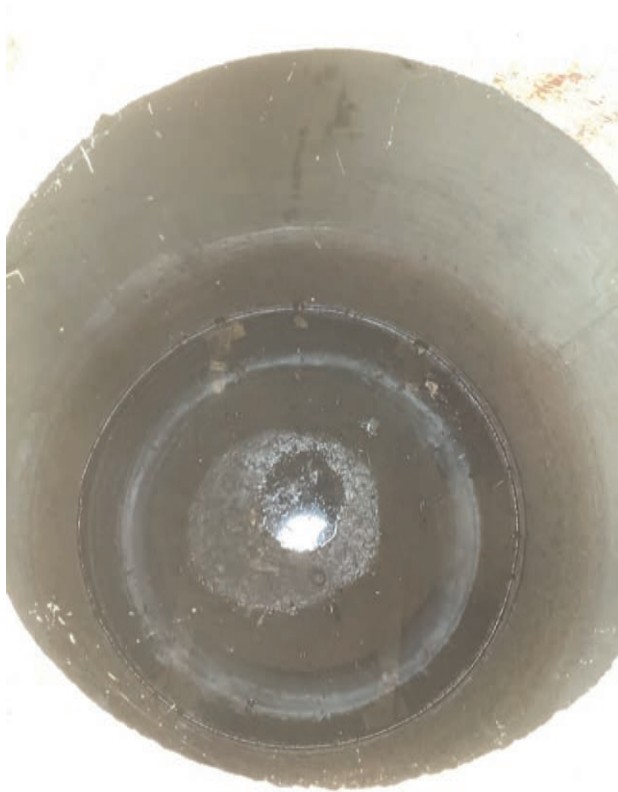
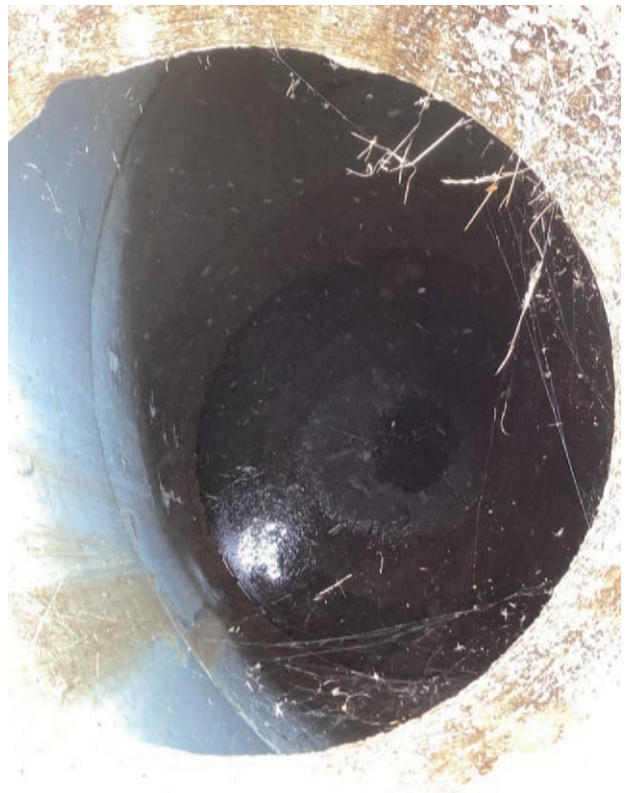
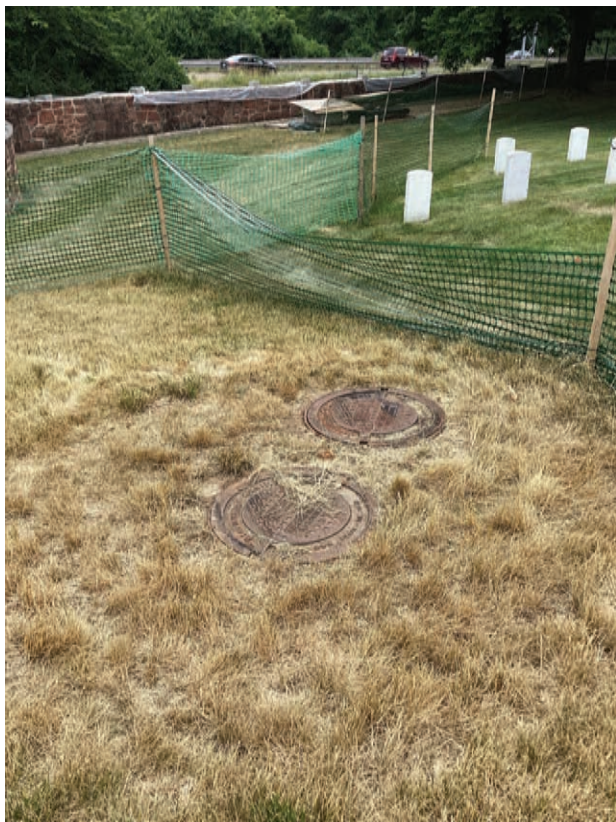
Arlington National Cemetery Post-Construction Inspection Checklist				HYDRODYNAMIC SEPARATOR	
Inspector Name, Title, Affiliation: Renee Lavinsky, Liz Shepherd (Bluestone)			Date: 6/12/2023	Date of last inspection: 6/28/2022	
Weather/site conditions: Cloudy, 80 degrees, humid			Time since last rainfall: 72+		
BMP INFORMATION					
BMP Installation Date: 2020			Model: Hydro Int'l Downstream Defender 8-ft		
BMP #: STC-9	Location: Section 52		As-Built Plans available: <input type="checkbox"/> Yes <input checked="" type="checkbox"/> No		
ROUTINE MAINTENANCE ACTIVITIES					
Activity			Frequency		Completed
None			NA		NA
FIELD INSPECTION CHECKLIST					
Criteria	Maintenance Required?	ANC or Professional fix	Comments		Date Repaired
Inlet/Outlet/Access					
Pipe blockages	<input type="checkbox"/> Yes <input checked="" type="checkbox"/> No				
Pipe or joint breaks or cracks	<input type="checkbox"/> Yes <input checked="" type="checkbox"/> No

Access portals cracked, damaged, or unable to open	<input type="checkbox"/> Yes <input checked="" type="checkbox"/> No				
Sediment Levels					
Sediment depth of the following values (sampling procedures provided below):		<input type="checkbox"/> Yes <input checked="" type="checkbox"/> No	Approximately 24 inches of sediment, will need to be cleaned out soon		
<i>Model #</i>	<i>Depth (in.)</i>				
STC 900	6				
STC 1200	7				
STC 1800	12				
STC 2400	12				
FD-6	18				
DD 8-ft	30				
Oil Levels					
Oil greater than 1" (sampling procedures provided below):	<input type="checkbox"/> Yes <input checked="" type="checkbox"/> No				
Upstream and Drainage Area					
Oil, fuel, or chemical spills	<input type="checkbox"/> Yes <input checked="" type="checkbox"/> No <input type="checkbox"/> N/A				
Sediment on pavement	<input type="checkbox"/> Yes <input checked="" type="checkbox"/> No <input type="checkbox"/> N/A

Trash, debris, bare soil, and/or erosion	<input type="checkbox"/> Yes <input checked="" type="checkbox"/> No <input type="checkbox"/> N/A				
Additional Observations or Comments:					
ANNUAL REPORTING					
Are significant maintenance activities required for the stormwater management facility to perform as designed? (does not activities such as grass mowing or trash collection)					<input type="checkbox"/> Yes <input checked="" type="checkbox"/> No

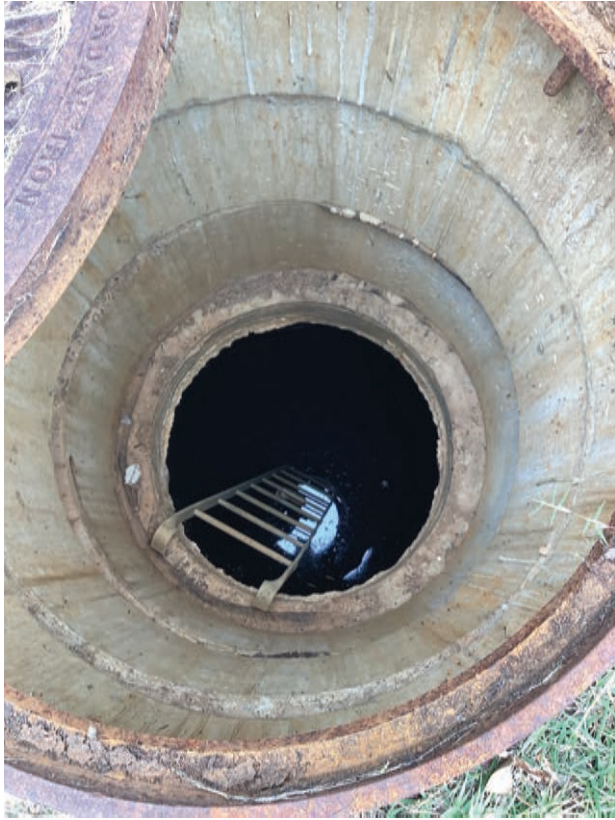
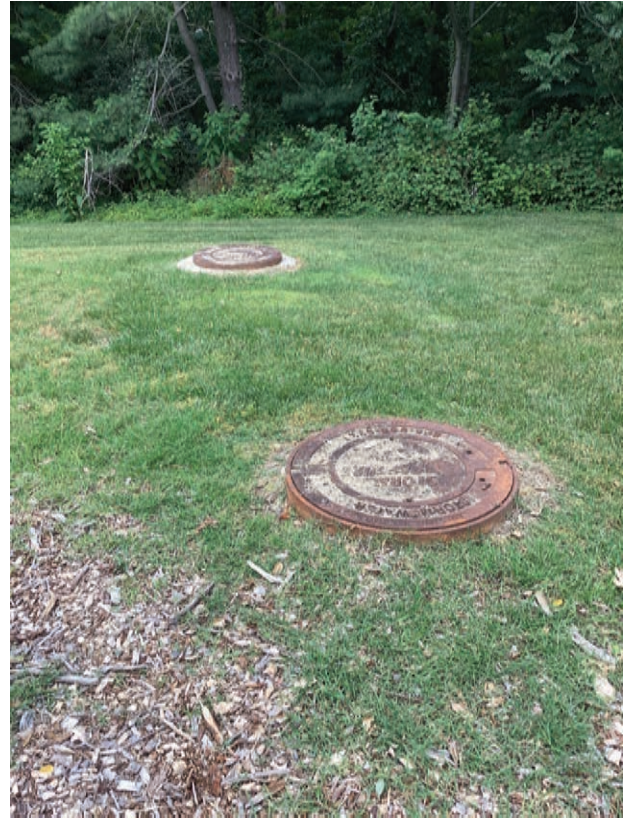
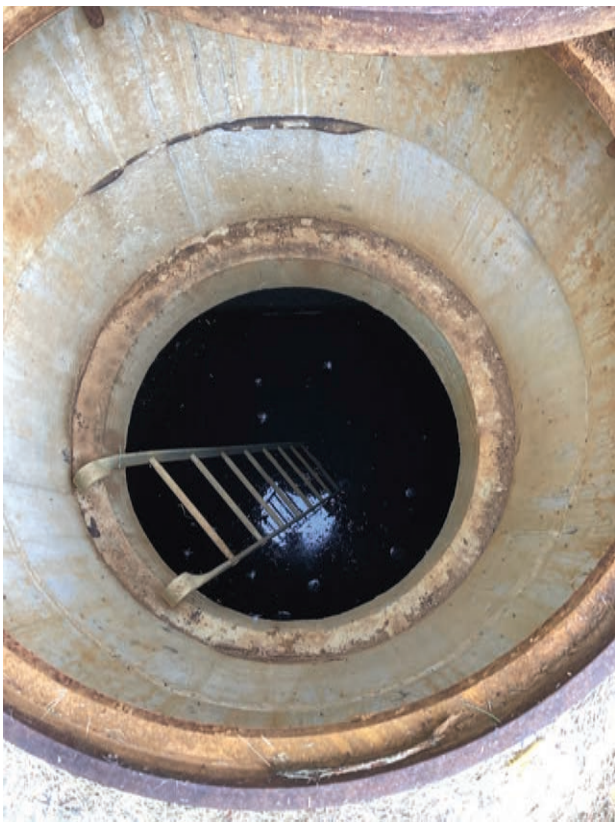
Arlington National Cemetery Post-Construction Inspection Checklist			UNDERGROUND CHAMBER/INFILTRATION CHAMBER	
Inspector Name, Title, Affiliation: Renee Lavinsky, Liz Shepherd (Bluestone)		Date: 6/12/2023	Date of last inspection: 6/28/2022	
Weather/site conditions: Cloudy, humid, 80 degrees		Time since last rainfall: 72+		
BMP INFORMATION				
BMP Installation Date: 2018		Type: <input type="checkbox"/> Pre-Treatment <input checked="" type="checkbox"/> Storage <input type="checkbox"/> Other		
BMP #: STCP-1	Location: Chaffee Parking Lot	As-Built Plans available: <input type="checkbox"/> Yes <input checked="" type="checkbox"/> No		
ROUTINE MAINTENANCE ACTIVITIES				
Activity		Frequency		Completed
None		NA		NA
FIELD INSPECTION CHECKLIST				
Criteria	Maintenance Required?	ANC or Professional fix	Comments	Date Repaired
Inlet/Outlet/Access				
Pipe blockages	<input type="checkbox"/> Yes <input checked="" type="checkbox"/> No

Pipe or joint breaks or cracks	<input type="checkbox"/> Yes <input checked="" type="checkbox"/> No			
Access cover missing, cracked, damaged, or unable to open	<input type="checkbox"/> Yes <input checked="" type="checkbox"/> No			
Sediment Level				
Sediment accumulation in forebay	<input type="checkbox"/> Yes <input checked="" type="checkbox"/> No <input type="checkbox"/> N/A			
Sediment depth on vault floor greater than 15% of diameter or interior depth of vault	<input type="checkbox"/> Yes <input checked="" type="checkbox"/> No			
Standing water inside chamber for more than 24 hours after storm	<input type="checkbox"/> Yes <input checked="" type="checkbox"/> No		One inch of standing water, no sediment	
Scum line present	<input type="checkbox"/> Yes <input checked="" type="checkbox"/> No			
Chamber cracked (cracks wider than ½ inch), collapsed, or bent out of shape	<input type="checkbox"/> Yes <input checked="" type="checkbox"/> No

Upstream and Drainage Area				
Oil, fuel, or chemical spills	<input type="checkbox"/> Yes <input checked="" type="checkbox"/> No <input type="checkbox"/> N/A			
Sediment on pavement	<input type="checkbox"/> Yes <input checked="" type="checkbox"/> No <input type="checkbox"/> N/A			
Trash, debris, bare soil, and/or erosion	<input type="checkbox"/> Yes <input checked="" type="checkbox"/> No <input type="checkbox"/> N/A			
Additional Observations or Comments:				
ANNUAL REPORTING				
Are significant maintenance activities required for the stormwater management facility to perform as designed? (does not activities such as grass mowing or trash collection)				<input type="checkbox"/> Yes <input checked="" type="checkbox"/> No

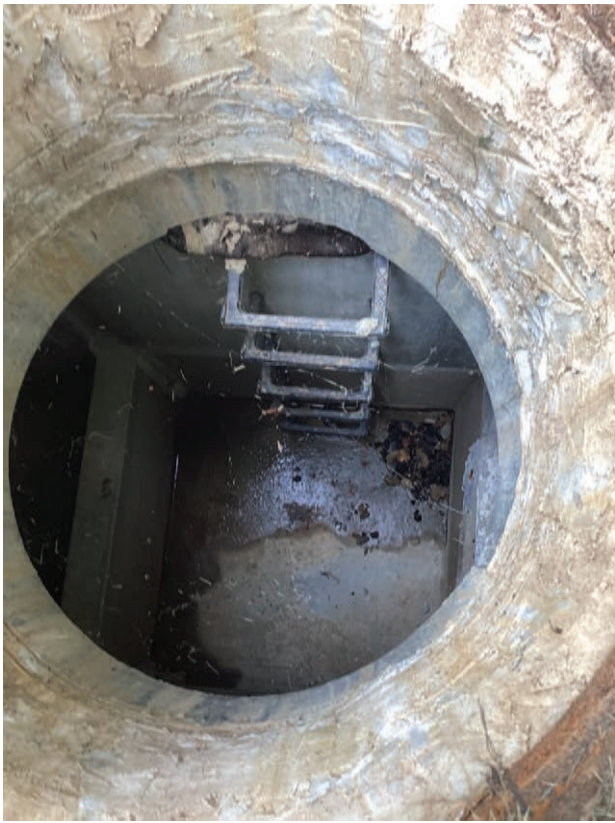
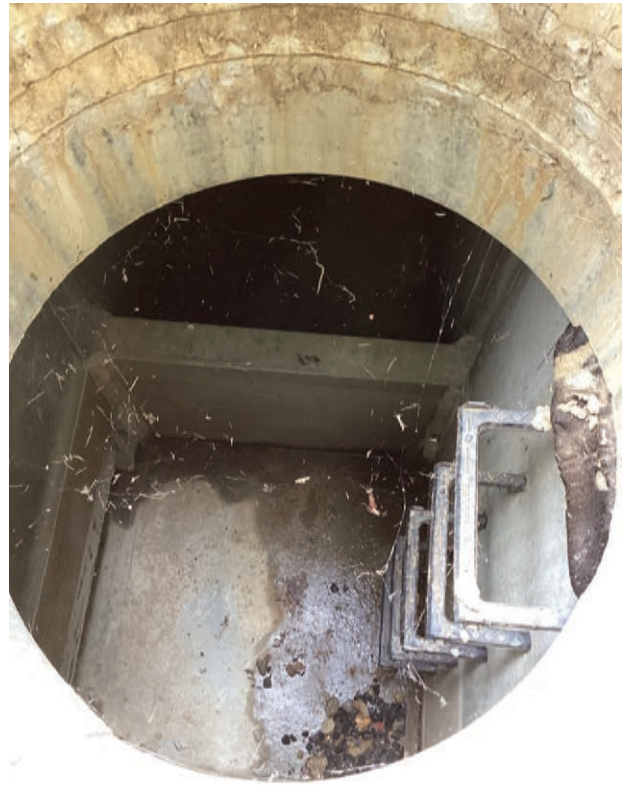
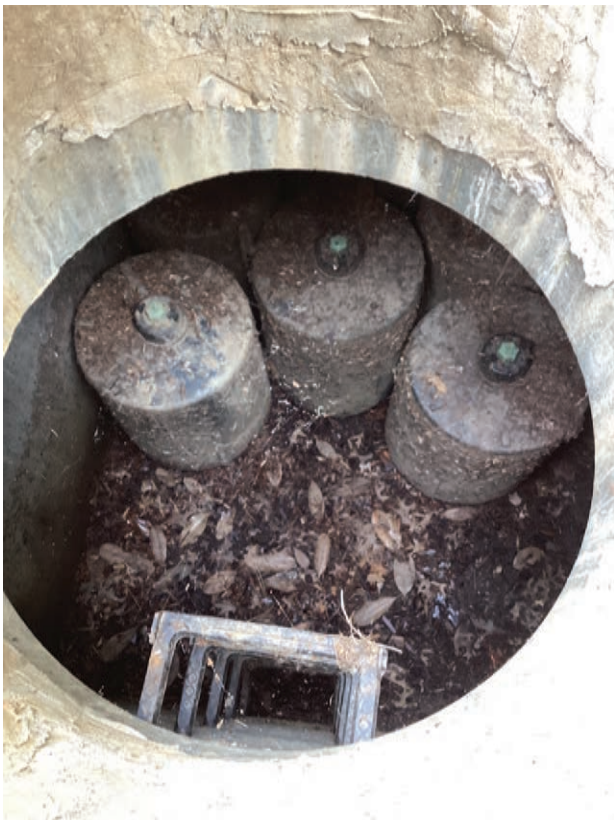
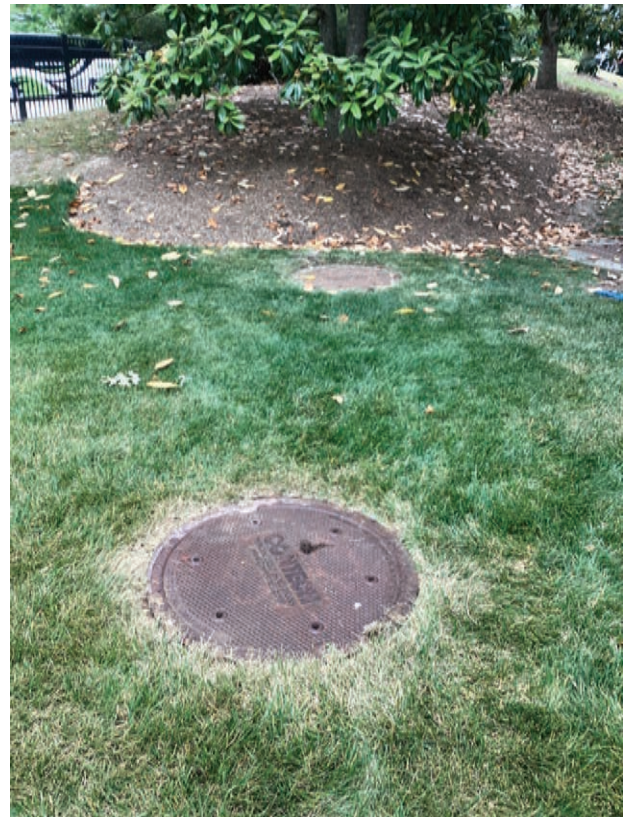
Arlington National Cemetery Post-Construction Inspection Checklist				STORMFILTER	
Inspector Name, Title, Affiliation: Renee Lavinsky, Liz Shepherd (Bluestone)			Date: 6/12/2023		Date of last inspection: 6/28/2022
Weather/site conditions: Cloudy, 80 degrees			Time since last rainfall: 72+		
BMP INFORMATION					
BMP Installation Date: 2018			Type: <input checked="" type="checkbox"/> Vault <input type="checkbox"/> Manhole <input type="checkbox"/> Linear <input type="checkbox"/> Other		
BMP #: STF-1	Location: East Employee Parking Lot		As-Built Plans available: <input type="checkbox"/> Yes <input checked="" type="checkbox"/> No		
ROUTINE MAINTENANCE ACTIVITIES					
Activity			Frequency		Completed
None			NA		NA
FIELD INSPECTION CHECKLIST					
Criteria	Maintenance Required?	ANC or Professional fix	Comments		Date Repaired
Inlet/Outlet/Access					
Pipe blockages	<input type="checkbox"/> Yes <input checked="" type="checkbox"/> No

Pipe or joint breaks or cracks	<input type="checkbox"/> Yes <input checked="" type="checkbox"/> No				
Access grates cracked, damaged, or unable to open	<input type="checkbox"/> Yes <input checked="" type="checkbox"/> No				
Sediment Level and Cartridges					
Sediment accumulation in forebay	<input type="checkbox"/> Yes <input checked="" type="checkbox"/> No <input type="checkbox"/> N/A				
Sediment depth on vault floor greater than 4 inches	<input type="checkbox"/> Yes <input checked="" type="checkbox"/> No		Leaf litter, may need cleaning out next inspection		
Sediment depth on top of cartridges greater than 0.25 inches	<input type="checkbox"/> Yes <input checked="" type="checkbox"/> No				
Cartridges submerged with greater than 4 inches water for more than 24 hours after storm	<input type="checkbox"/> Yes <input checked="" type="checkbox"/> No				
Filter media plugged (no pore space) or in bypass condition during storm	<input type="checkbox"/> Yes <input checked="" type="checkbox"/> No

Scum line present above top cap	<input type="checkbox"/> Yes <input checked="" type="checkbox"/> No				
Upstream and Drainage Area					
Oil, fuel, or chemical spills	<input type="checkbox"/> Yes <input checked="" type="checkbox"/> No <input type="checkbox"/> N/A				
Sediment on pavement	<input type="checkbox"/> Yes <input checked="" type="checkbox"/> No <input type="checkbox"/> N/A				
Trash, debris, bare soil, and/or erosion	<input type="checkbox"/> Yes <input checked="" type="checkbox"/> No <input type="checkbox"/> N/A				
Additional Observations or Comments:					
ANNUAL REPORTING					
Are significant maintenance activities required for the stormwater management facility to perform as designed? (does not activities such as grass mowing or trash collection)					<input type="checkbox"/> Yes <input checked="" type="checkbox"/> No

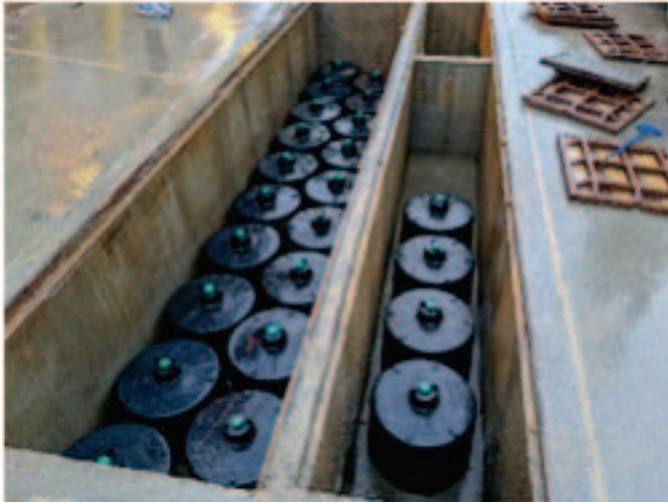
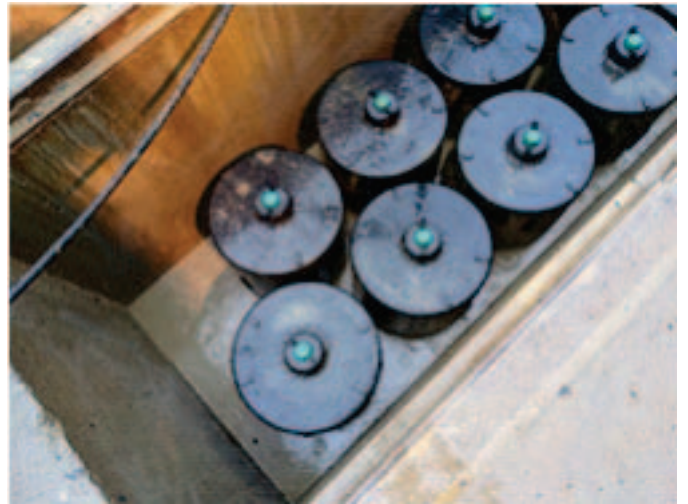
Arlington National Cemetery Post-Construction Inspection Checklist				STORMFILTER	
Inspector Name, Title, Affiliation: Renee Lavinsky, Liz Shepherd (Bluestone)			Date: 6/12/2023		Date of last inspection: 6/28/2022
Weather/site conditions: Unknown			Time since last rainfall: Unknown		
BMP INFORMATION					
BMP Installation Date: 2016			Type: <input checked="" type="checkbox"/> Vault <input type="checkbox"/> Manhole <input type="checkbox"/> Linear <input type="checkbox"/> Other		
BMP #: STF-2	Location: Bldg 129		As-Built Plans available: <input checked="" type="checkbox"/> Yes <input type="checkbox"/> No		
ROUTINE MAINTENANCE ACTIVITIES					
Activity			Frequency		Completed
None			NA		NA
FIELD INSPECTION CHECKLIST					
Criteria	Maintenance Required?	ANC or Professional fix	Comments		Date Repaired
Inlet/Outlet/Access					
Pipe blockages	<input type="checkbox"/> Yes <input checked="" type="checkbox"/> No

Pipe or joint breaks or cracks	<input type="checkbox"/> Yes <input checked="" type="checkbox"/> No				
Access grates cracked, damaged, or unable to open	<input type="checkbox"/> Yes <input checked="" type="checkbox"/> No				
Sediment Level and Cartridges					
Sediment accumulation in forebay	<input type="checkbox"/> Yes <input checked="" type="checkbox"/> No <input type="checkbox"/> N/A				
Sediment depth on vault floor greater than 4 inches	<input type="checkbox"/> Yes <input checked="" type="checkbox"/> No				
Sediment depth on top of cartridges greater than 0.25 inches	<input type="checkbox"/> Yes <input checked="" type="checkbox"/> No				
Cartridges submerged with greater than 4 inches water for more than 24 hours after storm	<input type="checkbox"/> Yes <input checked="" type="checkbox"/> No				
Filter media plugged (no pore space) or in bypass condition during storm	<input type="checkbox"/> Yes <input checked="" type="checkbox"/> No

Scum line present above top cap	<input type="checkbox"/> Yes <input checked="" type="checkbox"/> No				
Upstream and Drainage Area					
Oil, fuel, or chemical spills	<input type="checkbox"/> Yes <input checked="" type="checkbox"/> No <input type="checkbox"/> N/A				
Sediment on pavement	<input type="checkbox"/> Yes <input checked="" type="checkbox"/> No <input type="checkbox"/> N/A				
Trash, debris, bare soil, and/or erosion	<input type="checkbox"/> Yes <input checked="" type="checkbox"/> No <input type="checkbox"/> N/A				
Additional Observations or Comments:					
Inspection performed following clean out and filter replacement.					
ANNUAL REPORTING					
Are significant maintenance activities required for the stormwater management facility to perform as designed? (does not activities such as grass mowing or trash collection)					<input type="checkbox"/> Yes <input checked="" type="checkbox"/> No

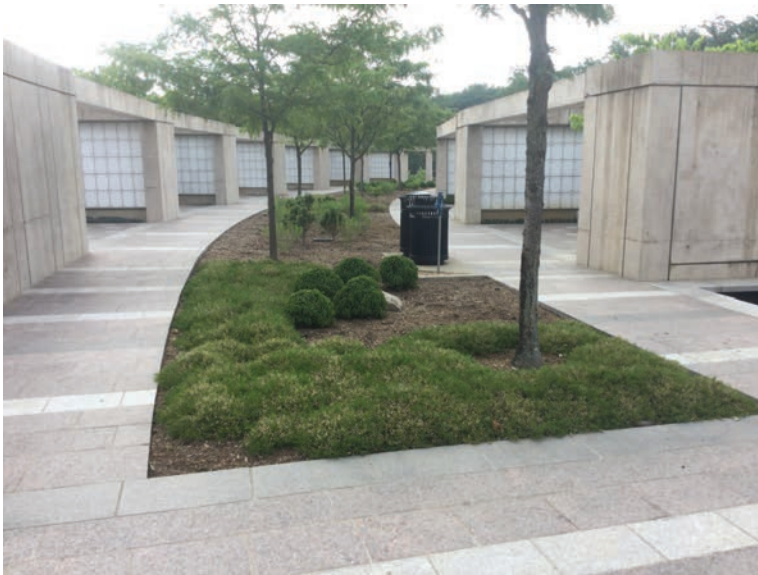
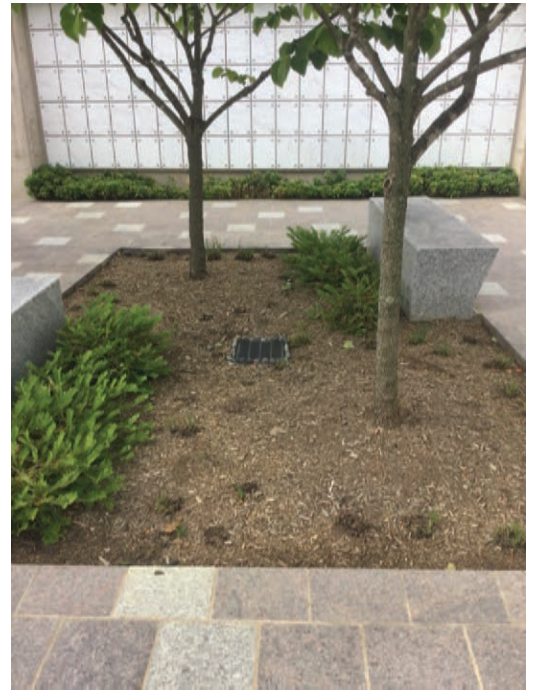
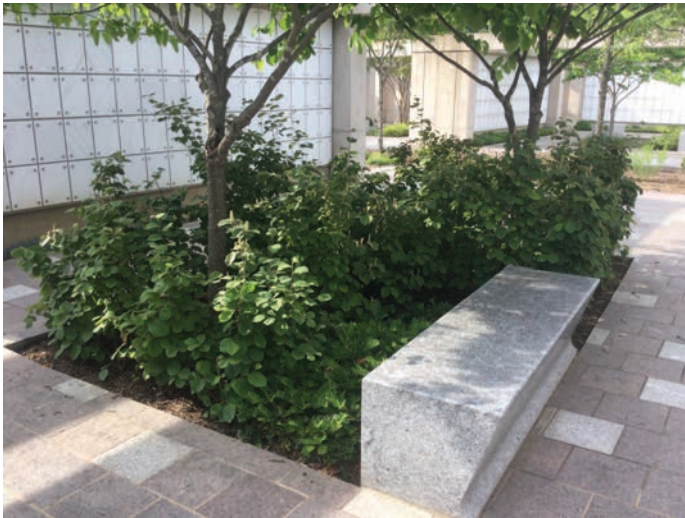
Arlington National Cemetery Post-Construction Inspection Checklist			BIORETENTION/RAIN GARDEN (with or without underdrain)	
Inspector Name, Title, Affiliation: Renee Lavinsky, Liz Shepherd (Bluestone)		Date: 6/12/2023	Date of last inspection: 6/28/2022	
Weather/site conditions: Cloudy, 70		Time since last rainfall: 72+		
BMP INFORMATION				
BMP Installation Date: 2018		Underdrain Present: <input checked="" type="checkbox"/> Yes <input type="checkbox"/> No		
BMP #: URG-1	Location: Columbarium 10	As-Built Plans available: <input type="checkbox"/> Yes <input checked="" type="checkbox"/> No		
ROUTINE MAINTENANCE ACTIVITIES				
Activity		Frequency	Completed	
Mowing grass filter strips and bioretention turf cover		At least 4 times a year	<input checked="" type="checkbox"/> Yes <input type="checkbox"/> No	
Spot weeding, erosion repair, trash removal, and mulch raking		Twice during growing season	<input checked="" type="checkbox"/> Yes <input type="checkbox"/> No

<ul style="list-style-type: none"> Spring visual inspection and cleanup Supplement mulch to maintain a 3" layer Prune trees and shrubs 		Annually	<input checked="" type="checkbox"/> Yes <input type="checkbox"/> No	
Remove sediment in pre-treatment cells and inflow points		Once every 2 to 3 years	<input type="checkbox"/> Yes <input type="checkbox"/> No <input checked="" type="checkbox"/> Not due	
Replace the mulch layer		Every 3 years	<input type="checkbox"/> Yes <input type="checkbox"/> No <input checked="" type="checkbox"/> Not due	
FIELD INSPECTION CHECKLIST				
Criteria	Maintenance Required?	ANC or Professional fix	Comments	Date Repaired
Surface				
Vegetation <ul style="list-style-type: none"> Vegetation species inconsistent with design specs Less than 75-90% cover (mulch plus vegetation) High grass Dying or dead vegetation Vegetation killed by salt or winter elements 	<input type="checkbox"/> Yes <input checked="" type="checkbox"/> No

Filter Media/Mulch Layer <ul style="list-style-type: none"> Too low, too compacted, and/or clogged Older than 3 years and/or in poor condition Ponding Chemicals, fertilizers, oil, grease, trash, debris, sediment, sand Erosion, exposed soil Topsoil in poor condition 	<input type="checkbox"/> Yes <input checked="" type="checkbox"/> No

FIELD INSPECTION CHECKLIST				
Criteria	Maintenance Required?	ANC or Professional fix	Comments	Date Repaired
Pre-treatment <ul style="list-style-type: none"> • Trash, sediment, debris, oil, grease • Clogging, standing water • Odor, algae, floating vegetation • Dead vegetation or exposed soil 	<input type="checkbox"/> Yes <input checked="" type="checkbox"/> No			
Outlet				
Erosion or sediment build-up	<input type="checkbox"/> Yes <input checked="" type="checkbox"/> No			
Grate or spillway condition	<input type="checkbox"/> Yes <input checked="" type="checkbox"/> No			
Proper Drainage, Underdrains and Observation Wells				
Does not dewater between storms or ponding for more than 48 hours after rain event	<input type="checkbox"/> Yes <input checked="" type="checkbox"/> No			
Clogged underdrains	<input type="checkbox"/> Yes <input checked="" type="checkbox"/> No			
Observation well caps present	<input type="checkbox"/> Yes <input type="checkbox"/> No <input checked="" type="checkbox"/> N/A

Inlets				
Sediment build-up, trash, debris, or erosion at curb cuts, pavement edges, and/or bypassing	<input type="checkbox"/> Yes <input checked="" type="checkbox"/> No			
Inflow hindered by vegetation	<input type="checkbox"/> Yes <input checked="" type="checkbox"/> No			
Drainage and Adjacent Upstream Areas				
Adequate vegetation	<input type="checkbox"/> Yes <input checked="" type="checkbox"/> No			
Trash, debris, bare soil, signs of scour, oil, grease, and/or erosion	<input type="checkbox"/> Yes <input checked="" type="checkbox"/> No			
Additional Observations or Comments:				
ANNUAL REPORTING				
Are significant maintenance activities required for the stormwater management facility to perform as designed? (does not activities such as grass mowing or trash collection)				<input type="checkbox"/> Yes <input checked="" type="checkbox"/> No
