ANNUAL REPORT UPDATE

Arlington National Cemetery

VPDES Permit Number: VAR40139

FINAL – MS4 ANNUAL REPORT

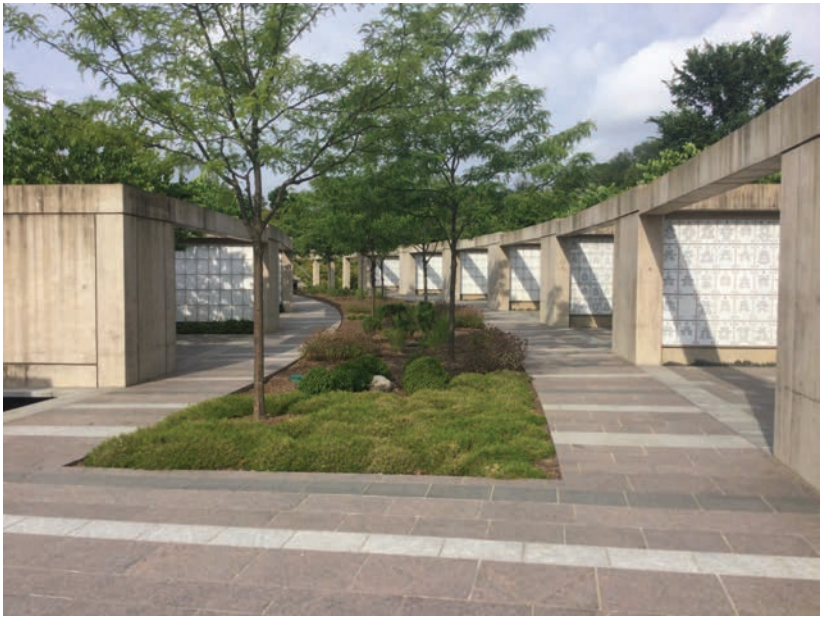
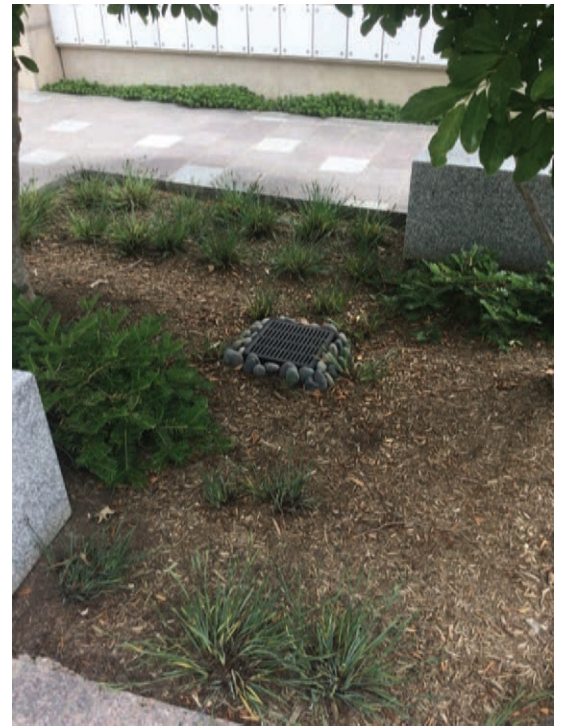
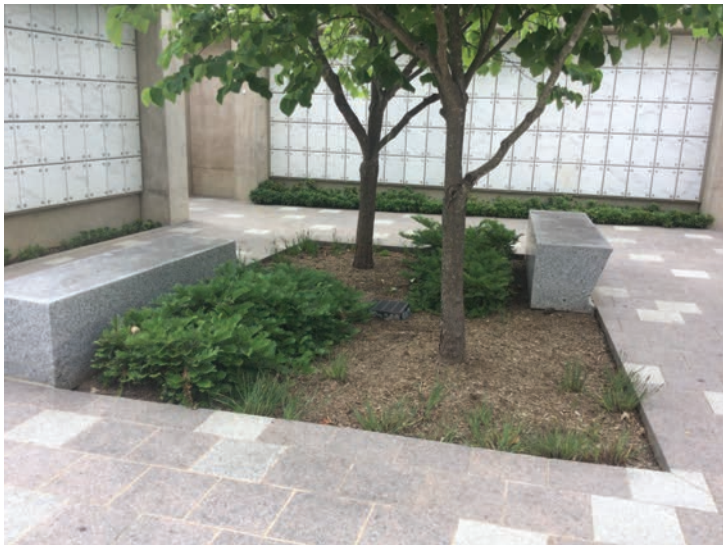
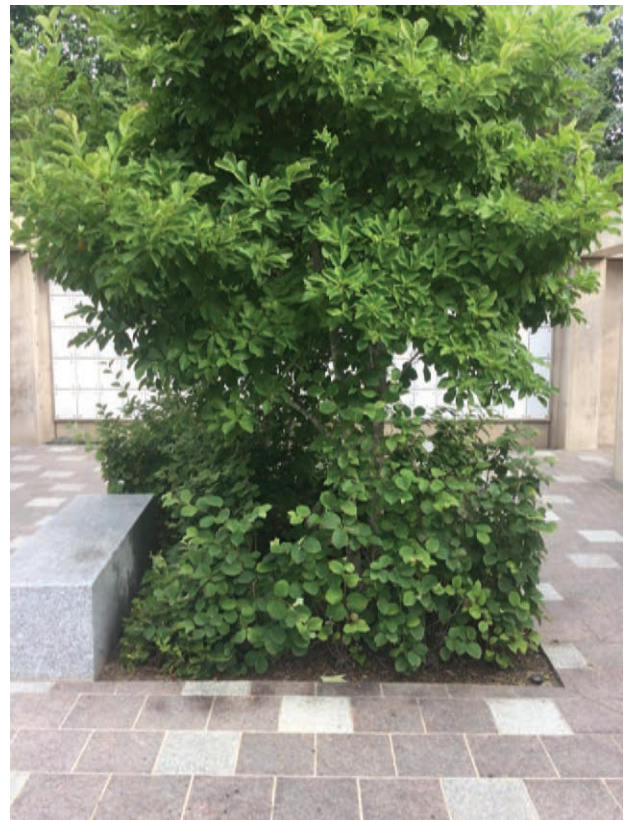
Arlington National Cemetery Post-Construction Inspection Checklist			BIORETENTION/RAIN GARDEN (with or without underdrain)	
Inspector Name, Title, Affiliation: Renee Lavinsky, Liz Shepherd (Bluestone)		Date: 6/12/2023	Date of last inspection: 6/28/2022	
Weather/site conditions: Cloudy, 75		Time since last rainfall: 72+		
BMP INFORMATION				
BMP Installation Date: 2018		Underdrain Present: <input type="checkbox"/> Yes <input checked="" type="checkbox"/> No		
BMP #: URG-2	Location: Columbarium 11	As-Built Plans available: <input type="checkbox"/> Yes <input checked="" type="checkbox"/> No		
ROUTINE MAINTENANCE ACTIVITIES				
Activity		Frequency	Completed	
Mowing grass filter strips and bioretention turf cover		At least 4 times a year	<input checked="" type="checkbox"/> Yes <input type="checkbox"/> No	
Spot weeding, erosion repair, trash removal, and mulch raking		Twice during growing season	<input checked="" type="checkbox"/> Yes <input type="checkbox"/> No

<ul style="list-style-type: none"> Spring visual inspection and cleanup Supplement mulch to maintain a 3" layer Prune trees and shrubs 		Annually	<input checked="" type="checkbox"/> Yes <input type="checkbox"/> No	
Remove sediment in pre-treatment cells and inflow points		Once every 2 to 3 years	<input type="checkbox"/> Yes <input type="checkbox"/> No <input checked="" type="checkbox"/> Not due	
Replace the mulch layer		Every 3 years	<input type="checkbox"/> Yes <input type="checkbox"/> No <input checked="" type="checkbox"/> Not due	
FIELD INSPECTION CHECKLIST				
Criteria	Maintenance Required?	ANC or Professional fix	Comments	Date Repaired
Surface				
Vegetation <ul style="list-style-type: none"> Vegetation species inconsistent with design specs Less than 75-90% cover (mulch plus vegetation) High grass Dying or dead vegetation Vegetation killed by salt or winter elements 	<input type="checkbox"/> Yes <input checked="" type="checkbox"/> No

Filter Media/Mulch Layer <ul style="list-style-type: none"> Too low, too compacted, and/or clogged Older than 3 years and/or in poor condition Ponding Chemicals, fertilizers, oil, grease, trash, debris, sediment, sand Erosion, exposed soil Topsoil in poor condition 	<input type="checkbox"/> Yes <input checked="" type="checkbox"/> No

FIELD INSPECTION CHECKLIST				
Criteria	Maintenance Required?	ANC or Professional fix	Comments	Date Repaired
Pre-treatment <ul style="list-style-type: none"> • Trash, sediment, debris, oil, grease • Clogging, standing water • Odor, algae, floating vegetation • Dead vegetation or exposed soil 	<input type="checkbox"/> Yes <input checked="" type="checkbox"/> No			
Outlet				
Erosion or sediment build-up	<input type="checkbox"/> Yes <input checked="" type="checkbox"/> No			
Grate or spillway condition	<input type="checkbox"/> Yes <input checked="" type="checkbox"/> No			
Proper Drainage, Underdrains and Observation Wells				
Does not dewater between storms or ponding for more than 48 hours after rain event	<input type="checkbox"/> Yes <input checked="" type="checkbox"/> No			
Clogged underdrains	<input type="checkbox"/> Yes <input checked="" type="checkbox"/> No			
Observation well caps present	<input type="checkbox"/> Yes <input type="checkbox"/> No <input checked="" type="checkbox"/> N/A

Inlets				
Sediment build-up, trash, debris, or erosion at curb cuts, pavement edges, and/or bypassing	<input type="checkbox"/> Yes <input checked="" type="checkbox"/> No			
Inflow hindered by vegetation	<input type="checkbox"/> Yes <input checked="" type="checkbox"/> No			
Drainage and Adjacent Upstream Areas				
Adequate vegetation	<input type="checkbox"/> Yes <input checked="" type="checkbox"/> No			
Trash, debris, bare soil, signs of scour, oil, grease, and/or erosion	<input type="checkbox"/> Yes <input checked="" type="checkbox"/> No			
Additional Observations or Comments:				
ANNUAL REPORTING				
Are significant maintenance activities required for the stormwater management facility to perform as designed? (does not activities such as grass mowing or trash collection)				<input type="checkbox"/> Yes <input checked="" type="checkbox"/> No

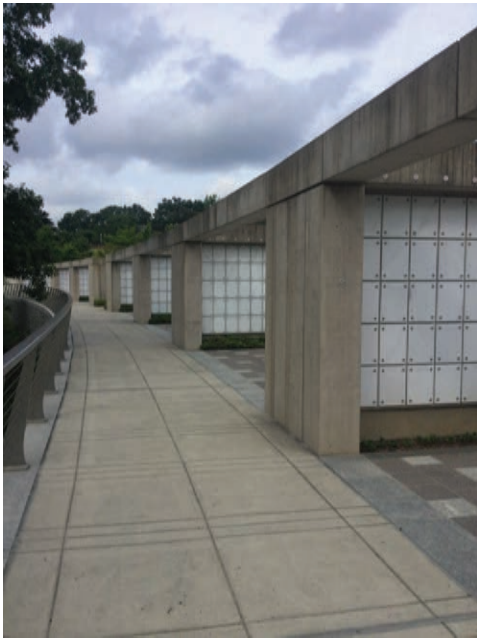
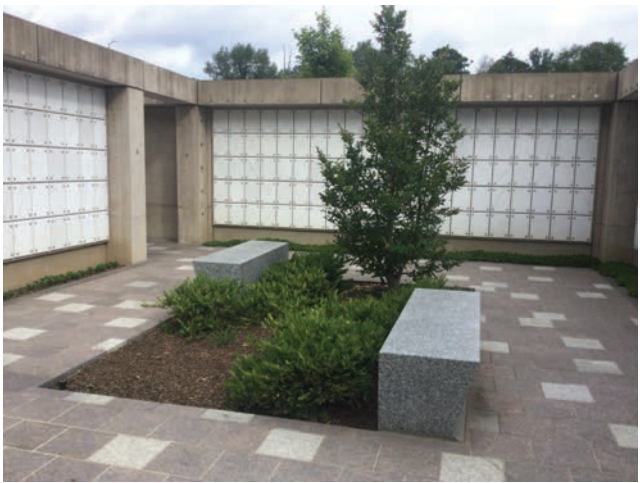
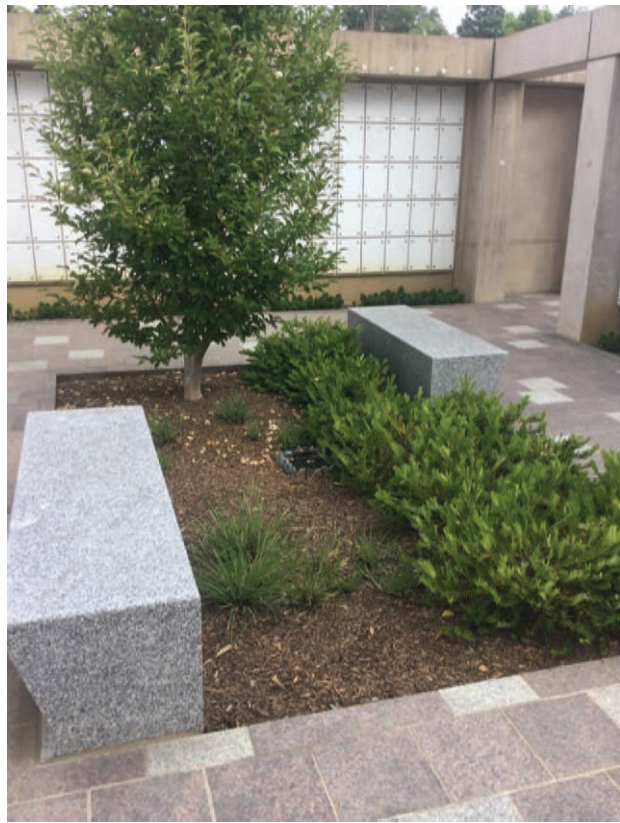
Arlington National Cemetery Post-Construction Inspection Checklist			BIORETENTION/RAIN GARDEN (with or without underdrain)	
Inspector Name, Title, Affiliation: Renee Lavinsky, Liz Shepherd (Bluestone)		Date: 6/12/2023	Date of last inspection: 6/28/2022	
Weather/site conditions: Cloudy, 80		Time since last rainfall: 72+		
BMP INFORMATION				
BMP Installation Date: 2018		Underdrain Present: <input type="checkbox"/> Yes <input checked="" type="checkbox"/> No		
BMP #: URG-3	Location: Columbarium 12	As-Built Plans available: <input type="checkbox"/> Yes <input checked="" type="checkbox"/> No		
ROUTINE MAINTENANCE ACTIVITIES				
Activity		Frequency	Completed	
Mowing grass filter strips and bioretention turf cover		At least 4 times a year	<input checked="" type="checkbox"/> Yes <input type="checkbox"/> No	
Spot weeding, erosion repair, trash removal, and mulch raking		Twice during growing season	<input checked="" type="checkbox"/> Yes <input type="checkbox"/> No

<ul style="list-style-type: none"> Spring visual inspection and cleanup Supplement mulch to maintain a 3" layer Prune trees and shrubs 		Annually	<input checked="" type="checkbox"/> Yes <input type="checkbox"/> No	
Remove sediment in pre-treatment cells and inflow points		Once every 2 to 3 years	<input checked="" type="checkbox"/> Yes <input type="checkbox"/> No <input type="checkbox"/> Not due	
Replace the mulch layer		Every 3 years	<input checked="" type="checkbox"/> Yes <input type="checkbox"/> No <input type="checkbox"/> Not due	
FIELD INSPECTION CHECKLIST				
Criteria	Maintenance Required?	ANC or Professional fix	Comments	Date Repaired
Surface				
Vegetation <ul style="list-style-type: none"> Vegetation species inconsistent with design specs Less than 75-90% cover (mulch plus vegetation) High grass Dying or dead vegetation Vegetation killed by salt or winter elements 	<input type="checkbox"/> Yes <input checked="" type="checkbox"/> No

Filter Media/Mulch Layer <ul style="list-style-type: none"> Too low, too compacted, and/or clogged Older than 3 years and/or in poor condition Ponding Chemicals, fertilizers, oil, grease, trash, debris, sediment, sand Erosion, exposed soil Topsoil in poor condition 	<input type="checkbox"/> Yes <input checked="" type="checkbox"/> No

FIELD INSPECTION CHECKLIST				
Criteria	Maintenance Required?	ANC or Professional fix	Comments	Date Repaired
Pre-treatment <ul style="list-style-type: none"> • Trash, sediment, debris, oil, grease • Clogging, standing water • Odor, algae, floating vegetation • Dead vegetation or exposed soil 	<input type="checkbox"/> Yes <input checked="" type="checkbox"/> No			
Outlet				
Erosion or sediment build-up	<input type="checkbox"/> Yes <input checked="" type="checkbox"/> No			
Grate or spillway condition	<input type="checkbox"/> Yes <input checked="" type="checkbox"/> No			
Proper Drainage, Underdrains and Observation Wells				
Does not dewater between storms or ponding for more than 48 hours after rain event	<input type="checkbox"/> Yes <input checked="" type="checkbox"/> No			
Clogged underdrains	<input type="checkbox"/> Yes <input checked="" type="checkbox"/> No			
Observation well caps present	<input type="checkbox"/> Yes <input checked="" type="checkbox"/> No <input type="checkbox"/> N/A

Inlets				
Sediment build-up, trash, debris, or erosion at curb cuts, pavement edges, and/or bypassing	<input type="checkbox"/> Yes <input checked="" type="checkbox"/> No			
Inflow hindered by vegetation	<input type="checkbox"/> Yes <input checked="" type="checkbox"/> No			
Drainage and Adjacent Upstream Areas				
Adequate vegetation	<input type="checkbox"/> Yes <input checked="" type="checkbox"/> No			
Trash, debris, bare soil, signs of scour, oil, grease, and/or erosion	<input type="checkbox"/> Yes <input checked="" type="checkbox"/> No			
Additional Observations or Comments: 				
ANNUAL REPORTING				
Are significant maintenance activities required for the stormwater management facility to perform as designed? (does not activities such as grass mowing or trash collection)				<input type="checkbox"/> Yes <input checked="" type="checkbox"/> No

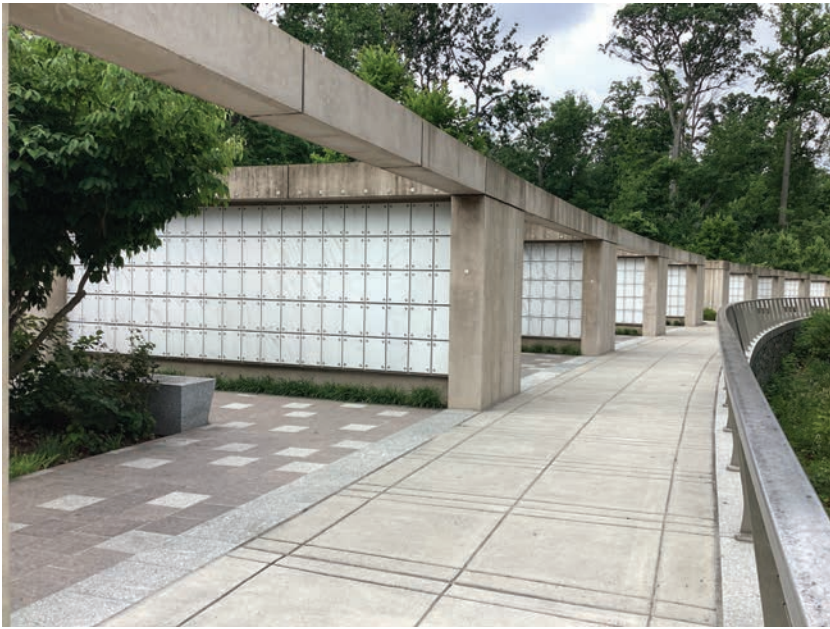
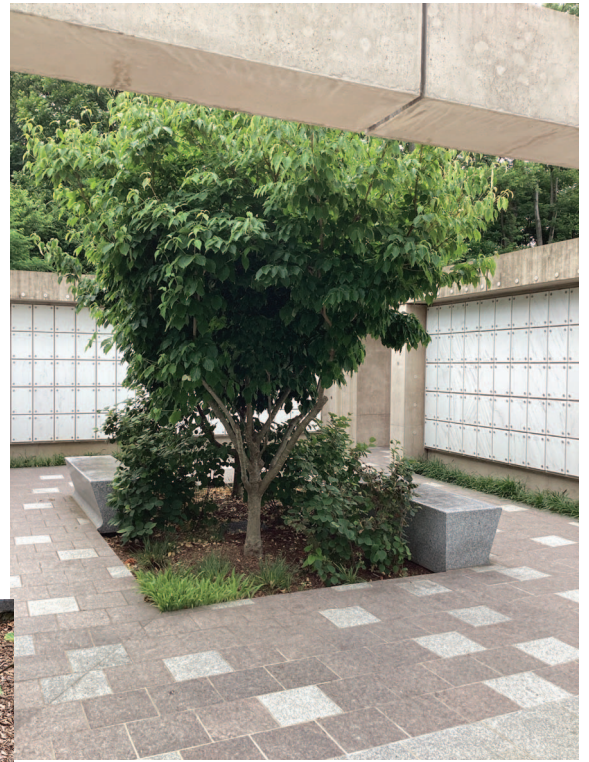
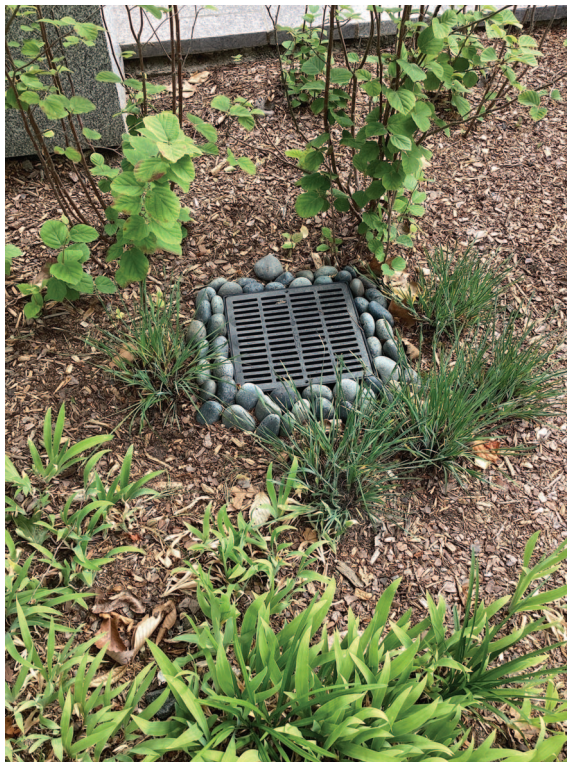
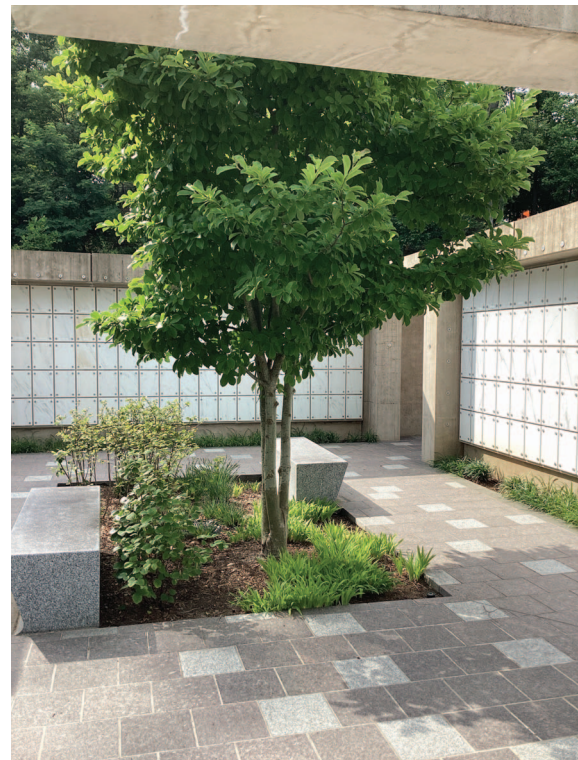
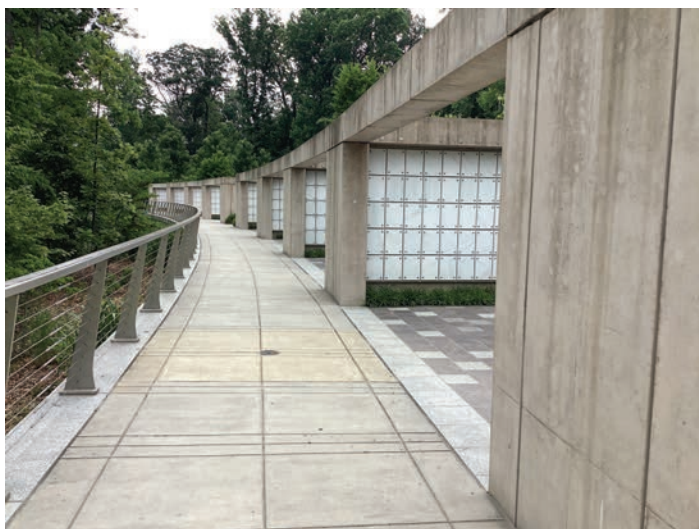
Arlington National Cemetery Post-Construction Inspection Checklist			BIORETENTION/RAIN GARDEN (with or without underdrain)	
Inspector Name, Title, Affiliation: Renee Lavinsky, Liz Shepherd (Bluestone)		Date: 6/12/2023	Date of last inspection: 6/28/2022	
Weather/site conditions: Cloudy, 80 degree		Time since last rainfall: 72+		
BMP INFORMATION				
BMP Installation Date: 2018		Underdrain Present: <input type="checkbox"/> Yes <input checked="" type="checkbox"/> No		
BMP #: URG-4	Location: Columbarium 13	As-Built Plans available: <input type="checkbox"/> Yes <input checked="" type="checkbox"/> No		
ROUTINE MAINTENANCE ACTIVITIES				
Activity		Frequency		Completed
Mowing grass filter strips and bioretention turf cover		At least 4 times a year		<input checked="" type="checkbox"/> Yes <input type="checkbox"/> No
Spot weeding, erosion repair, trash removal, and mulch raking		Twice during growing season		<input checked="" type="checkbox"/> Yes <input type="checkbox"/> No

<ul style="list-style-type: none"> Spring visual inspection and cleanup Supplement mulch to maintain a 3" layer Prune trees and shrubs 		Annually		<input checked="" type="checkbox"/> Yes <input type="checkbox"/> No
Remove sediment in pre-treatment cells and inflow points		Once every 2 to 3 years		<input type="checkbox"/> Yes <input type="checkbox"/> No <input checked="" type="checkbox"/> Not due
Replace the mulch layer		Every 3 years		<input type="checkbox"/> Yes <input type="checkbox"/> No <input checked="" type="checkbox"/> Not due
FIELD INSPECTION CHECKLIST				
Criteria	Maintenance Required?	ANC or Professional fix	Comments	Date Repaired
Surface				
Vegetation <ul style="list-style-type: none"> Vegetation species inconsistent with design specs Less than 75-90% cover (mulch plus vegetation) High grass Dying or dead vegetation Vegetation killed by salt or winter elements 	<input type="checkbox"/> Yes <input checked="" type="checkbox"/> No

Filter Media/Mulch Layer <ul style="list-style-type: none"> Too low, too compacted, and/or clogged Older than 3 years and/or in poor condition Ponding Chemicals, fertilizers, oil, grease, trash, debris, sediment, sand Erosion, exposed soil Topsoil in poor condition 	<input type="checkbox"/> Yes <input checked="" type="checkbox"/> No

FIELD INSPECTION CHECKLIST				
Criteria	Maintenance Required?	ANC or Professional fix	Comments	Date Repaired
Pre-treatment <ul style="list-style-type: none"> • Trash, sediment, debris, oil, grease • Clogging, standing water • Odor, algae, floating vegetation • Dead vegetation or exposed soil 	<input type="checkbox"/> Yes <input checked="" type="checkbox"/> No			
Outlet				
Erosion or sediment build-up	<input type="checkbox"/> Yes <input checked="" type="checkbox"/> No			
Grate or spillway condition	<input type="checkbox"/> Yes <input checked="" type="checkbox"/> No			
Proper Drainage, Underdrains and Observation Wells				
Does not dewater between storms or ponding for more than 48 hours after rain event	<input type="checkbox"/> Yes <input checked="" type="checkbox"/> No			
Clogged underdrains	<input type="checkbox"/> Yes <input checked="" type="checkbox"/> No			
Observation well caps present	<input type="checkbox"/> Yes <input type="checkbox"/> No <input checked="" type="checkbox"/> N/A

Inlets				
Sediment build-up, trash, debris, or erosion at curb cuts, pavement edges, and/or bypassing	<input type="checkbox"/> Yes <input checked="" type="checkbox"/> No			
Inflow hindered by vegetation	<input type="checkbox"/> Yes <input checked="" type="checkbox"/> No			
Drainage and Adjacent Upstream Areas				
Adequate vegetation	<input type="checkbox"/> Yes <input checked="" type="checkbox"/> No			
Trash, debris, bare soil, signs of scour, oil, grease, and/or erosion	<input type="checkbox"/> Yes <input checked="" type="checkbox"/> No			
Additional Observations or Comments:				
ANNUAL REPORTING				
Are significant maintenance activities required for the stormwater management facility to perform as designed? (does not activities such as grass mowing or trash collection)				<input checked="" type="checkbox"/> Yes <input type="checkbox"/> No

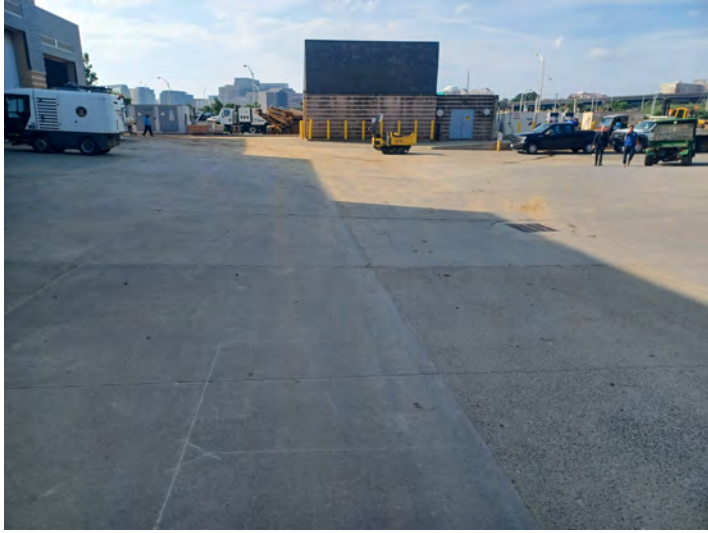
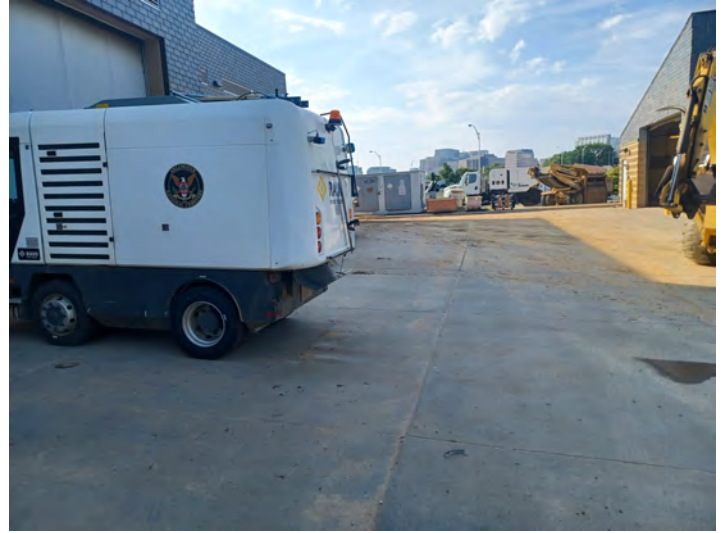
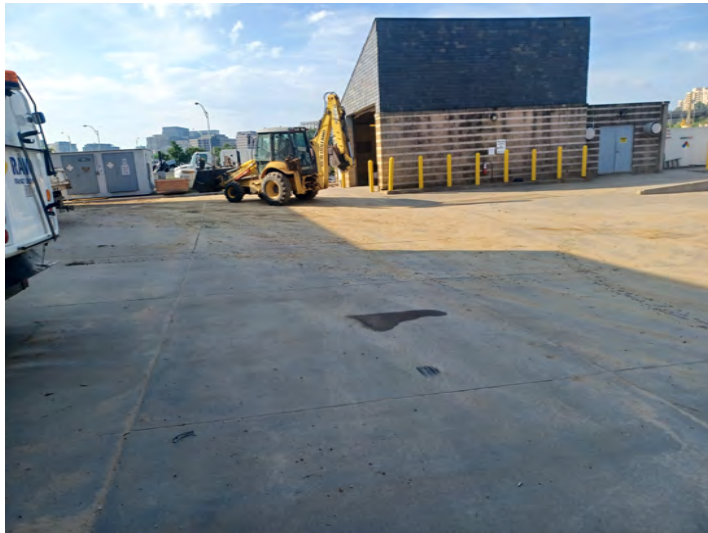
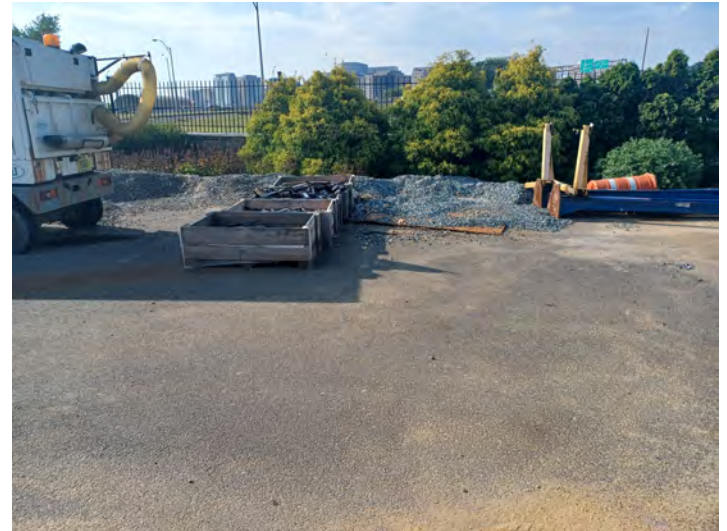
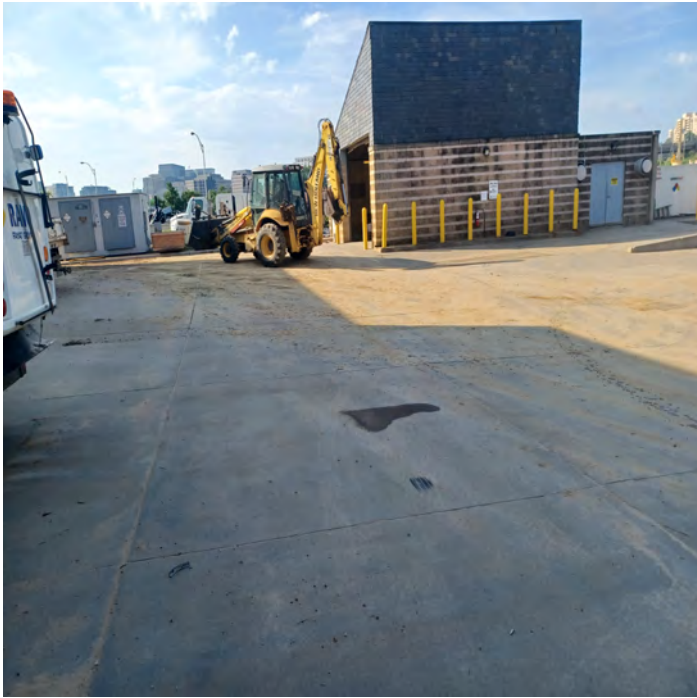
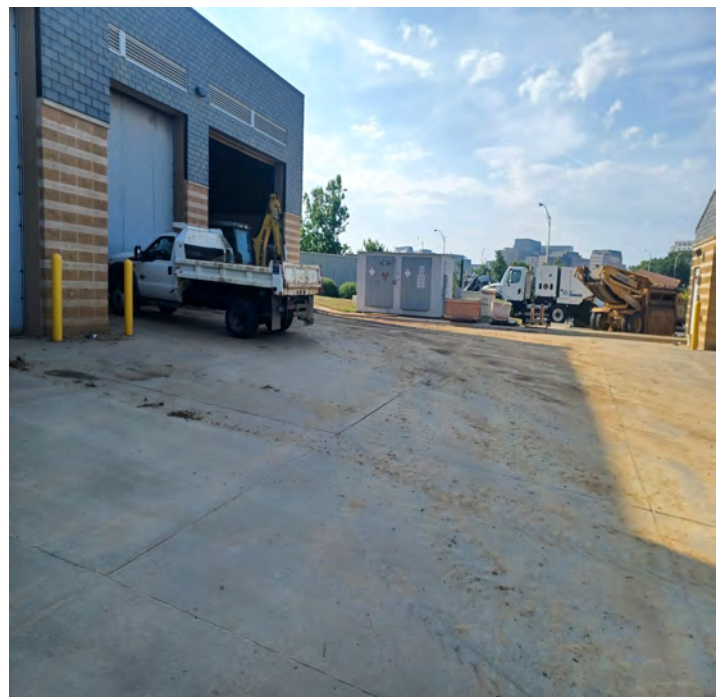
Building 123 Complex

Inspection Report		Results
Summary/Additional Comments		
<p>Recommend improving the cleanliness of the area where indoor soil and salt with the street sweeper and the closer of the doors.</p>

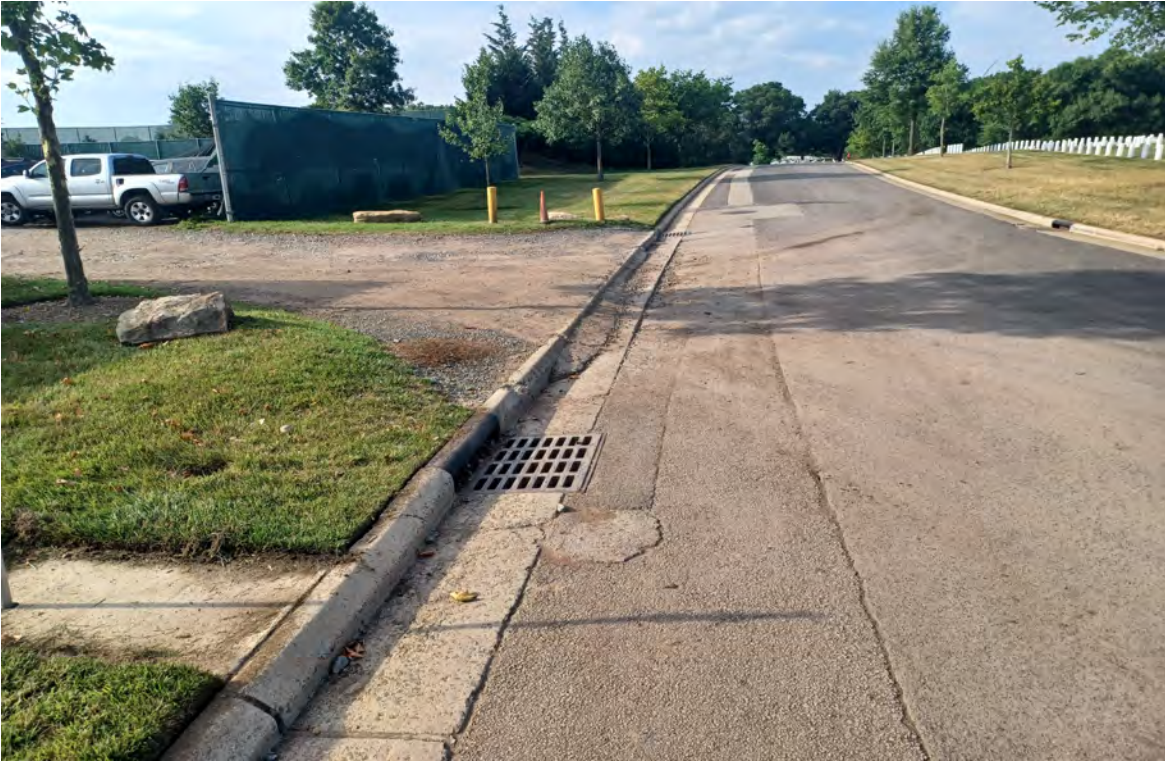
CONTRACTOR YARD

Inspection Report		Results
Summary/Additional Comments		
<p>Recommend ANC or contractors refresh stone entrance.</p> <p>Soil being stored in contractor yard needs to be covered by a tarp to help limit runoff. Contractors to store small gas powered equipment in containers. Contractors should continue to store equipment and soil properly.</p>

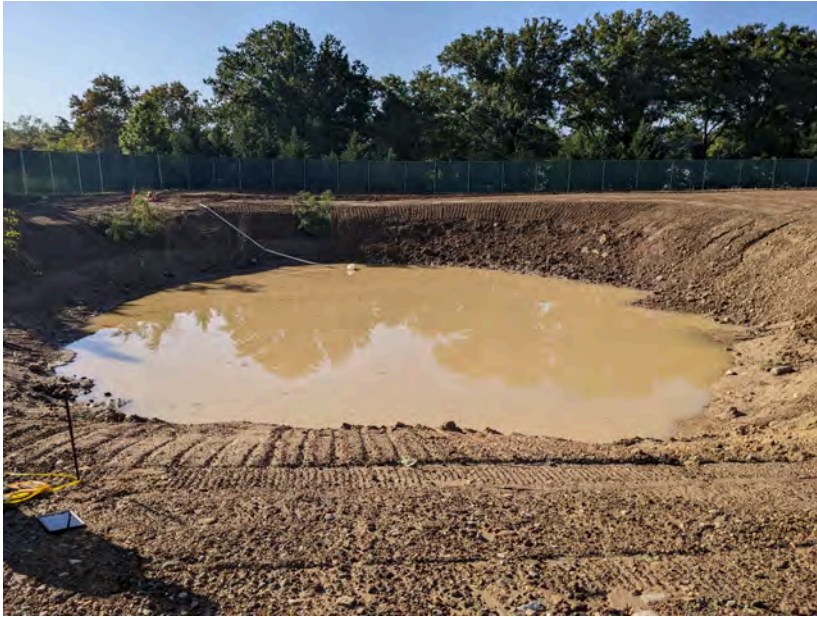
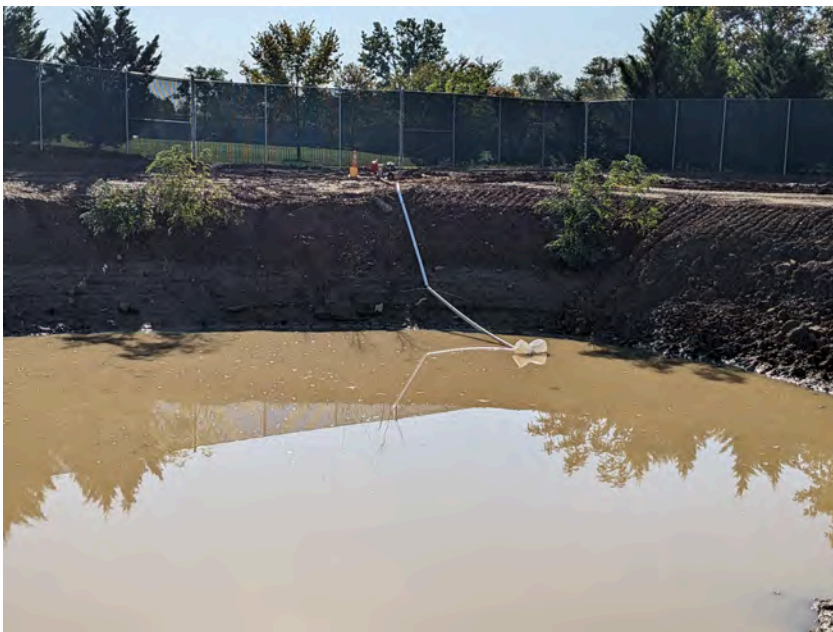
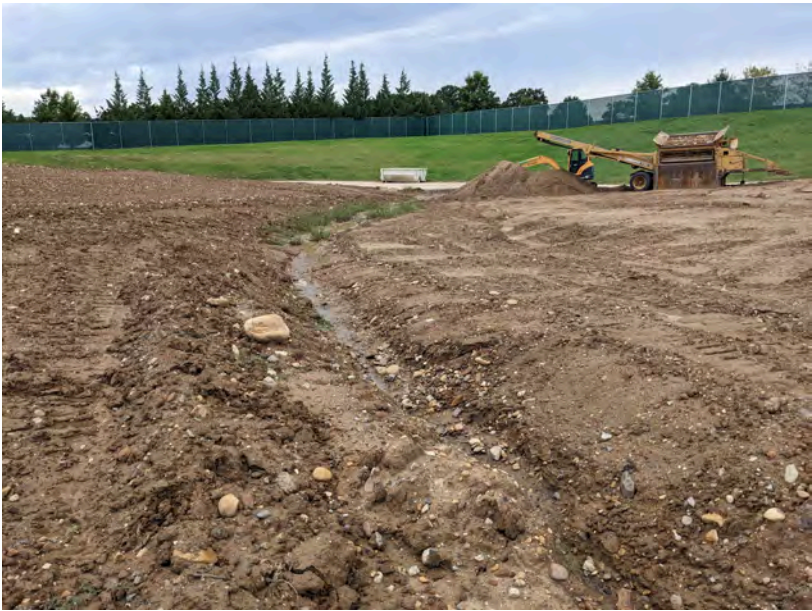
Photos collected in September 2023

Inspection Report	Results
Summary/Additional Comments	
<p>The Spoils Yard has a stormwater retention basin. The basin does not have an overflow or underdrain. Stormwater runoff is managed within the Spoils Yard. Each access point (Marshall Drive and Halsey Drive) to the Spoils Yard has a washrack.</p> <p>Stormwater retention basin requires permanent stabilization. Even though, ANC seeded the basin and the surrounding area in fall 2020, operations in the Spoils Yard requires ANC to grade (slope) and reseed the basin and the area surrounding the basin. ANC has a contract in place to evaluate and propose permanent engineered solutions.</p> <p>Storm drain inlets along Halsey and Marshall Drives, adjacent to the Spoils Yard, discharge through STC7 to OF8-SEC74 and Boundary Channel. ANC cleans out most of its storm drain inlets at least annually and others, such as those adjacent to the spoils yard, they clean out several times a year.</p> <p>Recommend Interment Operations develop a schedule for cleaning the wash racks and picking up trash.</p>
